Interagency Mitigation Monitoring Program Pilot Project Final Report

September 2008

MSG¹ Interagency Mitigation Monitoring Program Subcommittee Members²

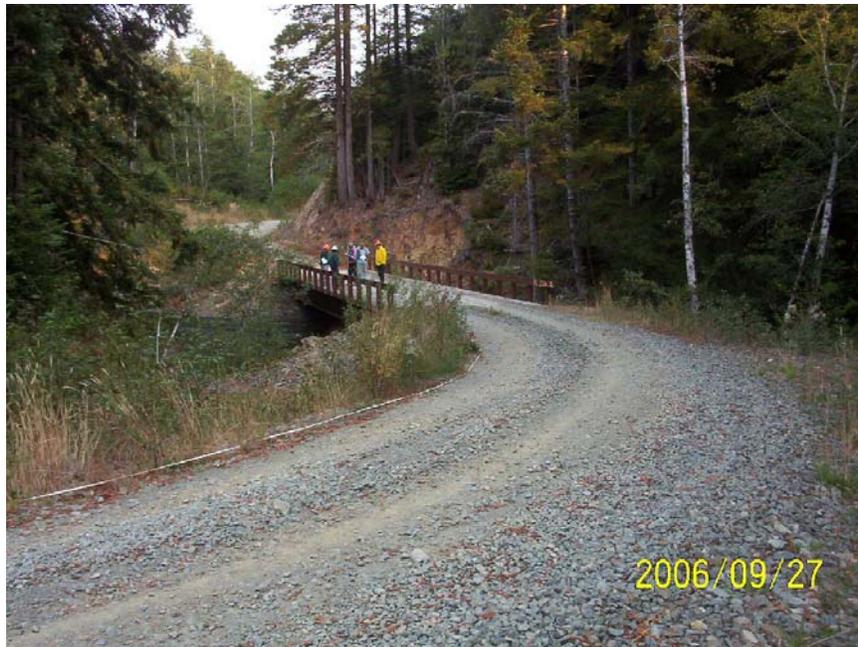
Figure 9. Bridge evaluated in Humboldt County by the Coast team during the 2006 field season. Note the tape stretched along the road approach to measure road length in the WLPZ.

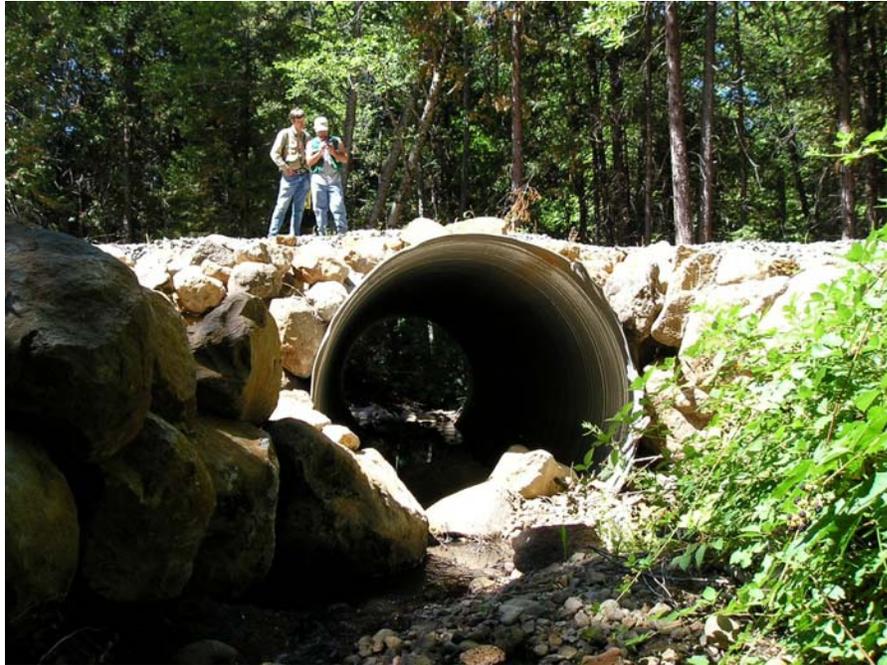
Figure 12. Pilot project Inland team members Dave Longstreth, CGS, and Joe Croteau, DFG, at a culvert installed on a THP in Shasta County in August 2006.

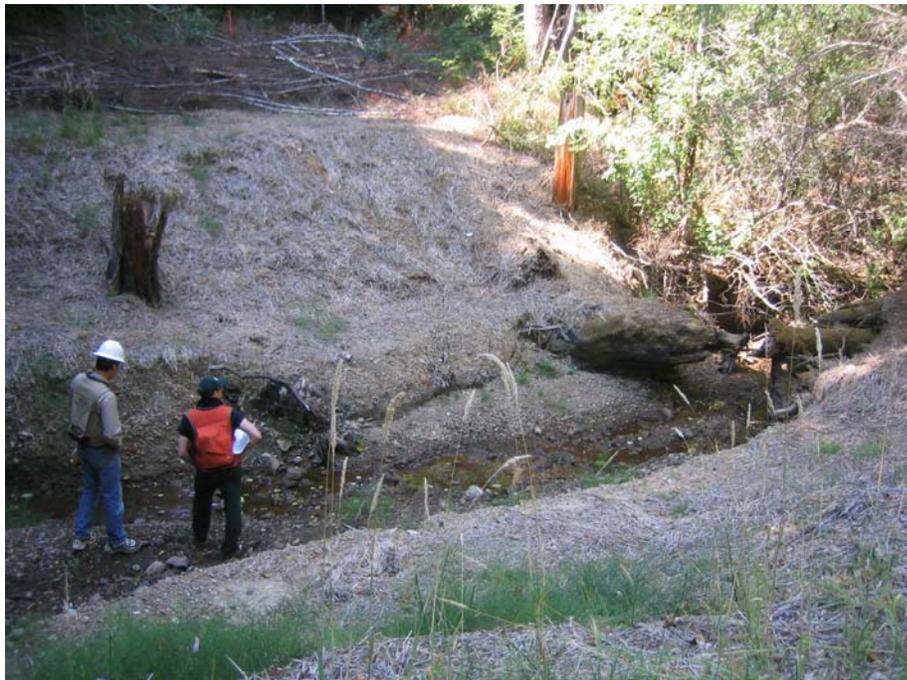
Figure 13. Pilot project Coast team members Dave Longstreth, CGS, and Richard Fitzgerald, DFG, evaluating a removed watercourse crossing in Mendocino County in August 2006.
