**9GA22700
HAMEY WOODS
SANTA CRUZ MOUNTAINS POST-FIRE REDWOOD DEFECT STUDY**

Date: December 30, 2023

Project Status and Progress Report:

Post-fire Effects, Tomography Scans, and Log Scaling of
San Vicente Redwood Trees -- Photo Documentation
DRAFT

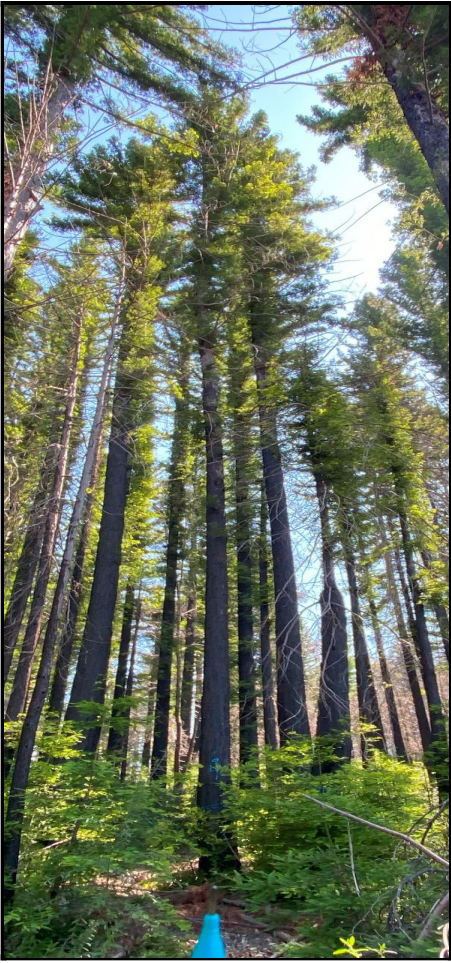
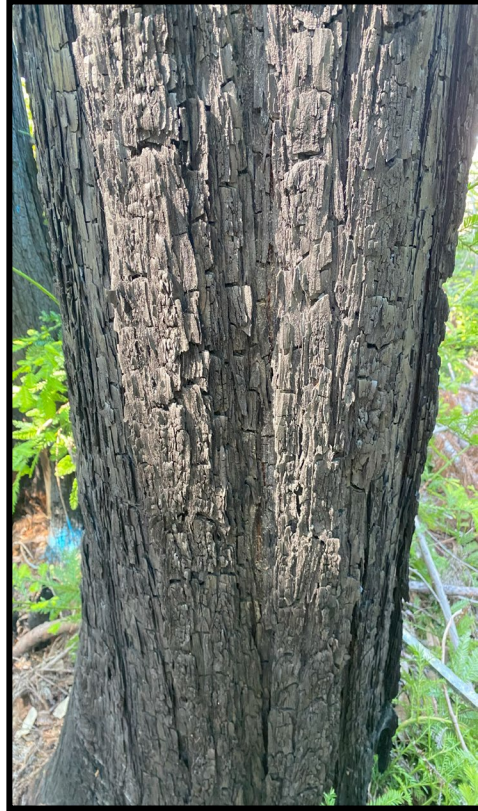
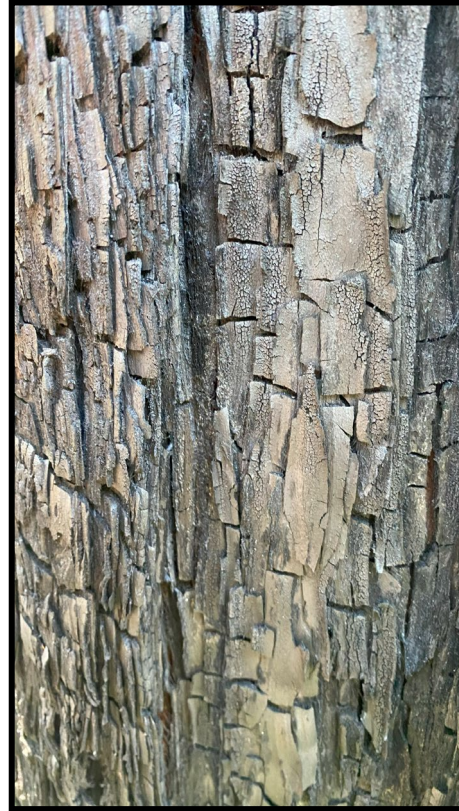
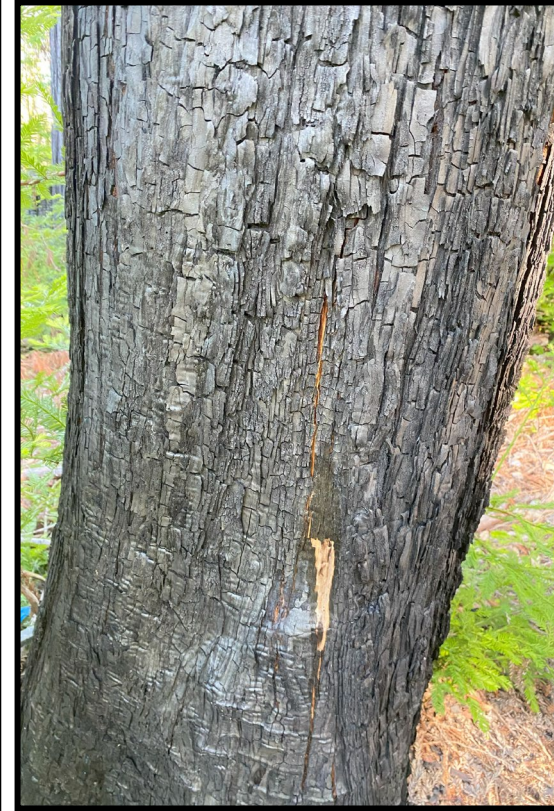
Full Tree and Fungus Photos

- ~64 sq. in of white rot
- ¼ quadrants of fungus
- ¼ quadrants of dead cambium
- Branch & Bole Sprouting
- Low-Moderate Burn Severity Zone

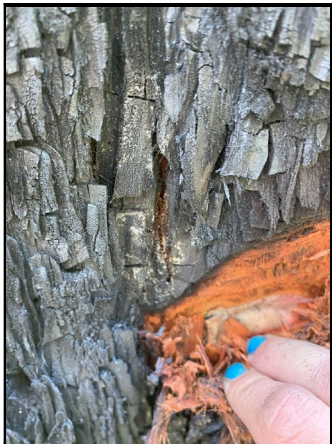
Alive/Fungus

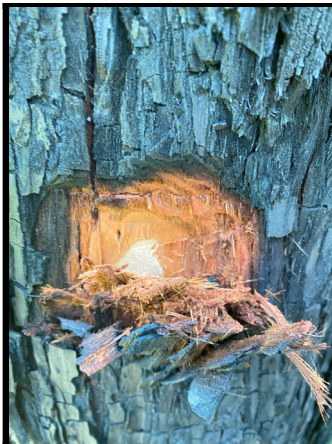
Dead/No Fungus

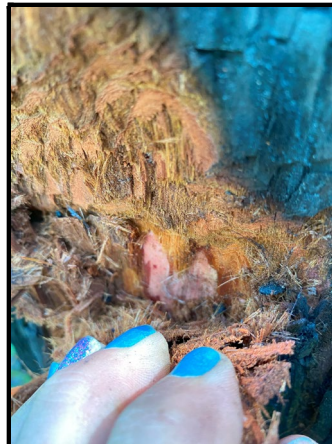
Alive/No Fungus

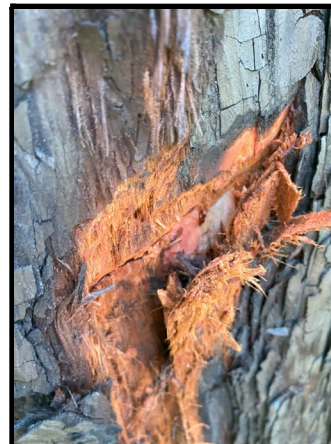
Alive/No Fungus

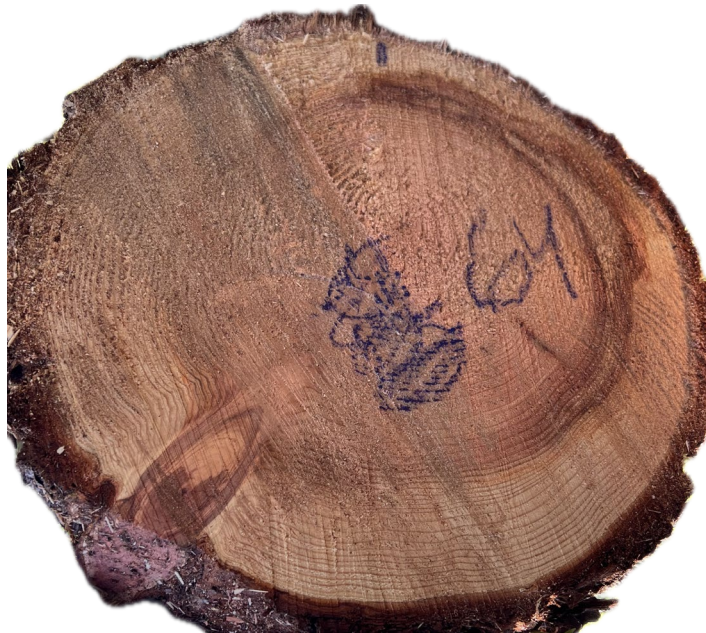
Log #1- Big End:

- 17" Inside Bark (IB) before deductions
- 1-2" of sapwood rot around 45% circumference to the edge of heartwood
- Yellowing sapwood

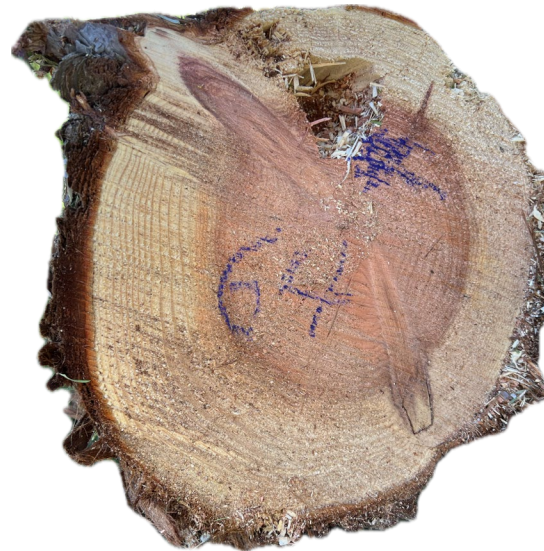
Log #1 Small End/ Log #2 Big End

- 11" IB
- Healthy sapwood and heartwood

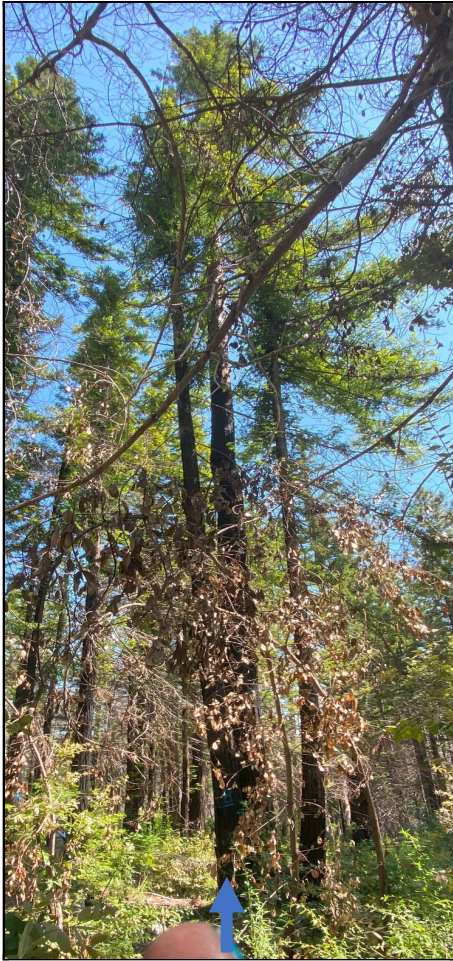
← Full Tree Photo

- $\frac{1}{4}$ quadrants of fungus
- $\frac{1}{4}$ quadrants of dead cambium
- Bole Sprouting
- Moderate-High Burn Severity Zone
- Dead top

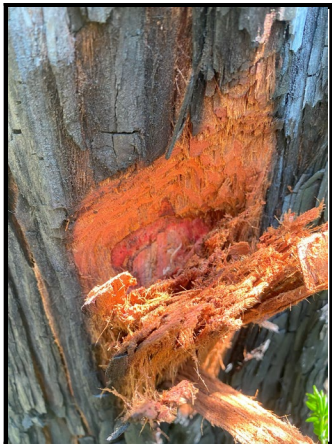
Alive/No Fungus

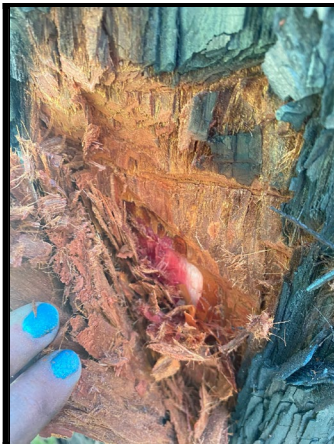
Alive/No Fungus

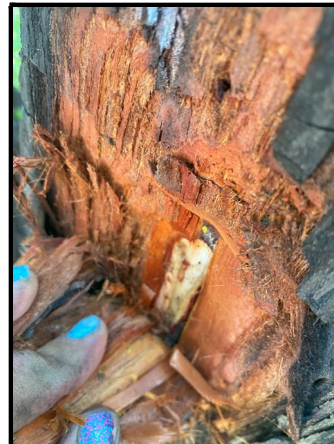
Alive/No Fungus

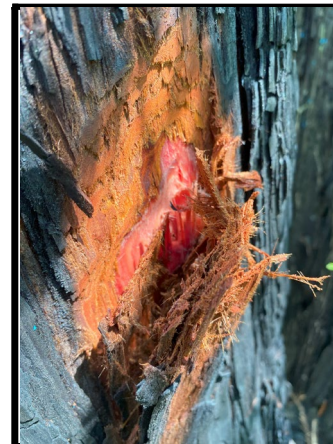
Alive/No Fungus

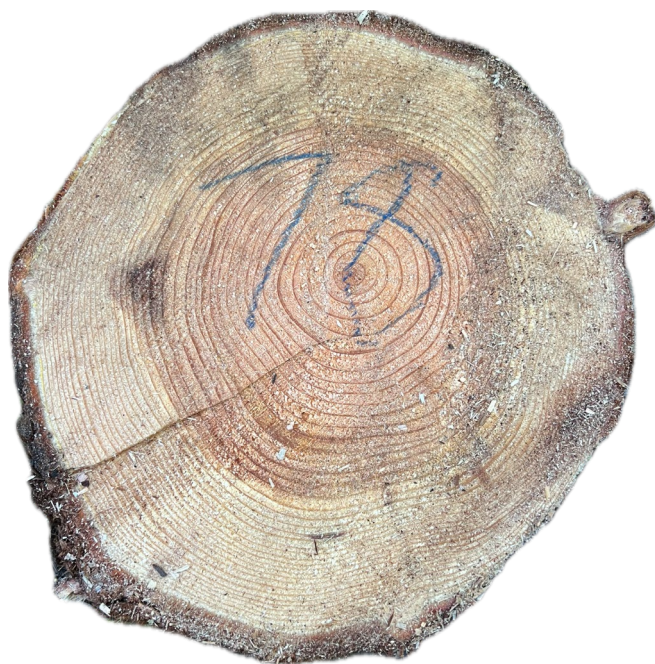
Log #1 Big End

- 18" Inside Bark (IB) before deductions
- 1.5-2.25" of sapwood rot around 10% circumference to the edge of heartwood
- Yellowing sapwood

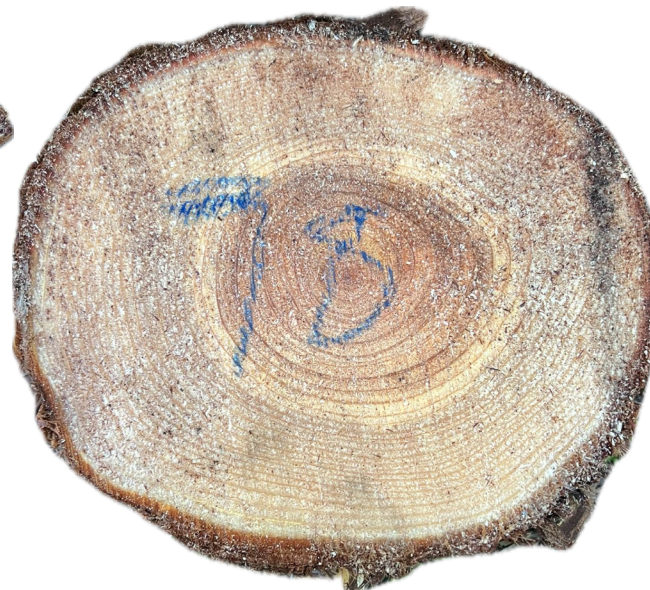
Log #1 Small End/ Log #2 Big End

- 11" IB
- Healthy sapwood and heartwood

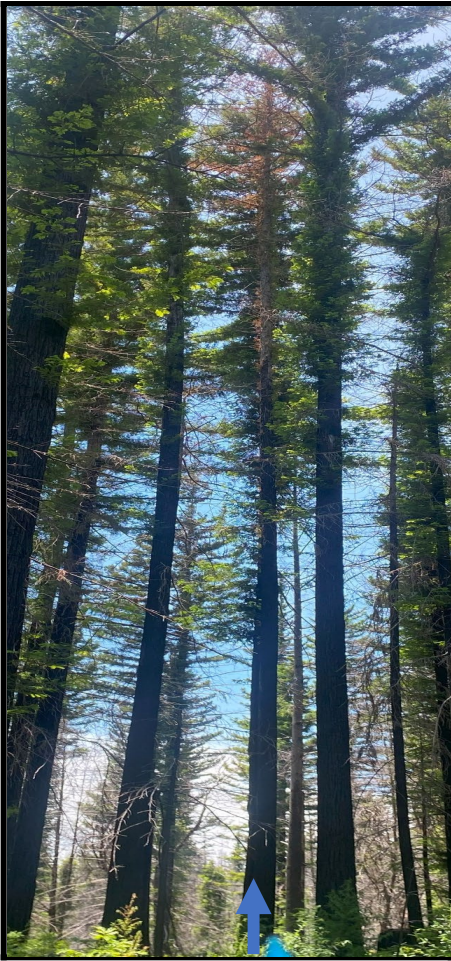
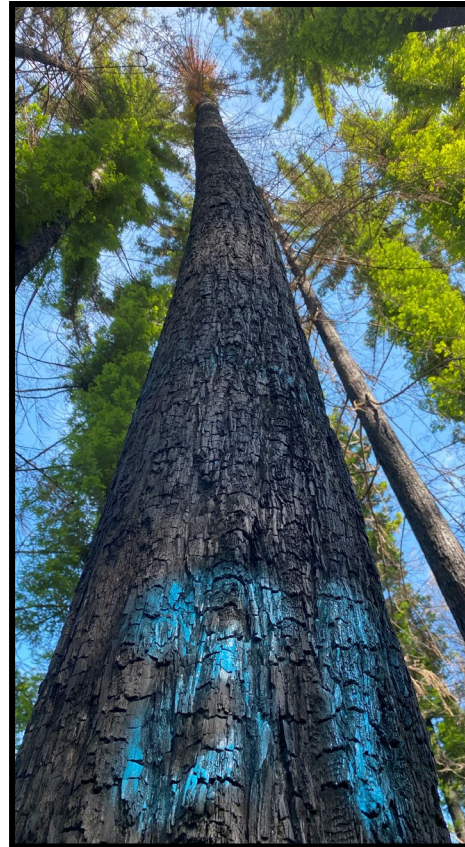
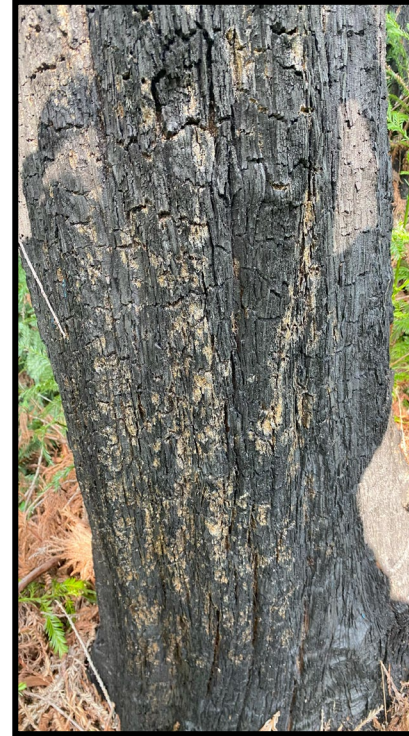
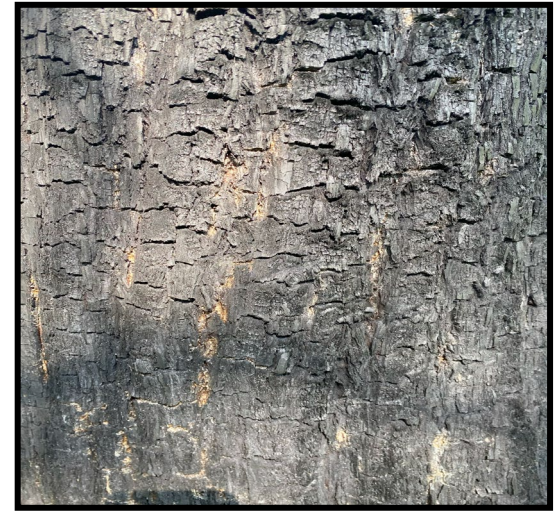
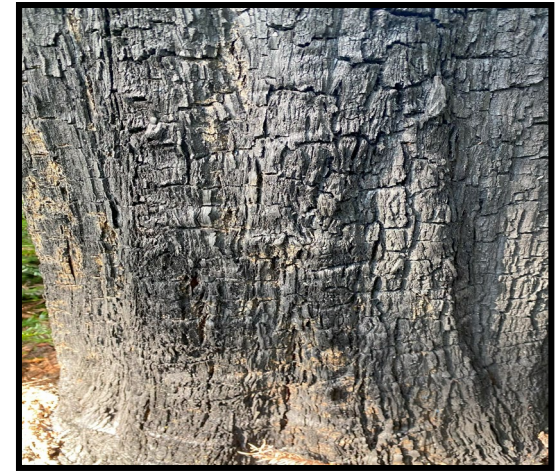
Full Tree and Fungus Photos

- ~890 sq. in of white rot
- $\frac{3}{4}$ quadrants of fungus
- $\frac{4}{4}$ quadrants of dead cambium
- Tree was dying at time of measurement and was dead at the time of cutting
- Branch & Bole Sprouting (Branch sprouts dead at time of measurement)
- Moderate-High Burn Severity Zone

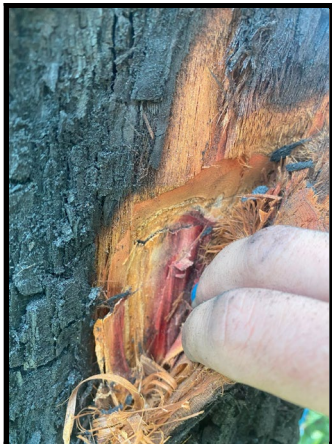
Dead/Fungus

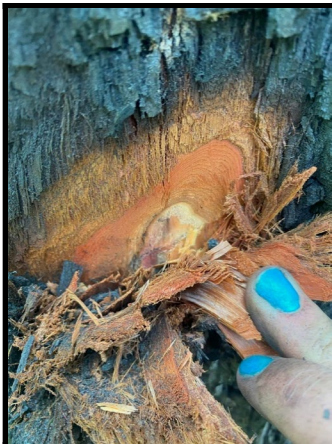
Dead/Fungus

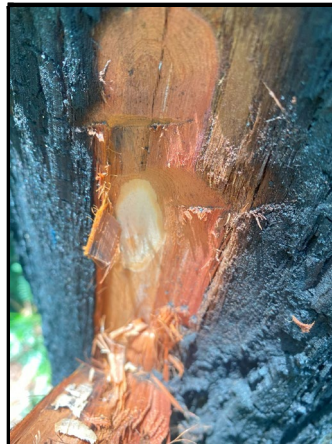
Dead/Fungus

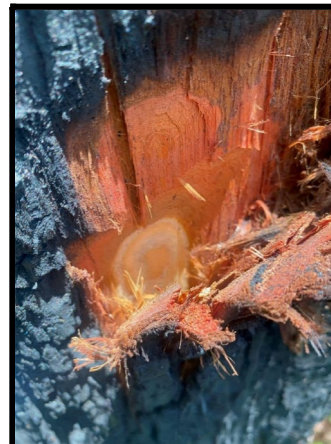
Dead/No Fungus

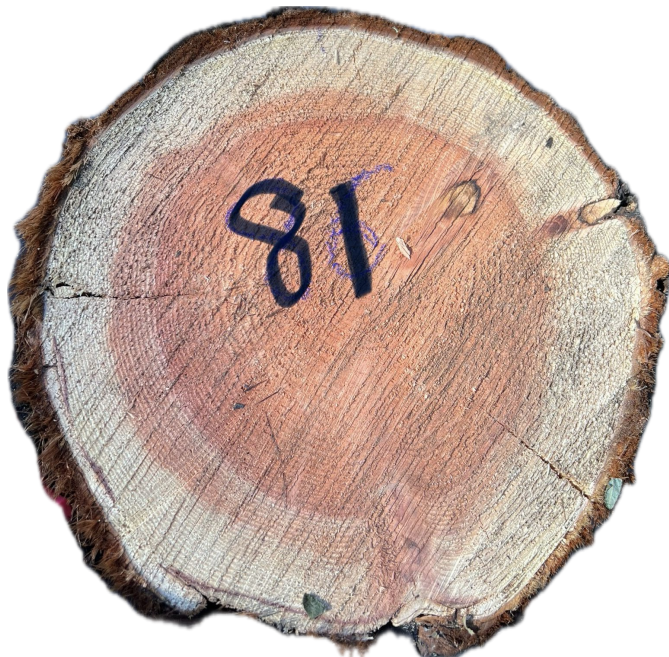
Log #1 Big End

- 15" Inside Bark (IB) before deductions
- 1.75-2" of sapwood rot around 90% circumference to the edge of heartwood
- Yellowing sapwood

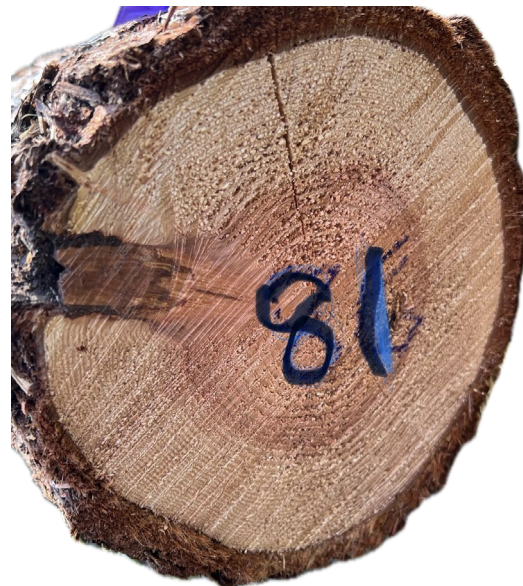
Log #1 Small End/ Log #2 Big End

- 9" IB
- Healthy sapwood and heartwood

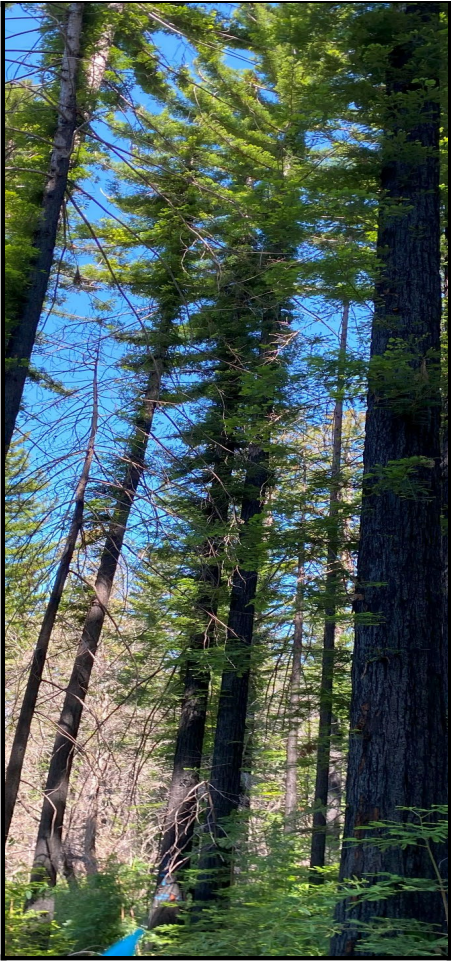
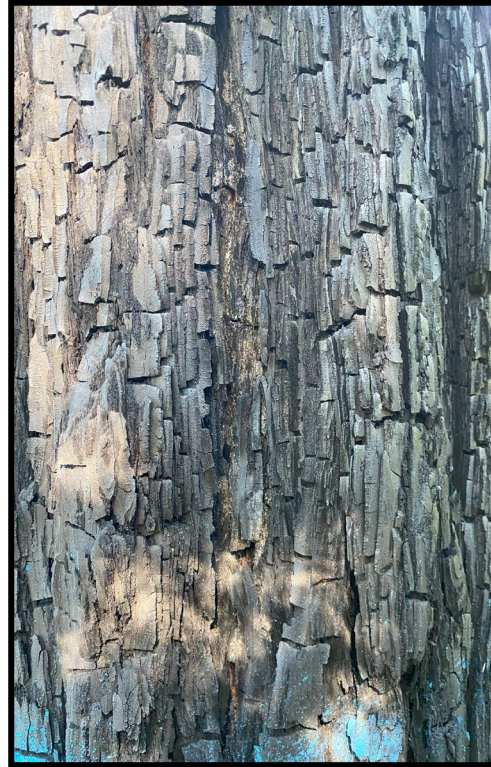
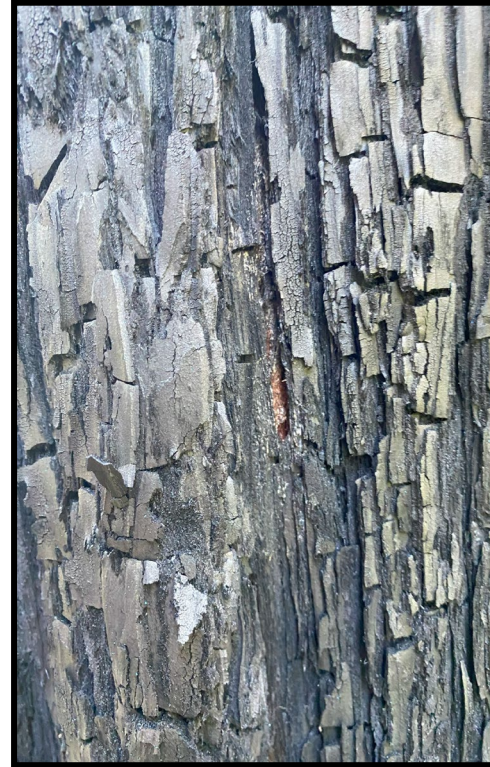
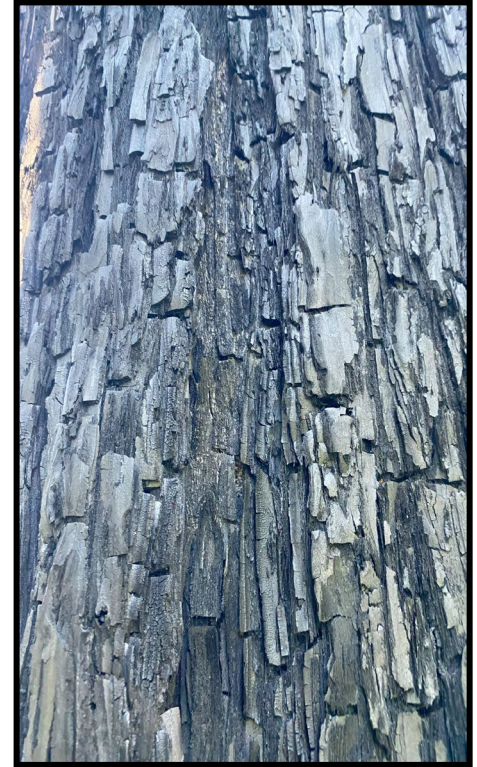
Full Tree and Fungus Photos

- ~74 sq. in of white rot
- 1/4 quadrants of fungus
- 9/4 quadrants of dead cambium
- Branch & Bole Sprouting
- Low-Moderate Burn Severity Zone

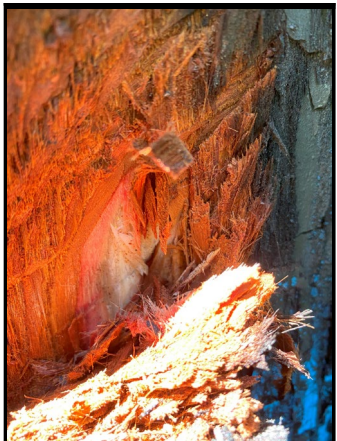
Alive/Fungus

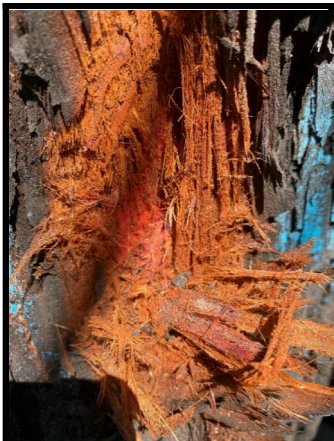
Alive/No Fungus

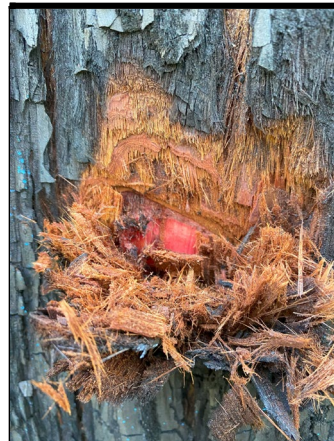
Alive/No Fungus

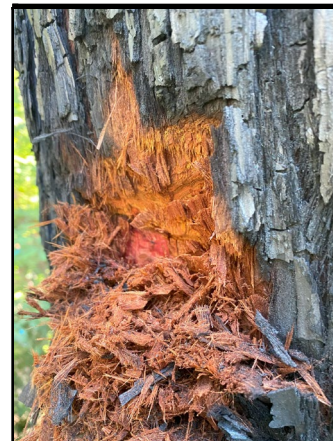
Alive/No Fungus

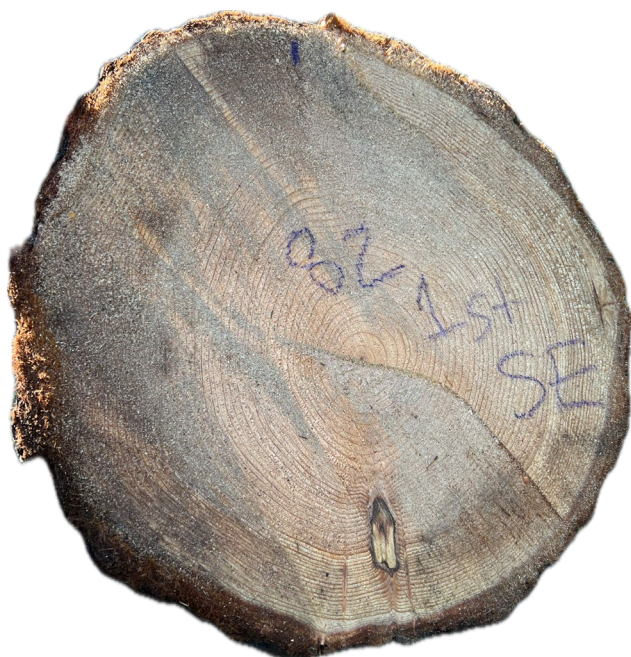
Log #1 Big End

- 18" Inside Bark (IB) before deductions
- 1-2" of sapwood rot around 8% circumference to the edge of heartwood
- Yellowing sapwood

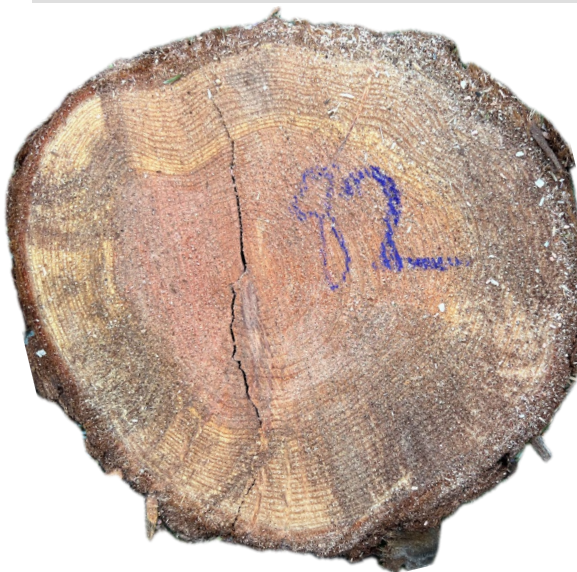
Log #1 Small End/ Log #2 Big End

- 12" IB
- Healthy sapwood and heartwood
- Knot present
