**9GA22700
HAMEY WOODS
SANTA CRUZ MOUNTAINS POST-FIRE REDWOOD DEFECT STUDY**

Date: December 30, 2023

Project Status and Progress Report:

Post-fire Effects, Tomography Scans, and Log Scaling of
San Vicente Redwood Trees -- Photo Documentation
DRAFT

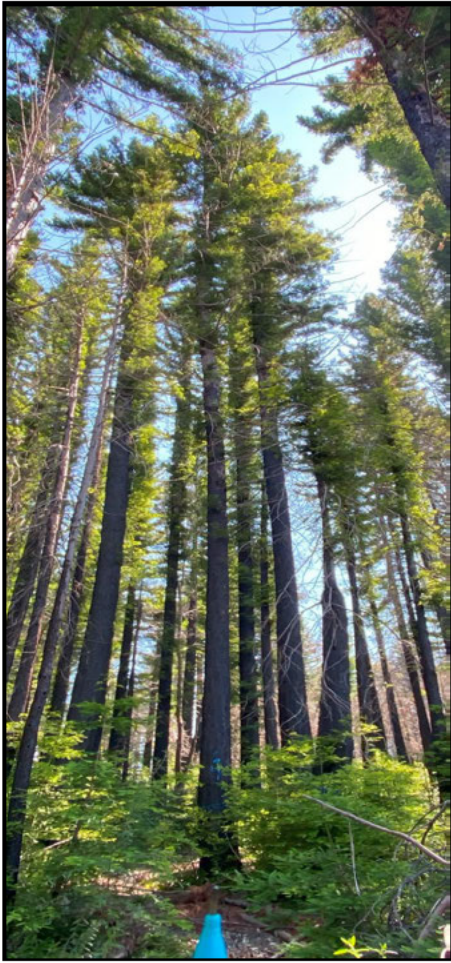
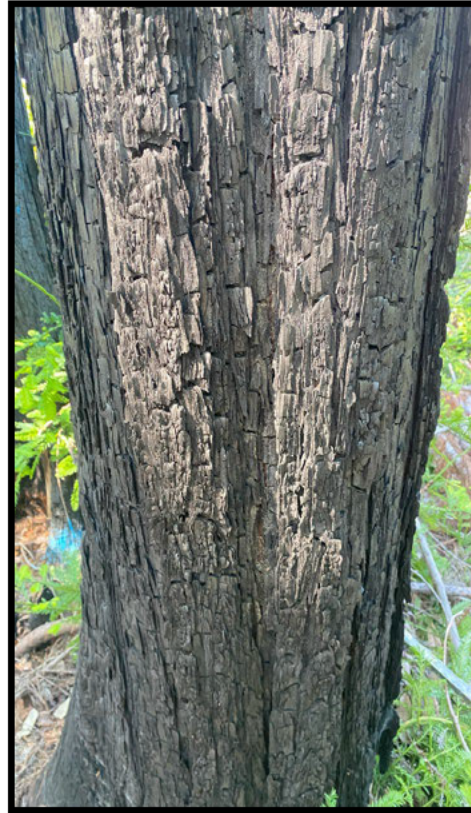
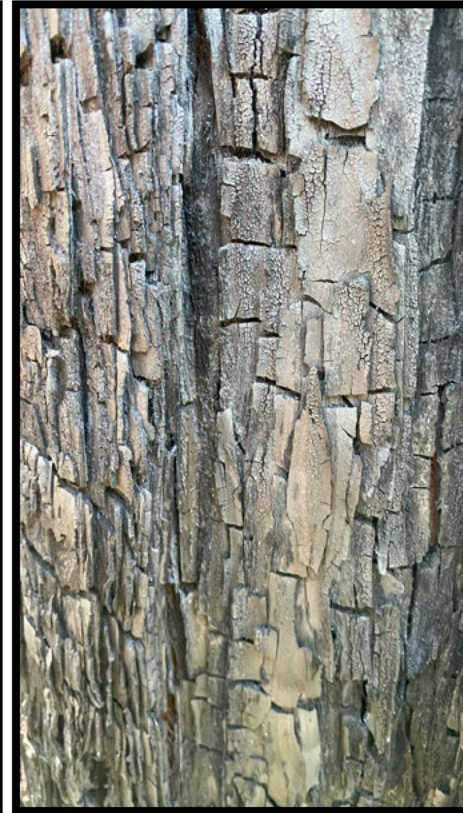
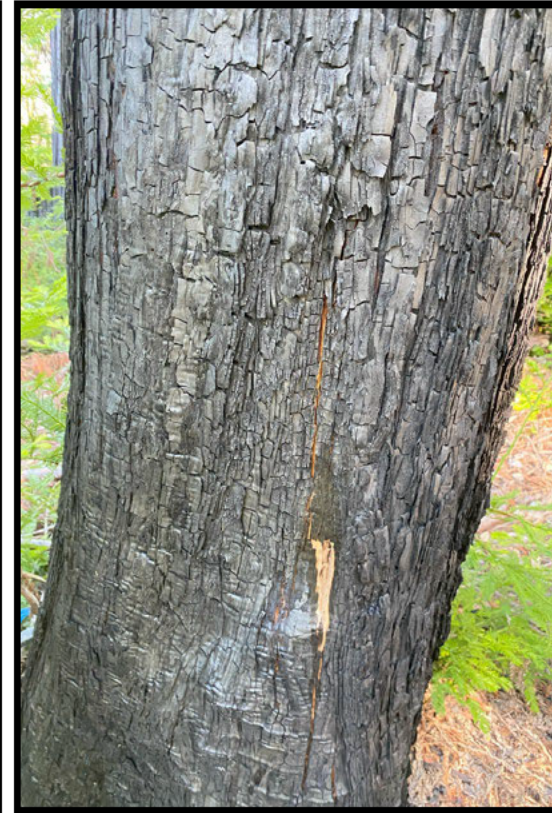
- ~64 sq. in of white rot
- ¼ quadrants of fungus
- ¼ quadrants of dead cambium
- Branch & Bole Sprouting
- Low-Moderate Burn Severity Zone

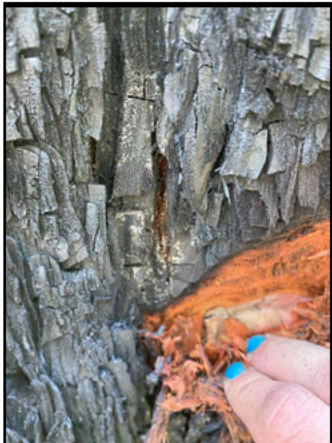
Alive/Fungus

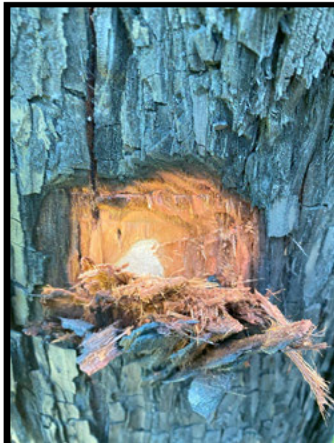
Dead/No Fungus

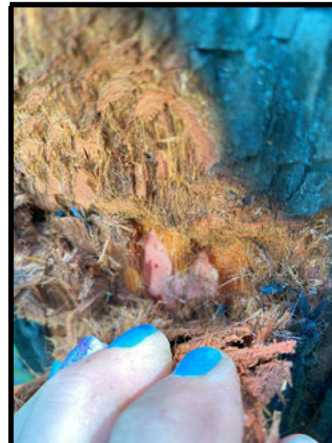
Alive/No Fungus

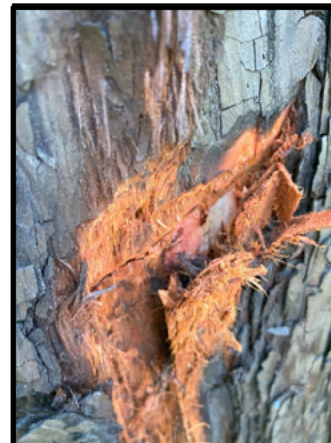
Alive/No Fungus

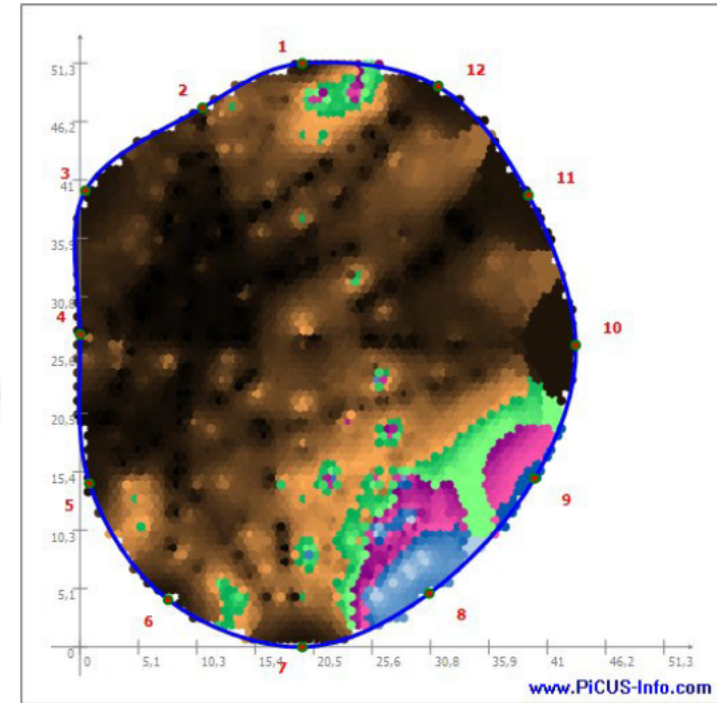
Log #1- Big End:

- 17" Inside Bark (IB) before deductions
- 1-2" of sapwood rot around 45% circumference to the edge of heartwood
- Yellowing sapwood

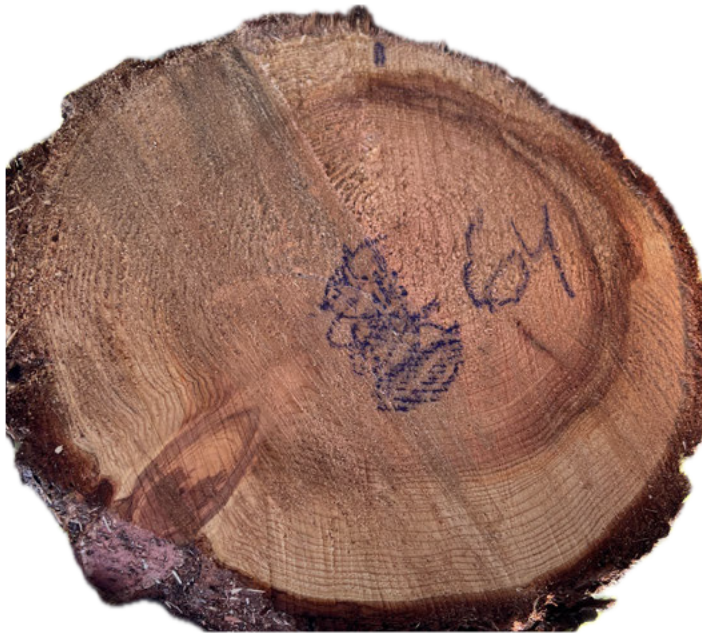
Log #1 Small End/ Log #2 Big End

- 11" IB
- Healthy sapwood and heartwood

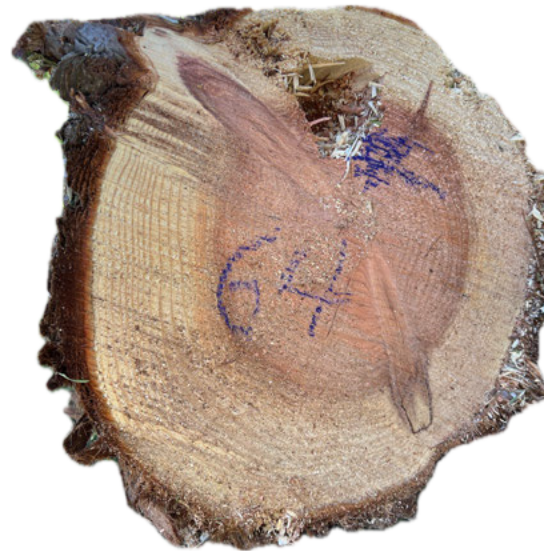
Log #2 Small End

- 9" IB
- Healthy sapwood and heartwood
- Slight mechanical damage

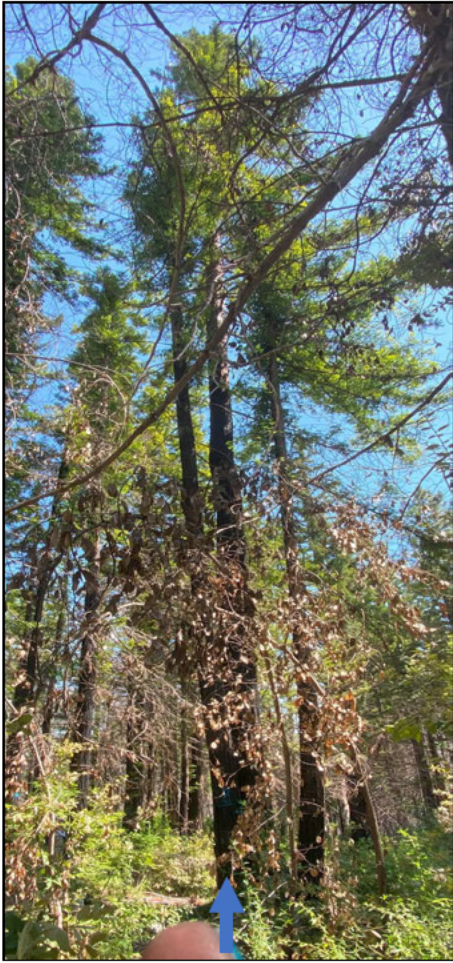
- ¼ quadrants of fungus
- ¼ quadrants of dead cambium
- Bole Sprouting
- Moderate-High Burn Severity Zone
- Dead top

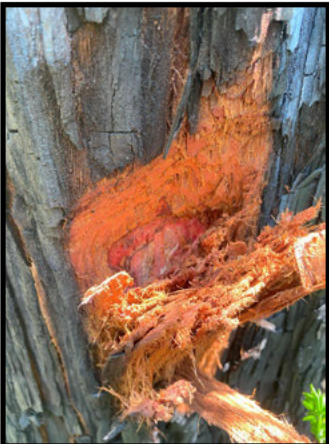
Alive/No Fungus

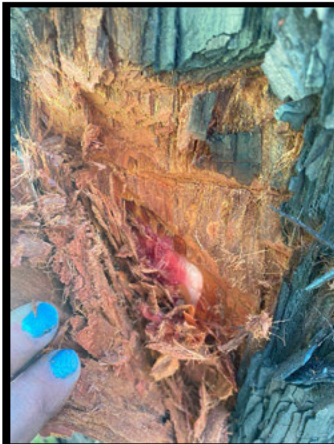
Alive/No Fungus

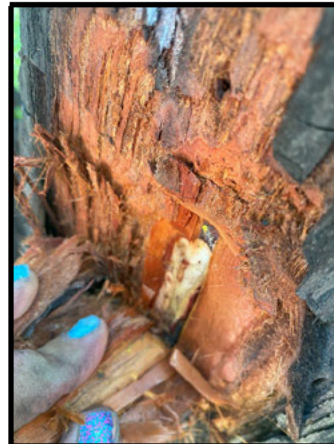
Alive/No Fungus

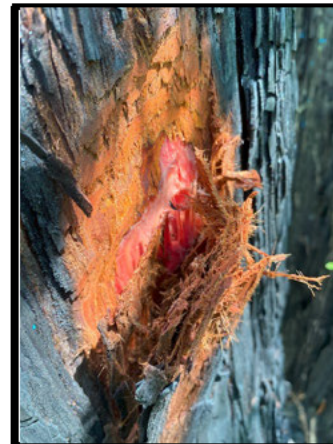
Alive/No Fungus

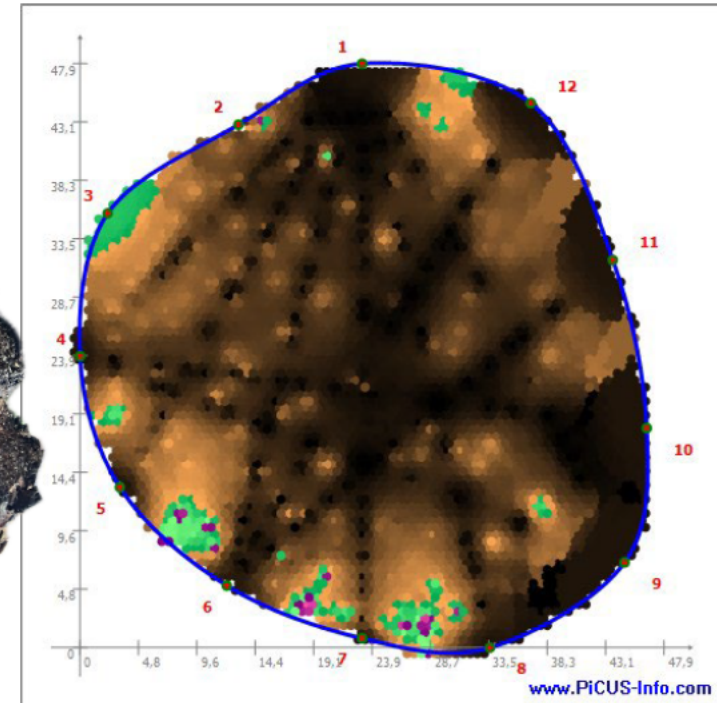
Log #1 Big End

- 18" Inside Bark (IB) before deductions
- 1.5-2.25" of sapwood rot around 10% circumference to the edge of heartwood
- Yellowing sapwood

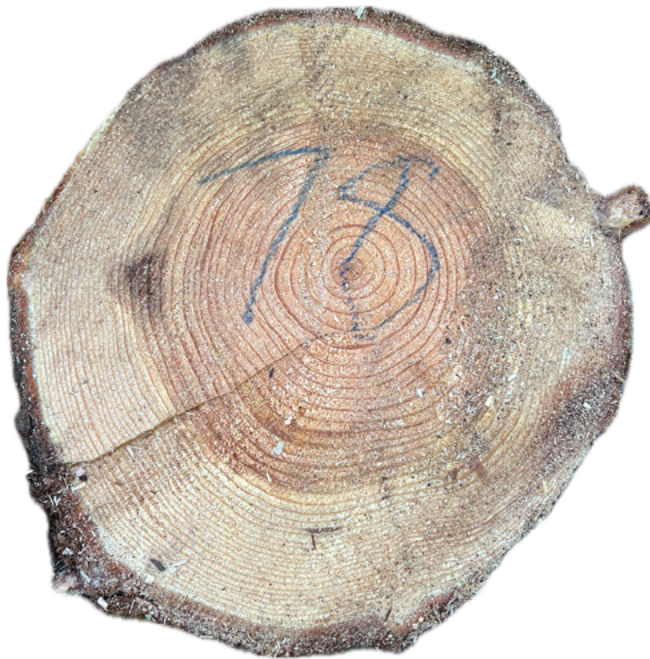
Log #1 Small End/ Log #2 Big End

- 11" IB
- Healthy sapwood and heartwood

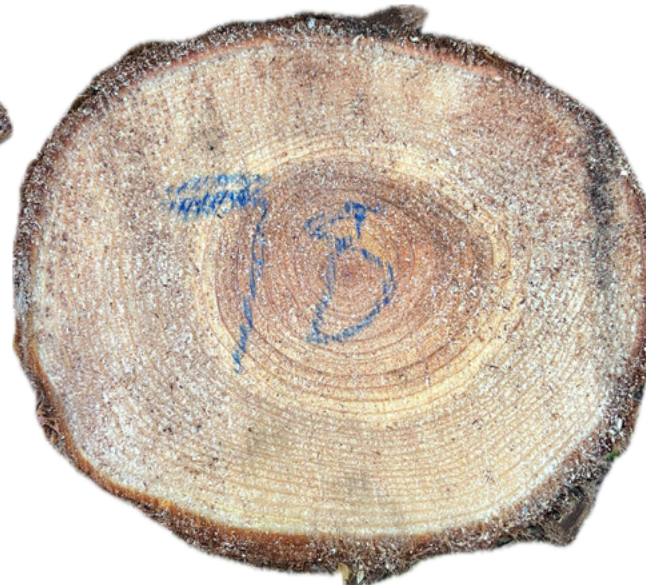
Log #2 Small End

- 7" IB
- Healthy sapwood and heartwood

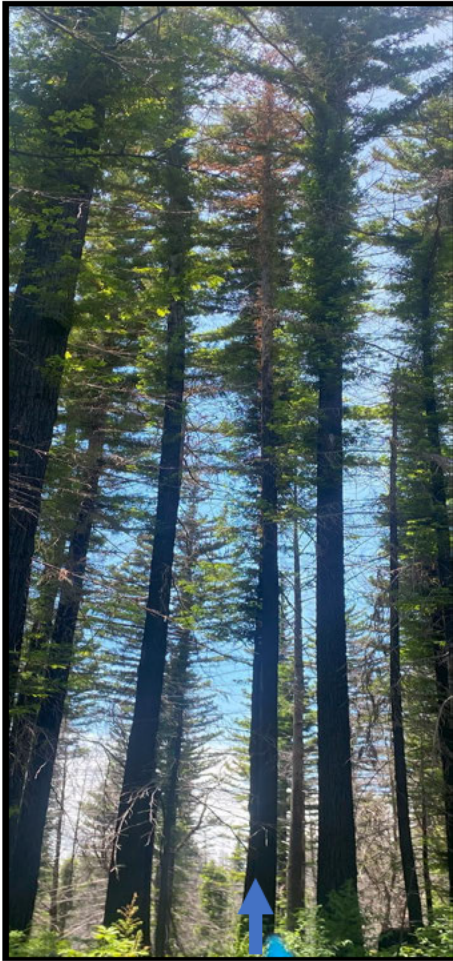
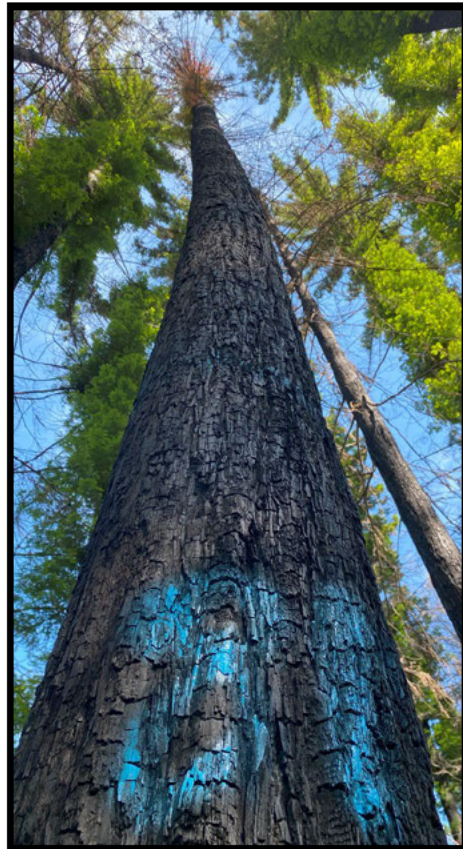
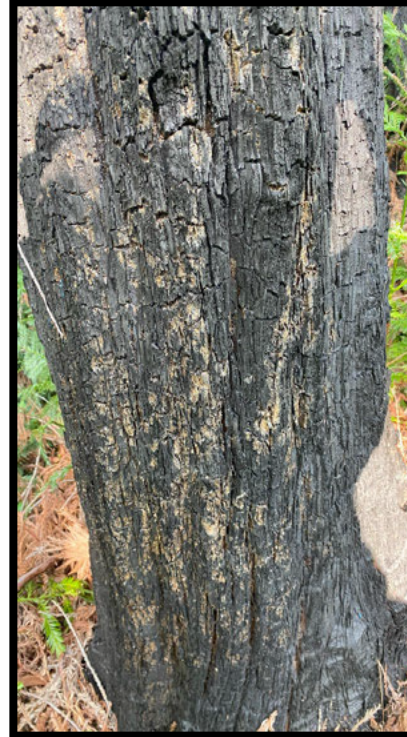
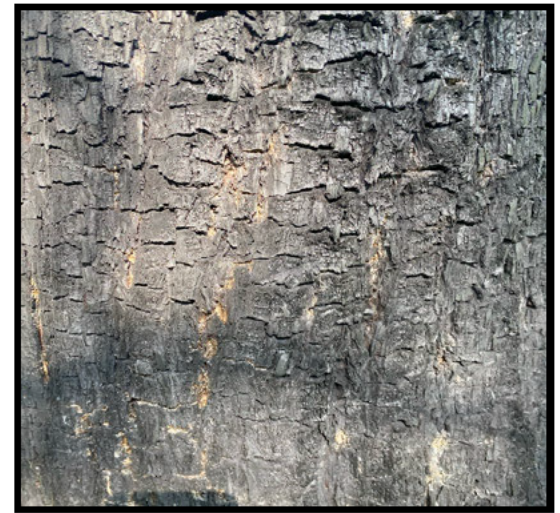
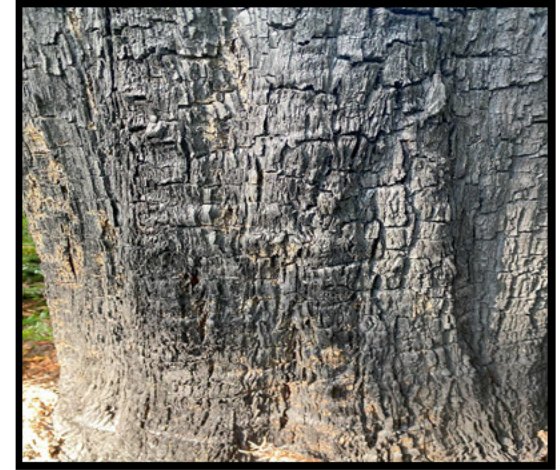
- ~890 sq. in of white rot
- $\frac{3}{4}$ quadrants of fungus
- $\frac{4}{4}$ quadrants of dead cambium
- Tree was dying at time of measurement and was dead at the time of cutting
- Branch & Bole Sprouting (Branch sprouts dead at time of measurement)
- Moderate-High Burn Severity Zone

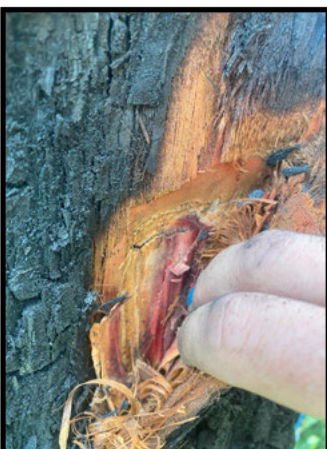
Dead/Fungus

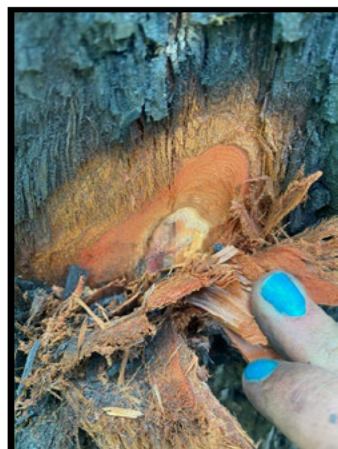
Dead/Fungus

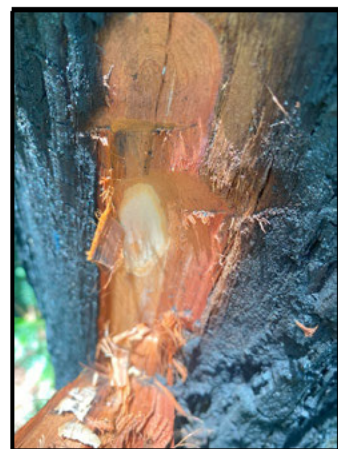
Dead/Fungus

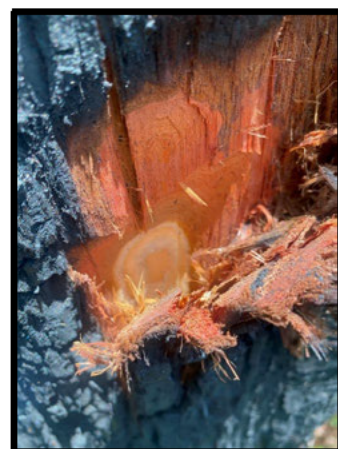
Dead/No Fungus

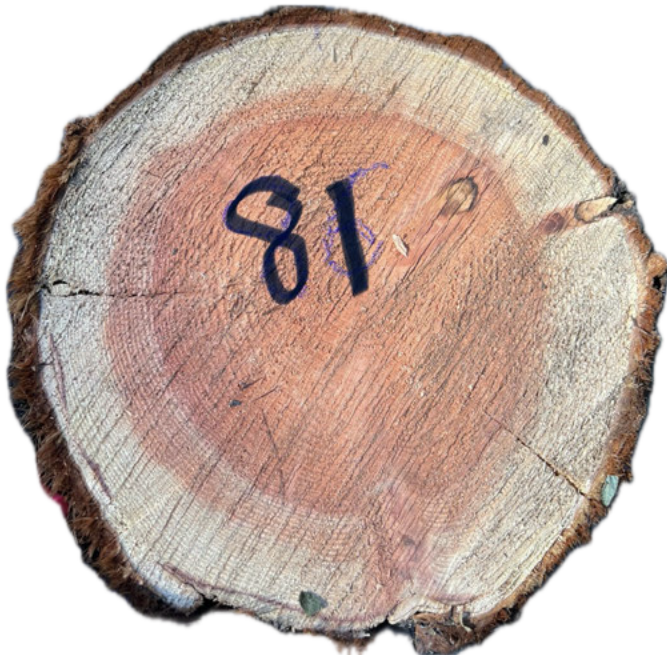
Log #1 Small End/ Log #2 Big End

- 9" IB
- Healthy sapwood and heartwood

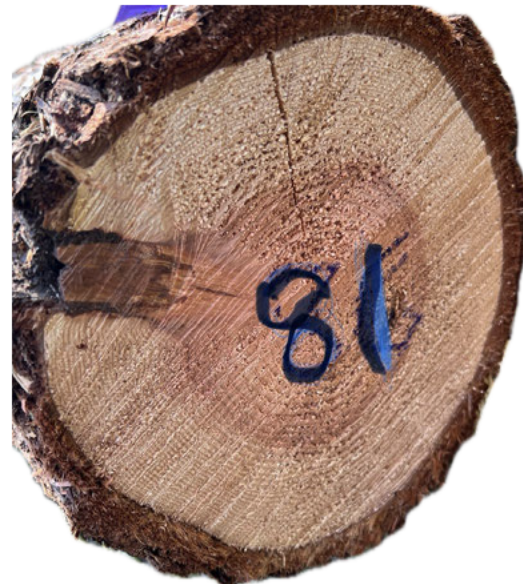
Log #2 Small End

- 6" IB
- Healthy sapwood and heartwood
- Yellowing sapwood
- Knot present

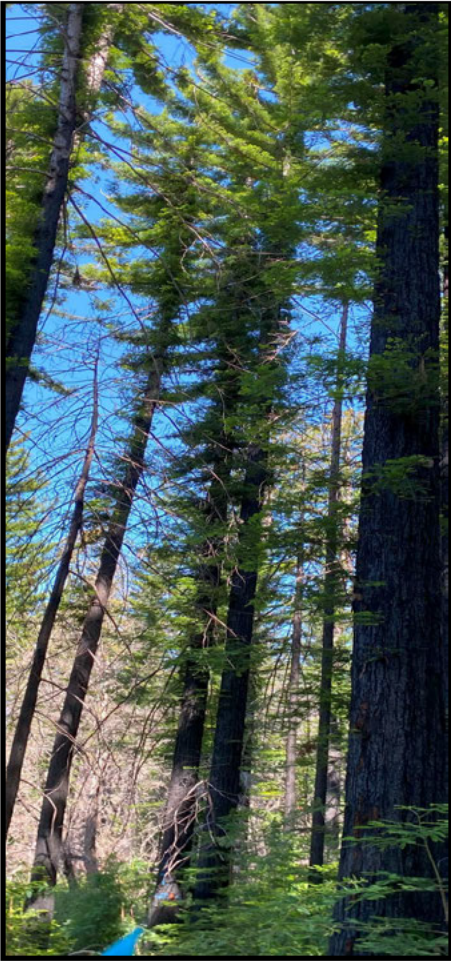
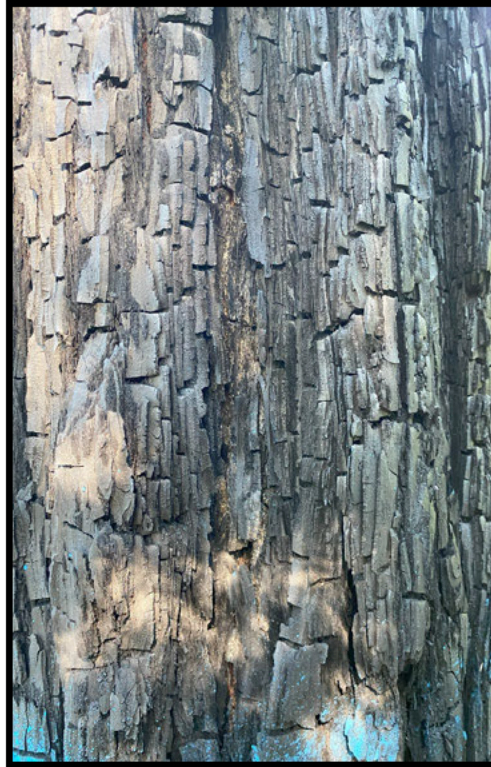
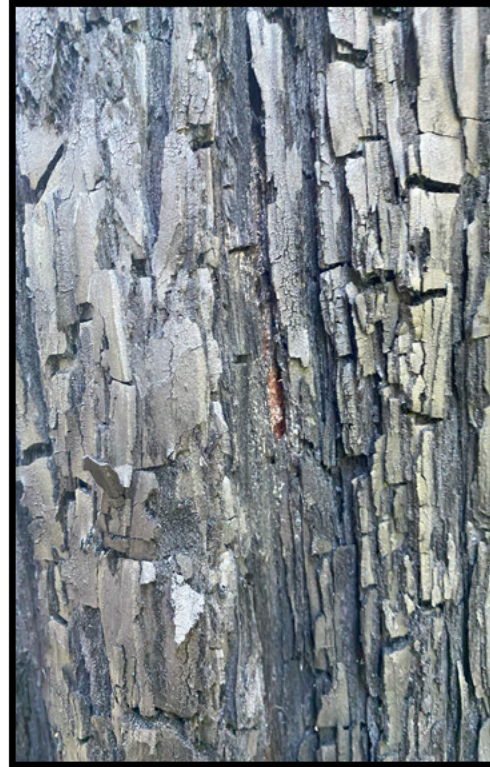
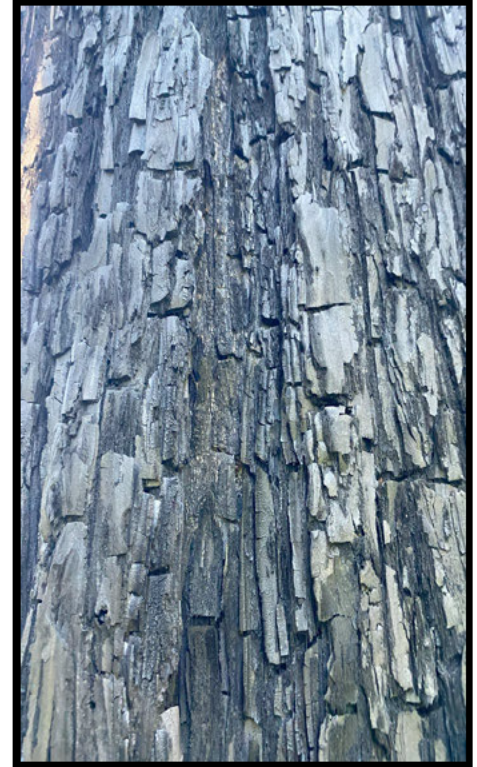
- ~74 sq. in of white rot
- 1/4 quadrants of fungus
- 9/4 quadrants of dead cambium
- Branch & Bole Sprouting
- Low-Moderate Burn Severity Zone

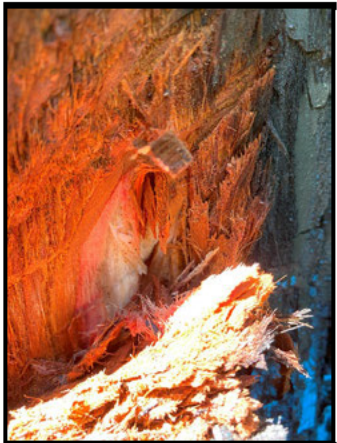
Alive/Fungus

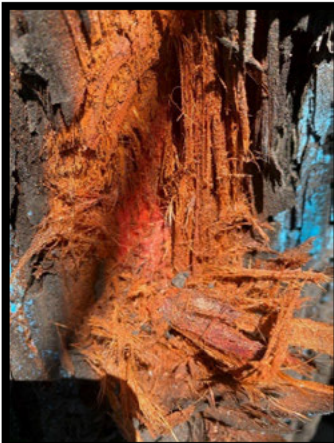
Alive/No Fungus

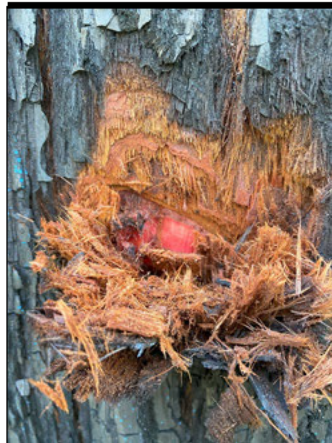
Alive/No Fungus

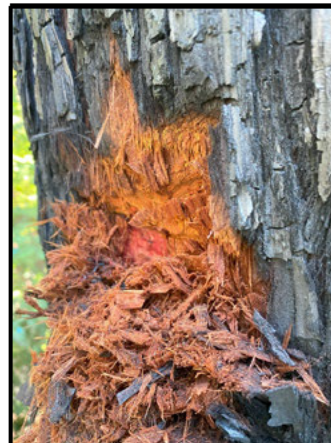
Alive/No Fungus

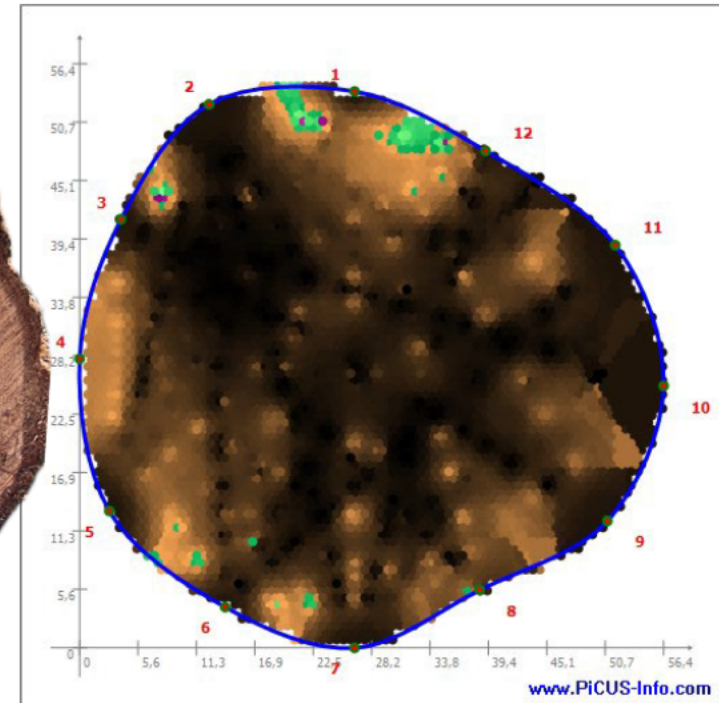
Log #1 Big End

- 18" Inside Bark (IB) before deductions
- 1-2" of sapwood rot around 8% circumference to the edge of heartwood
- Yellowing sapwood

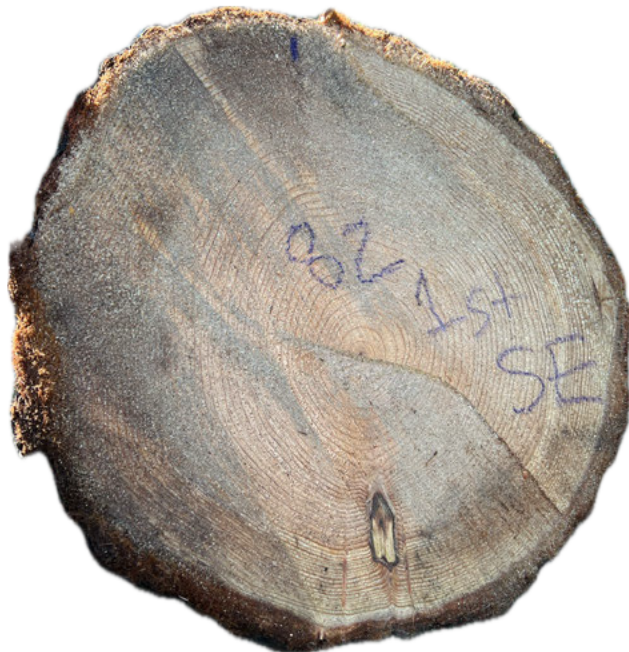
Log #1 Small End/ Log #2 Big End

- 12" IB
- Healthy sapwood and heartwood
- Knot present

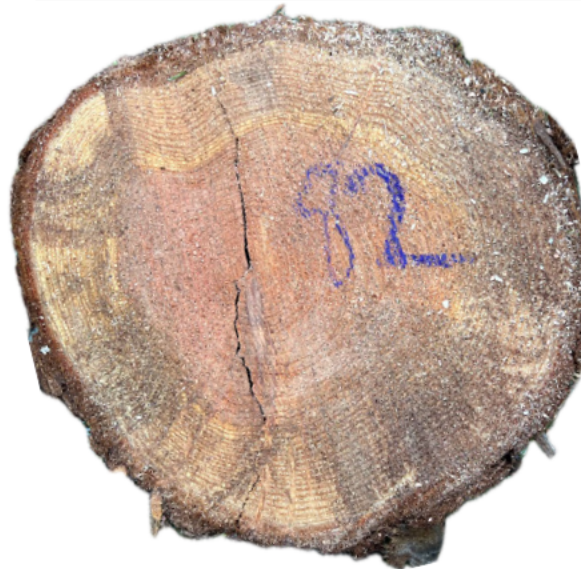
Log #2 Small End

- 10" IB
- Healthy sapwood and heartwood
