Santa Cruz Mountains Post-Fire Redwood Defect Study

Nadia Hamey, Hamey Woods

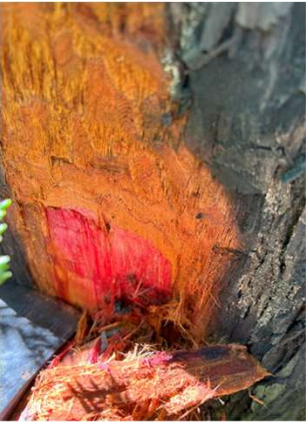
West
Alive,
Fungus

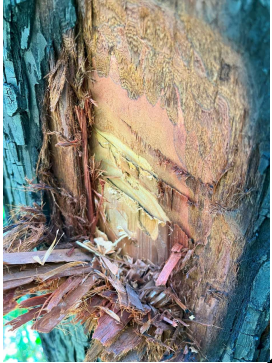
North
Dead,
Fungus

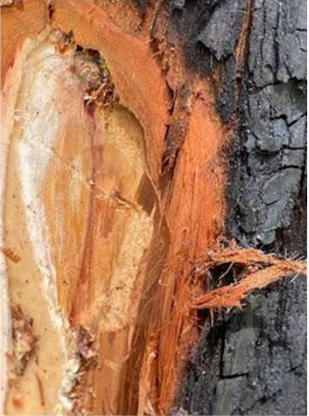
East
Dead,
No fungus

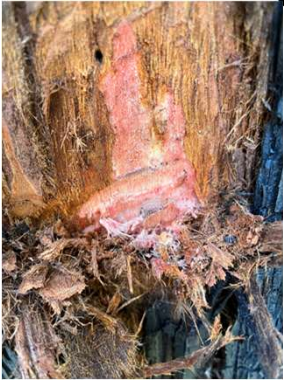
South
Alive,
No fungus

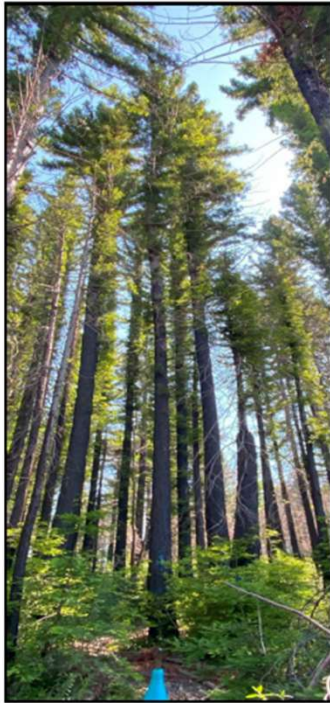
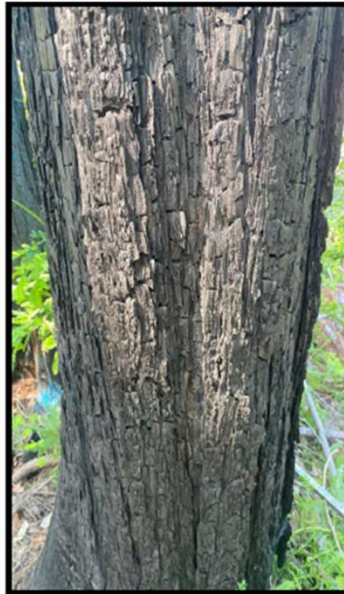
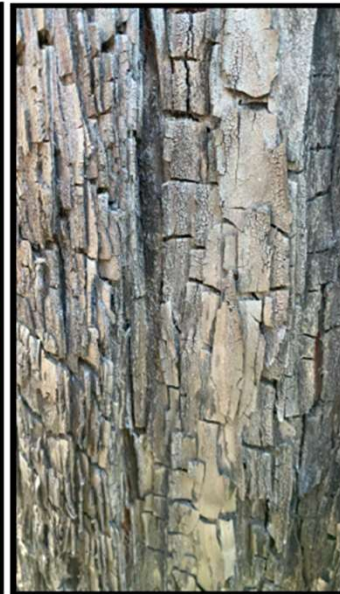
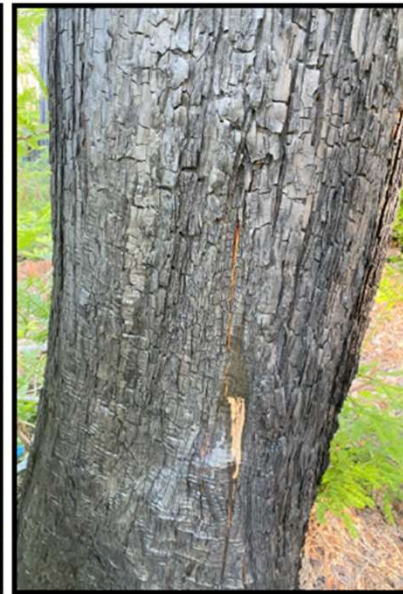
Tree #64

Alive/Fungus

Dead/No Fungus

Alive/No Fungus

- ~64 sq. in of white rot
- ¼ quadrants of fungus
- ¼ quadrants of dead cambium
- Branch & Bole Sprouting
- Low-Moderate Burn Severity Zone

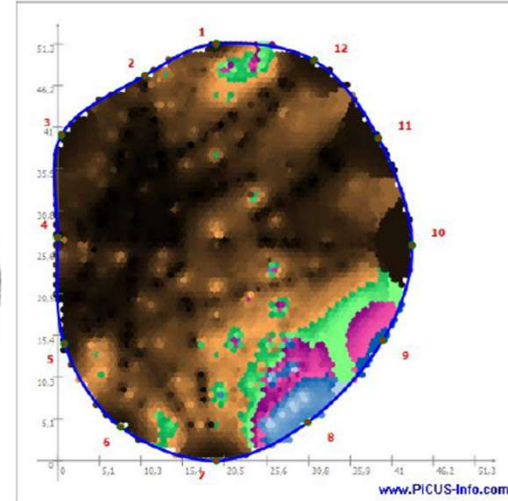
Log #1 Small End/ Log #2 Big End

- 11" IB
- Healthy sapwood and heartwood

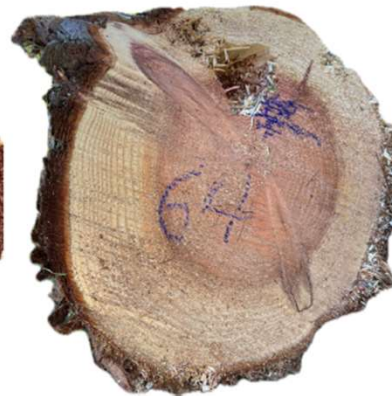
Log #2 Small End

- 9" IB
- Healthy sapwood and heartwood
- Slight mechanical damage
