**9GA22700
HAMEY WOODS
SANTA CRUZ MOUNTAINS POST-FIRE REDWOOD DEFECT STUDY**

Date: August 1, 2023

Project Status and Progress Report:

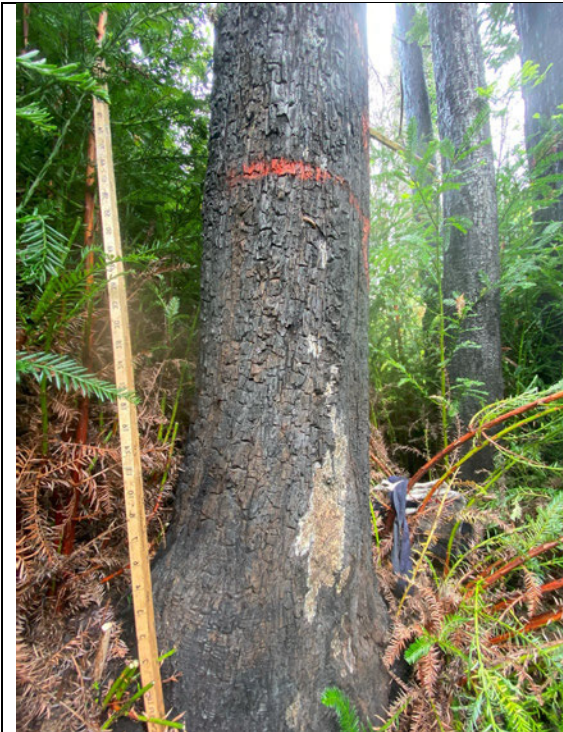
SPR Redwood Study Tree with Wet Rot fruiting bodies (*Coniophora puteana*)

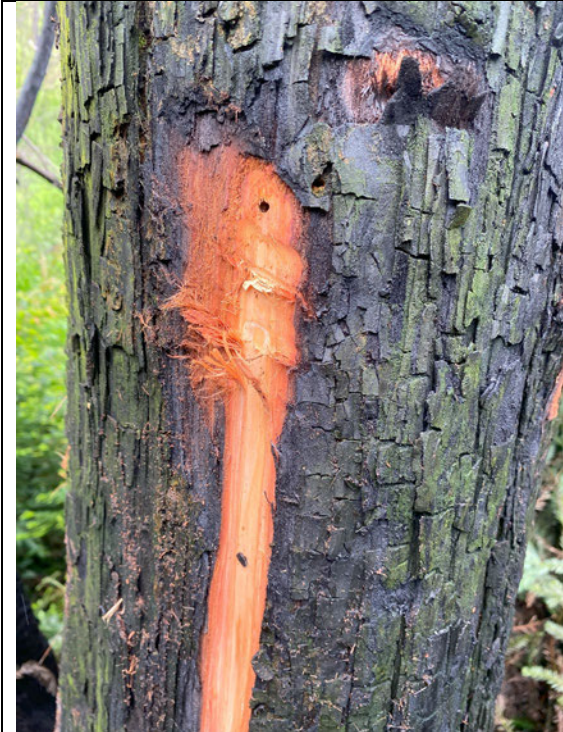
SPR Redwood Study Tree – Cambium check with insect bore holes

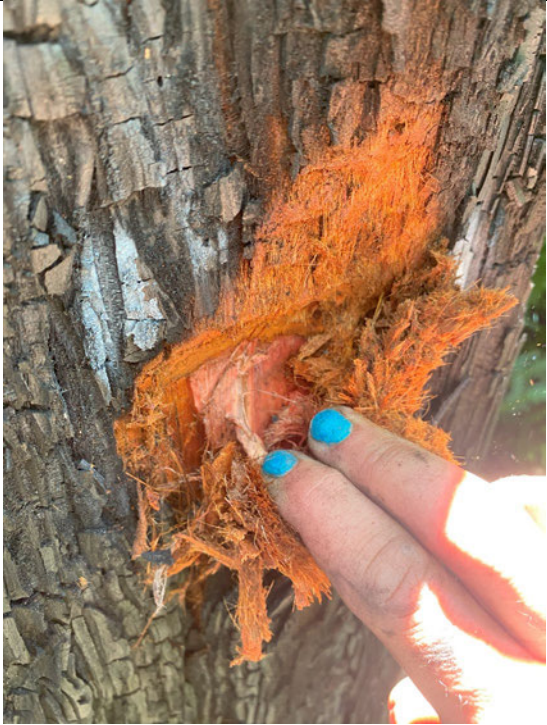
SVR Redwood Study Tree – Cambium check
