NTMP Monitoring

**NCRWQCB and CAL FIRE
MSG Meeting
November 16, 2011**

**1-97NTMP-001 HUM August 10, 2011
Diamond R Ranch NTMP near Rio Dell and Scotia**

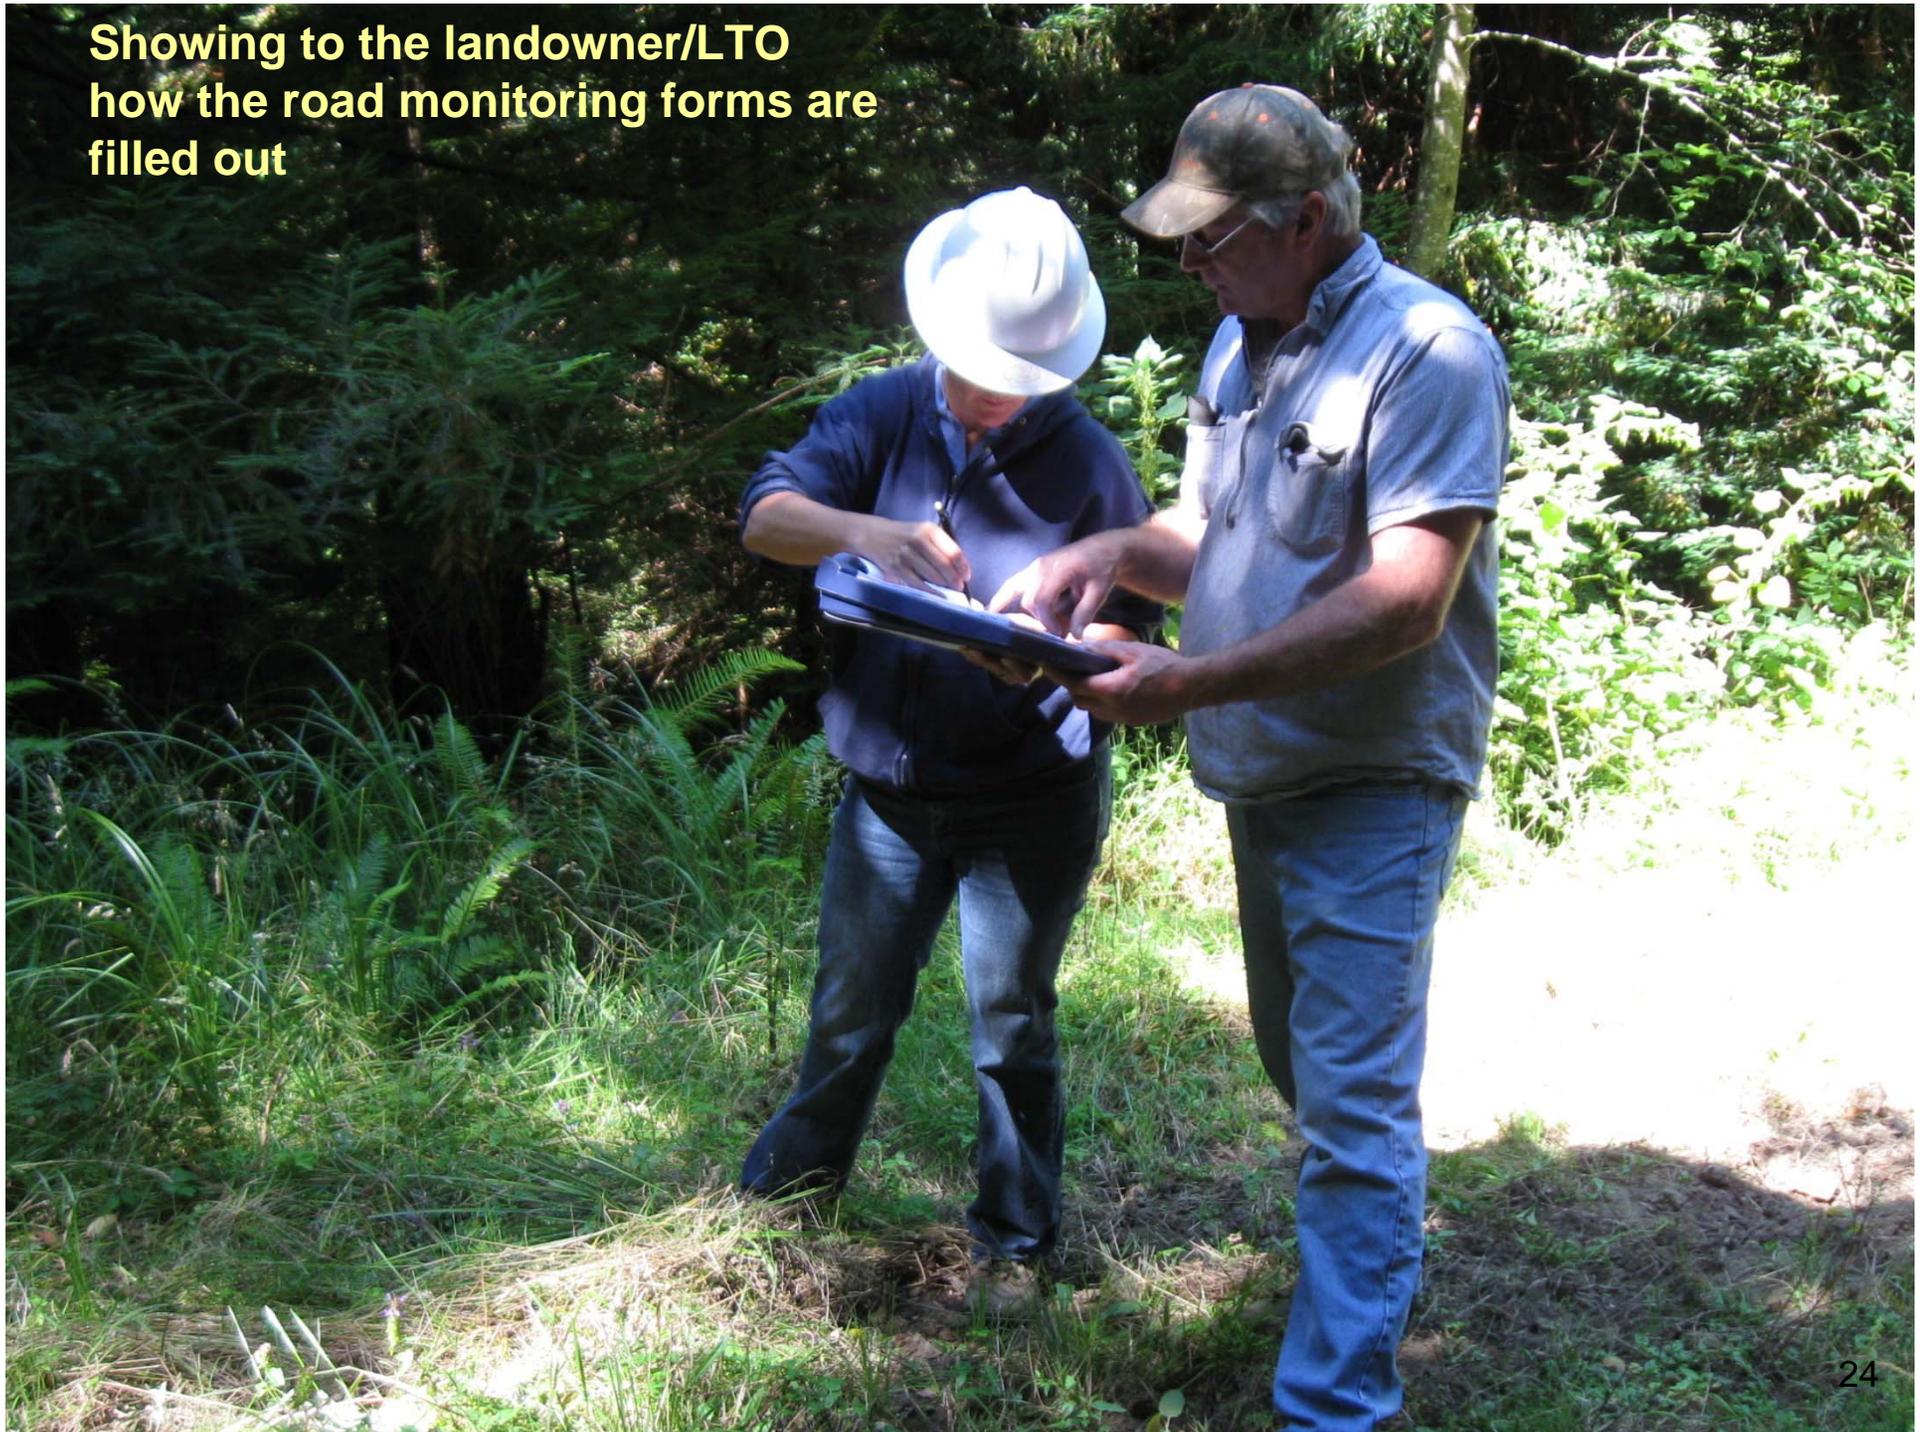
**Filling out Stream Crossing Effectiveness Form at temporary crossing No. 6
Price Creek, Class I watercourse**

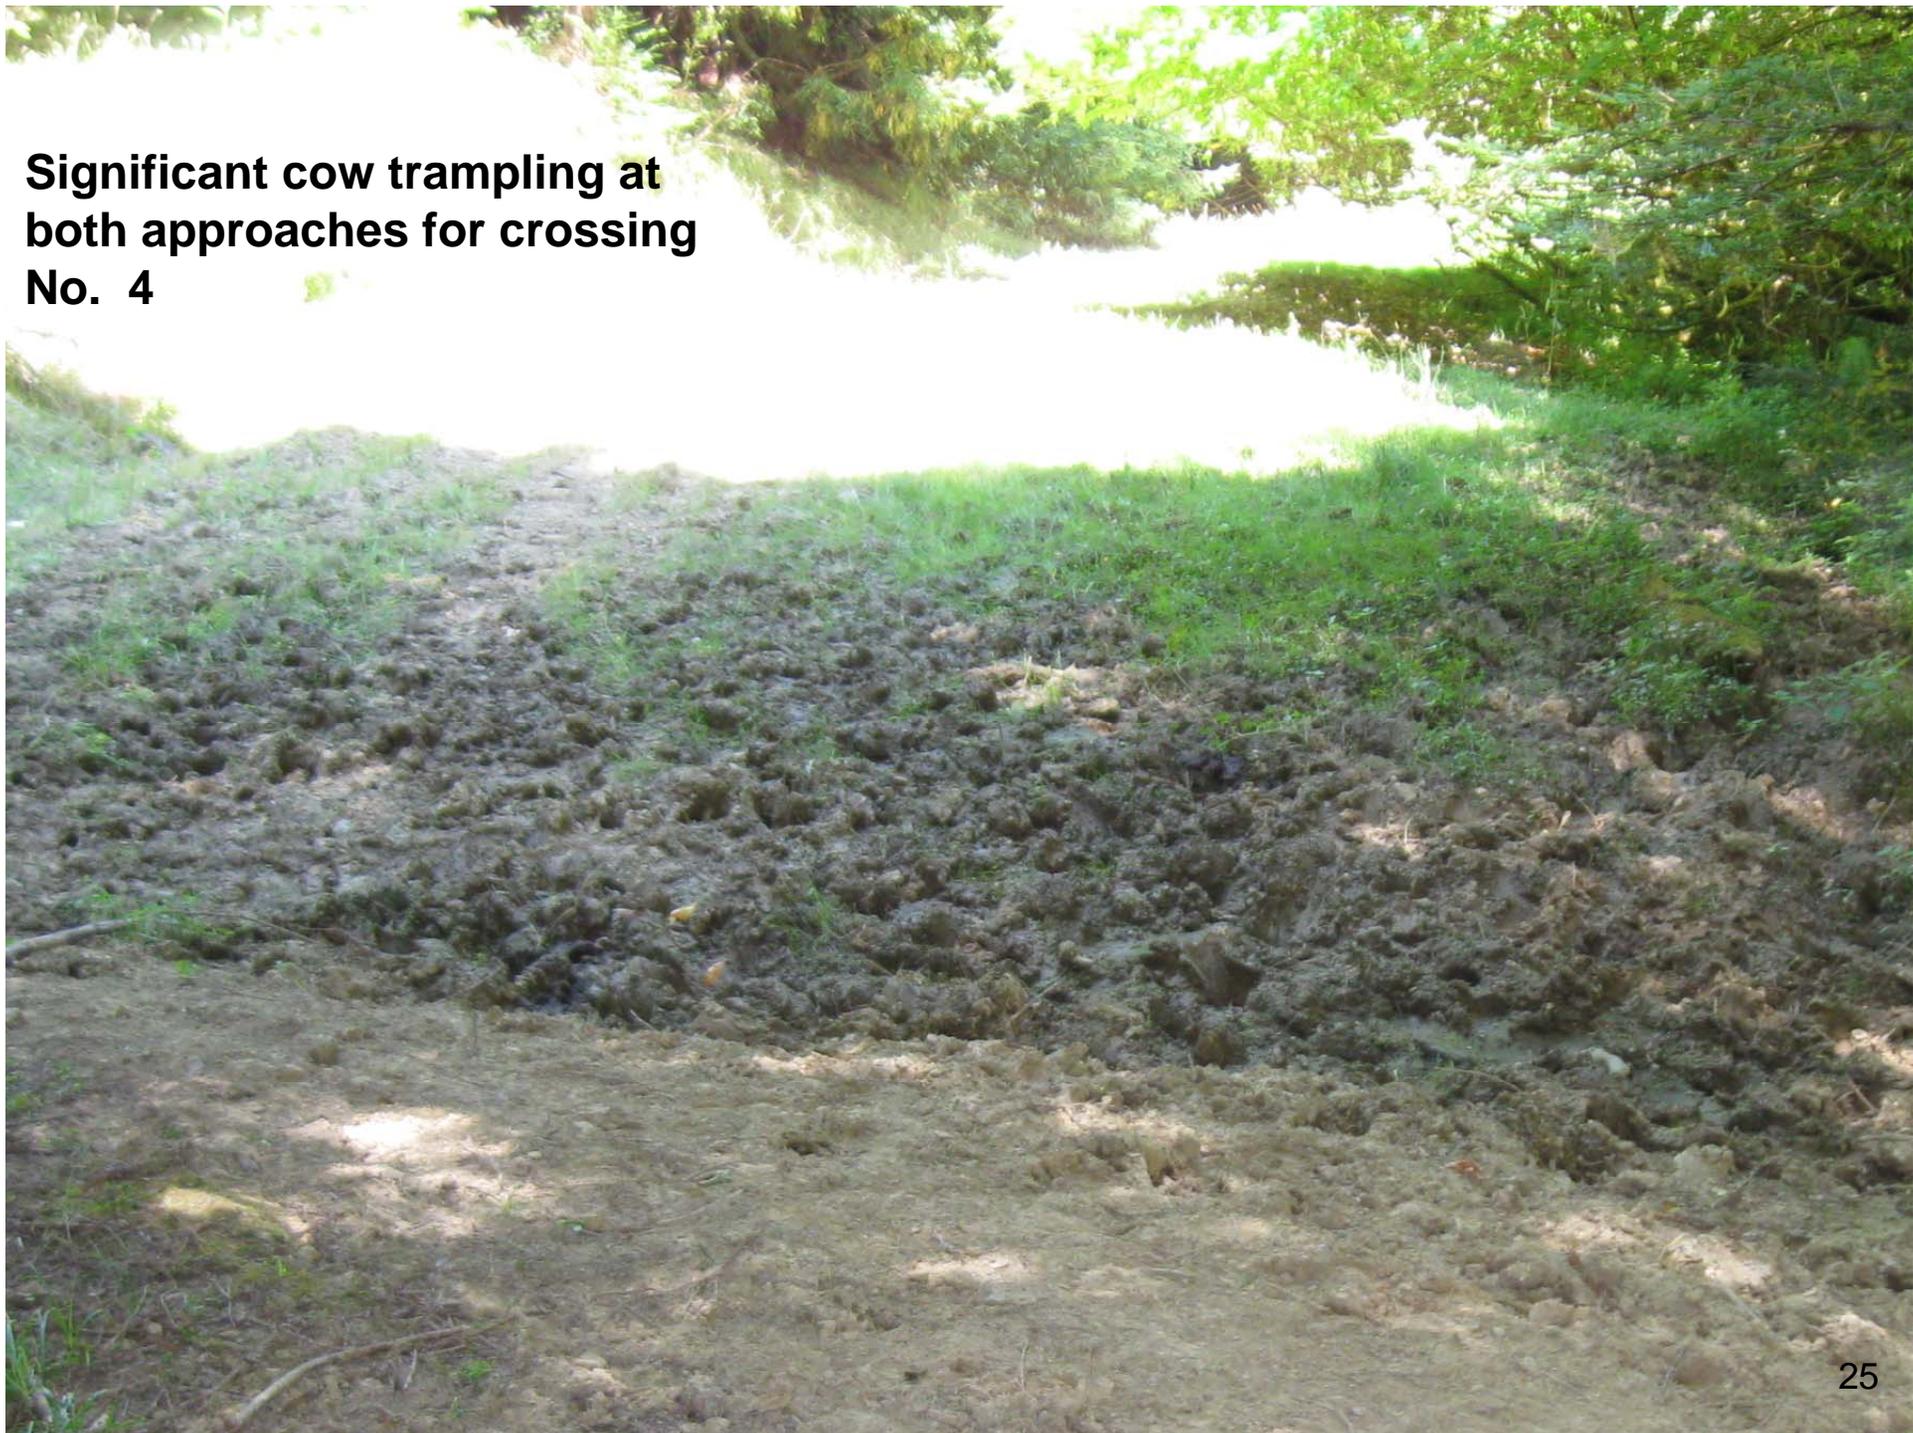
**Significant cow trampling at
both approaches for crossing
No. 4**

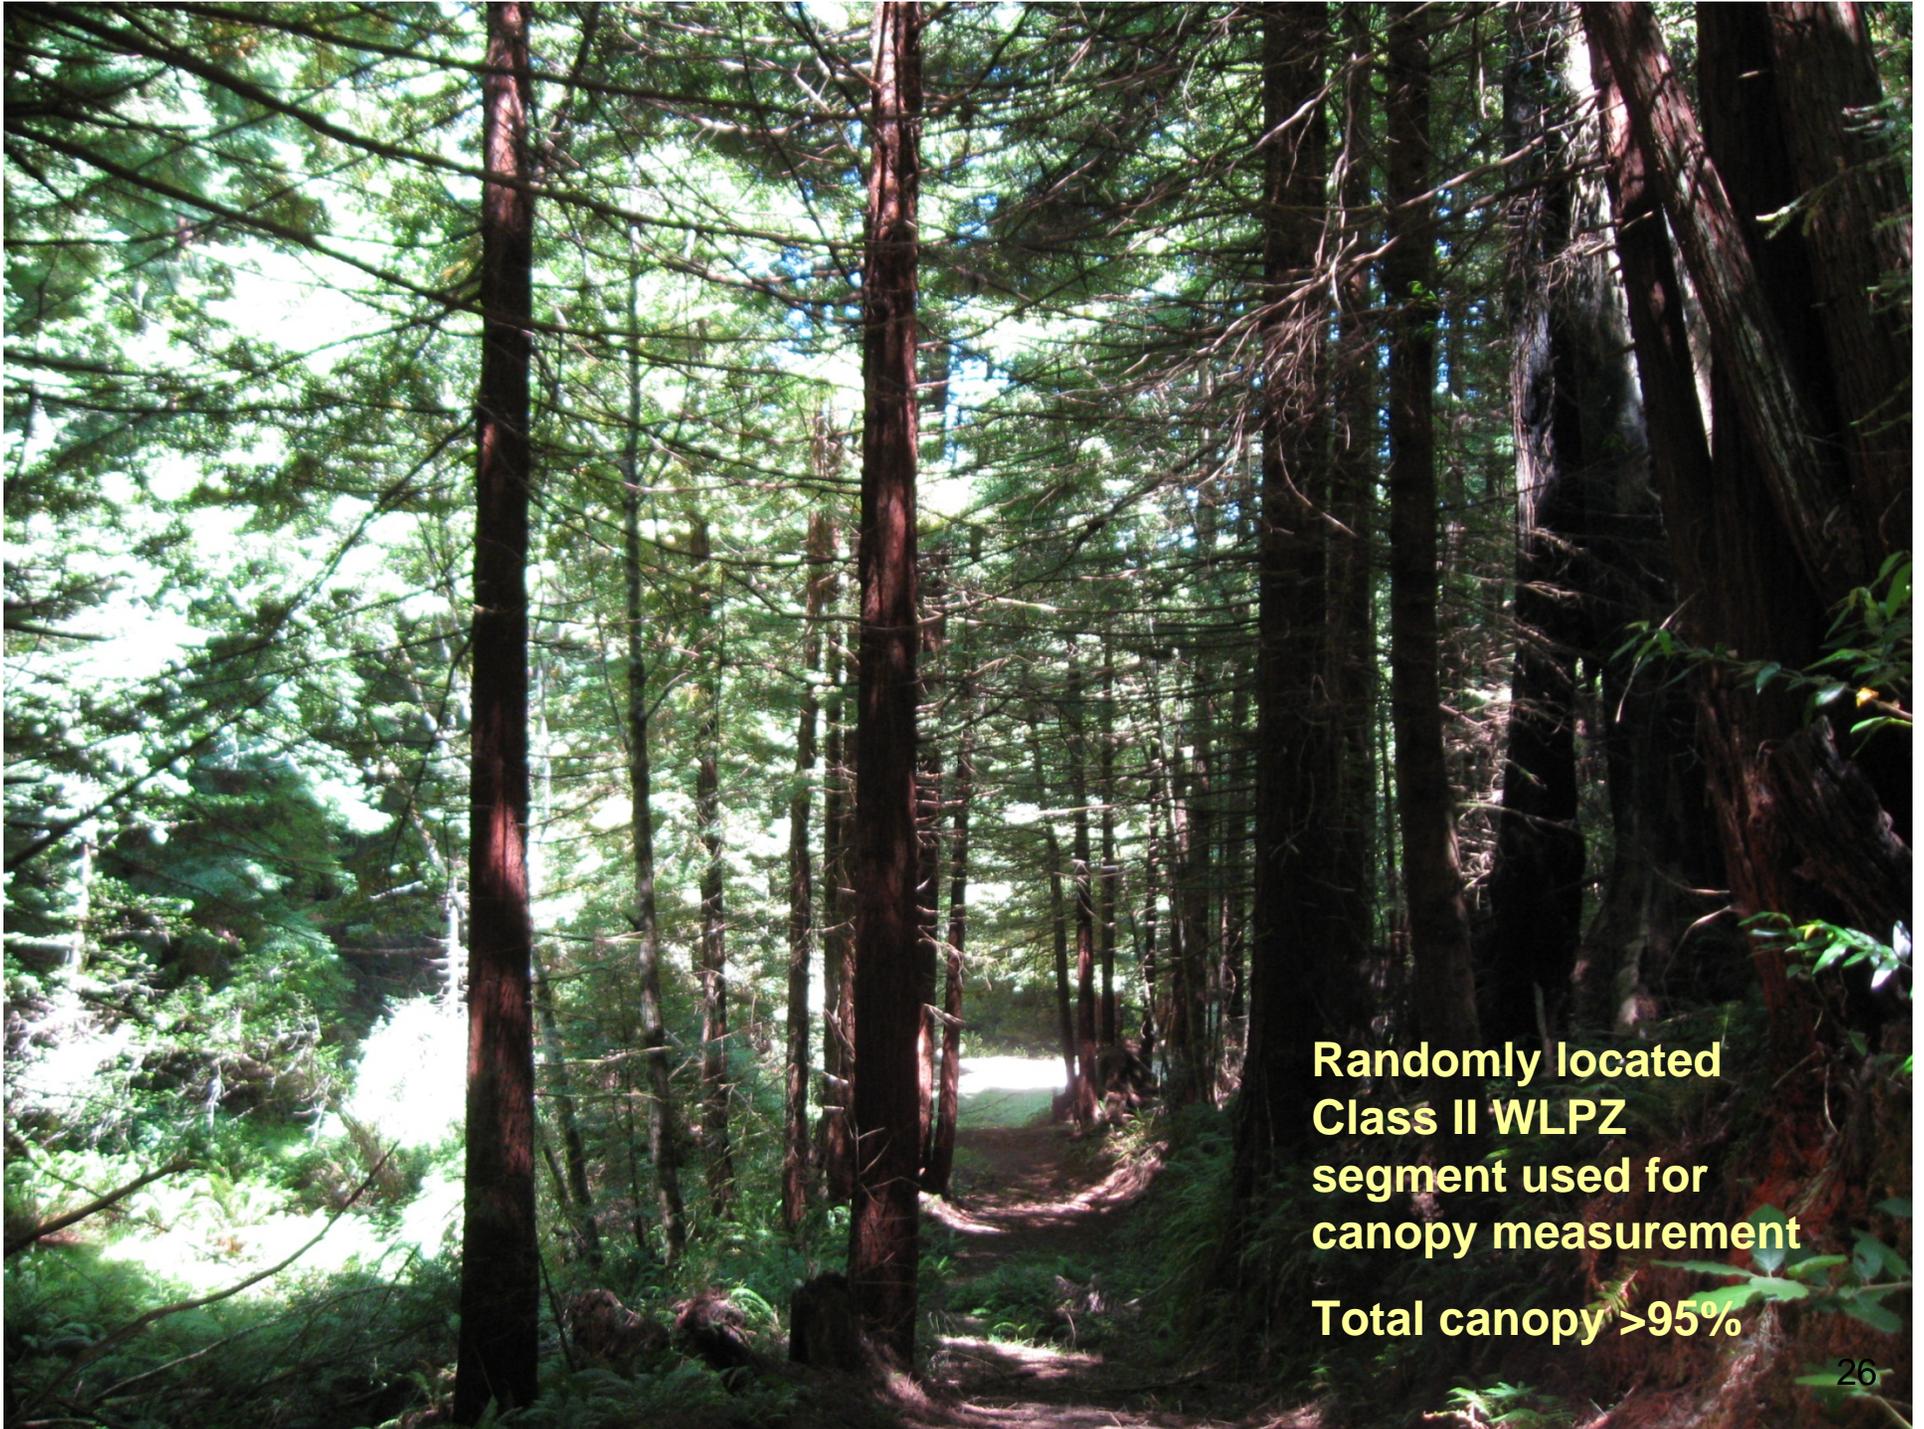
Randomly located
Class II WLPZ
segment used for
canopy measurement
Total canopy >95%

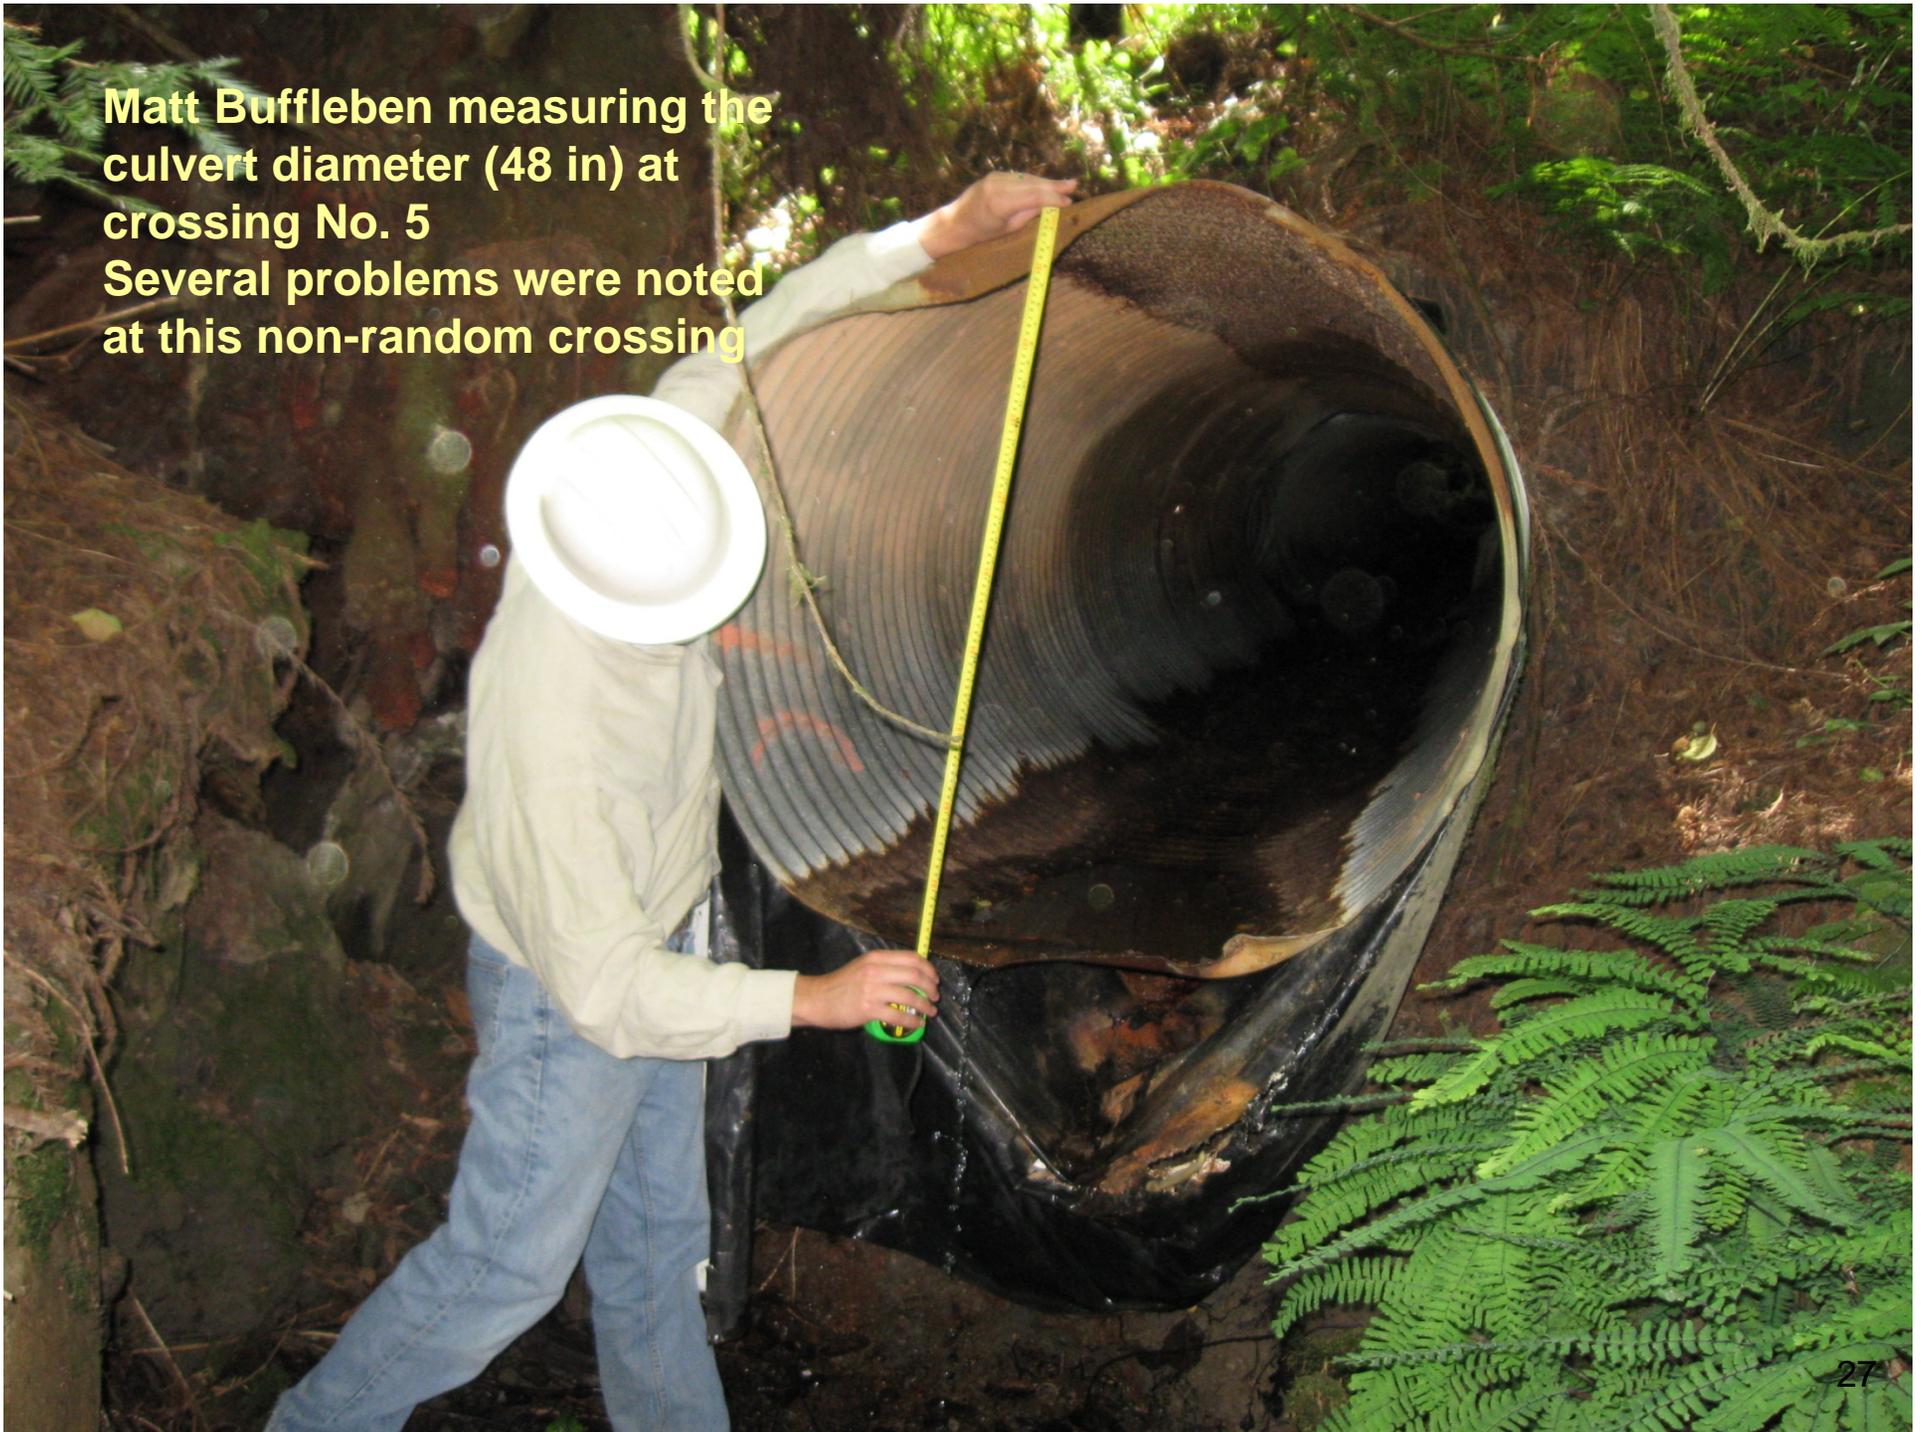
**Matt Buffleben measuring the culvert diameter (48 in) at crossing No. 5
Several problems were noted at this non-random crossing**

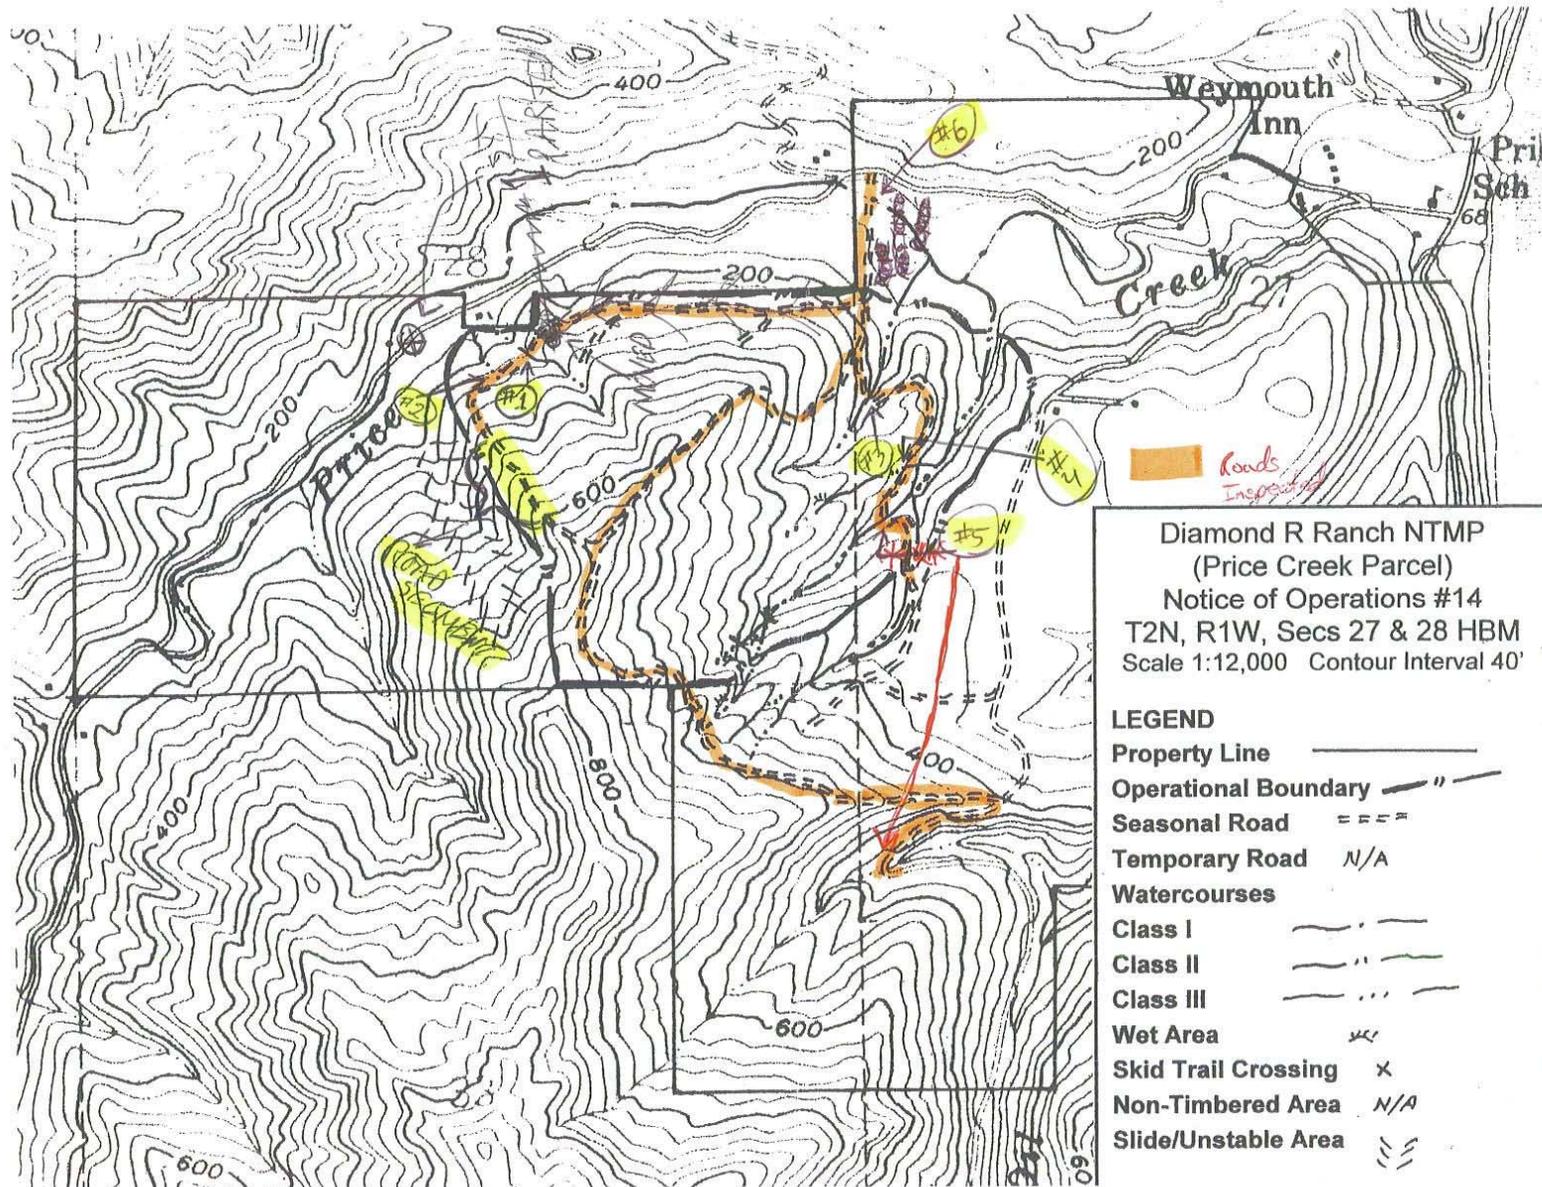
Map Showing Locations of Crossings and Road Segments Observed

Roads and crossings were both rated as a moderate problem to water quality, biggest problem noted was significant cattle impacts, especially at crossing approaches

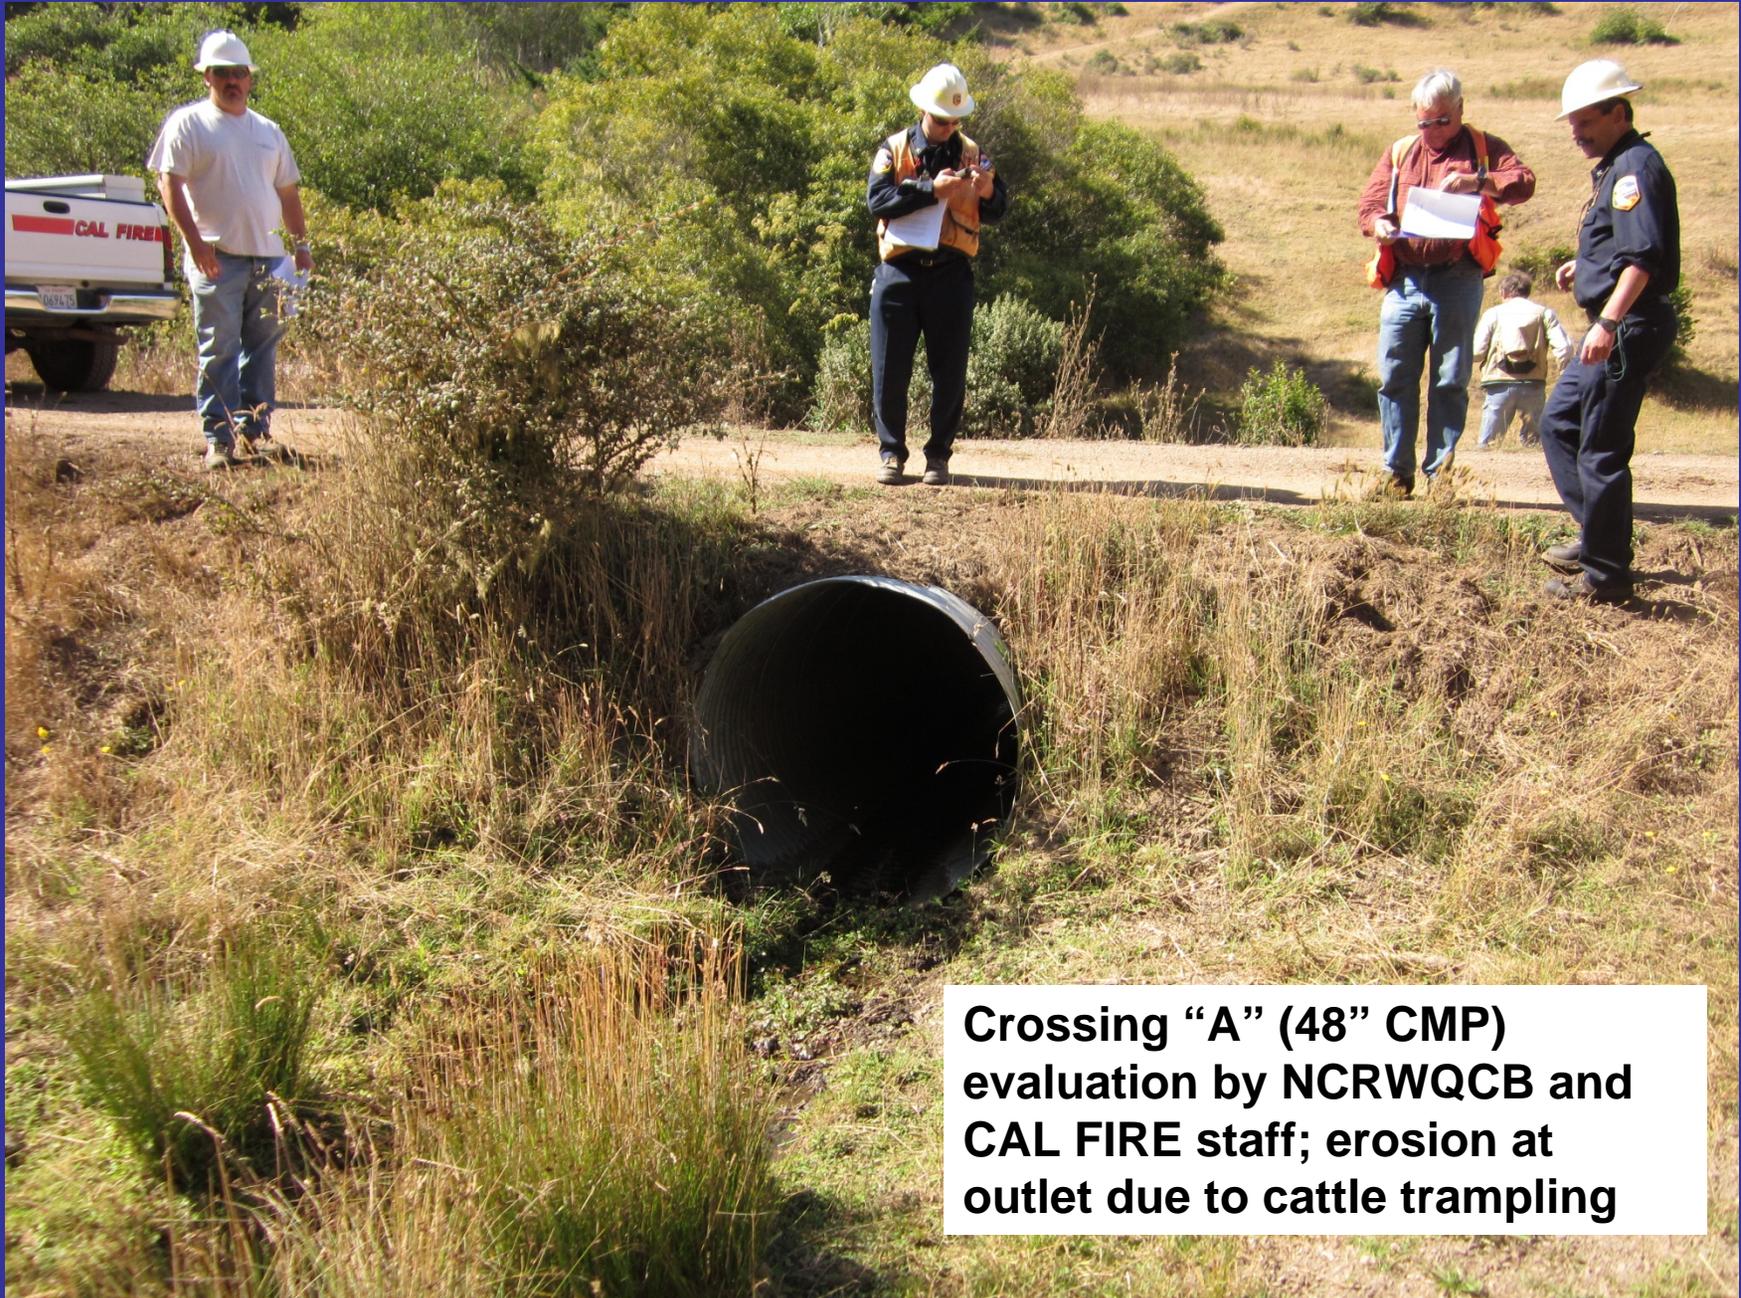
Crossing "A" (48" CMP) evaluation by NCRWQCB and CAL FIRE staff; erosion at outlet due to cattle trampling

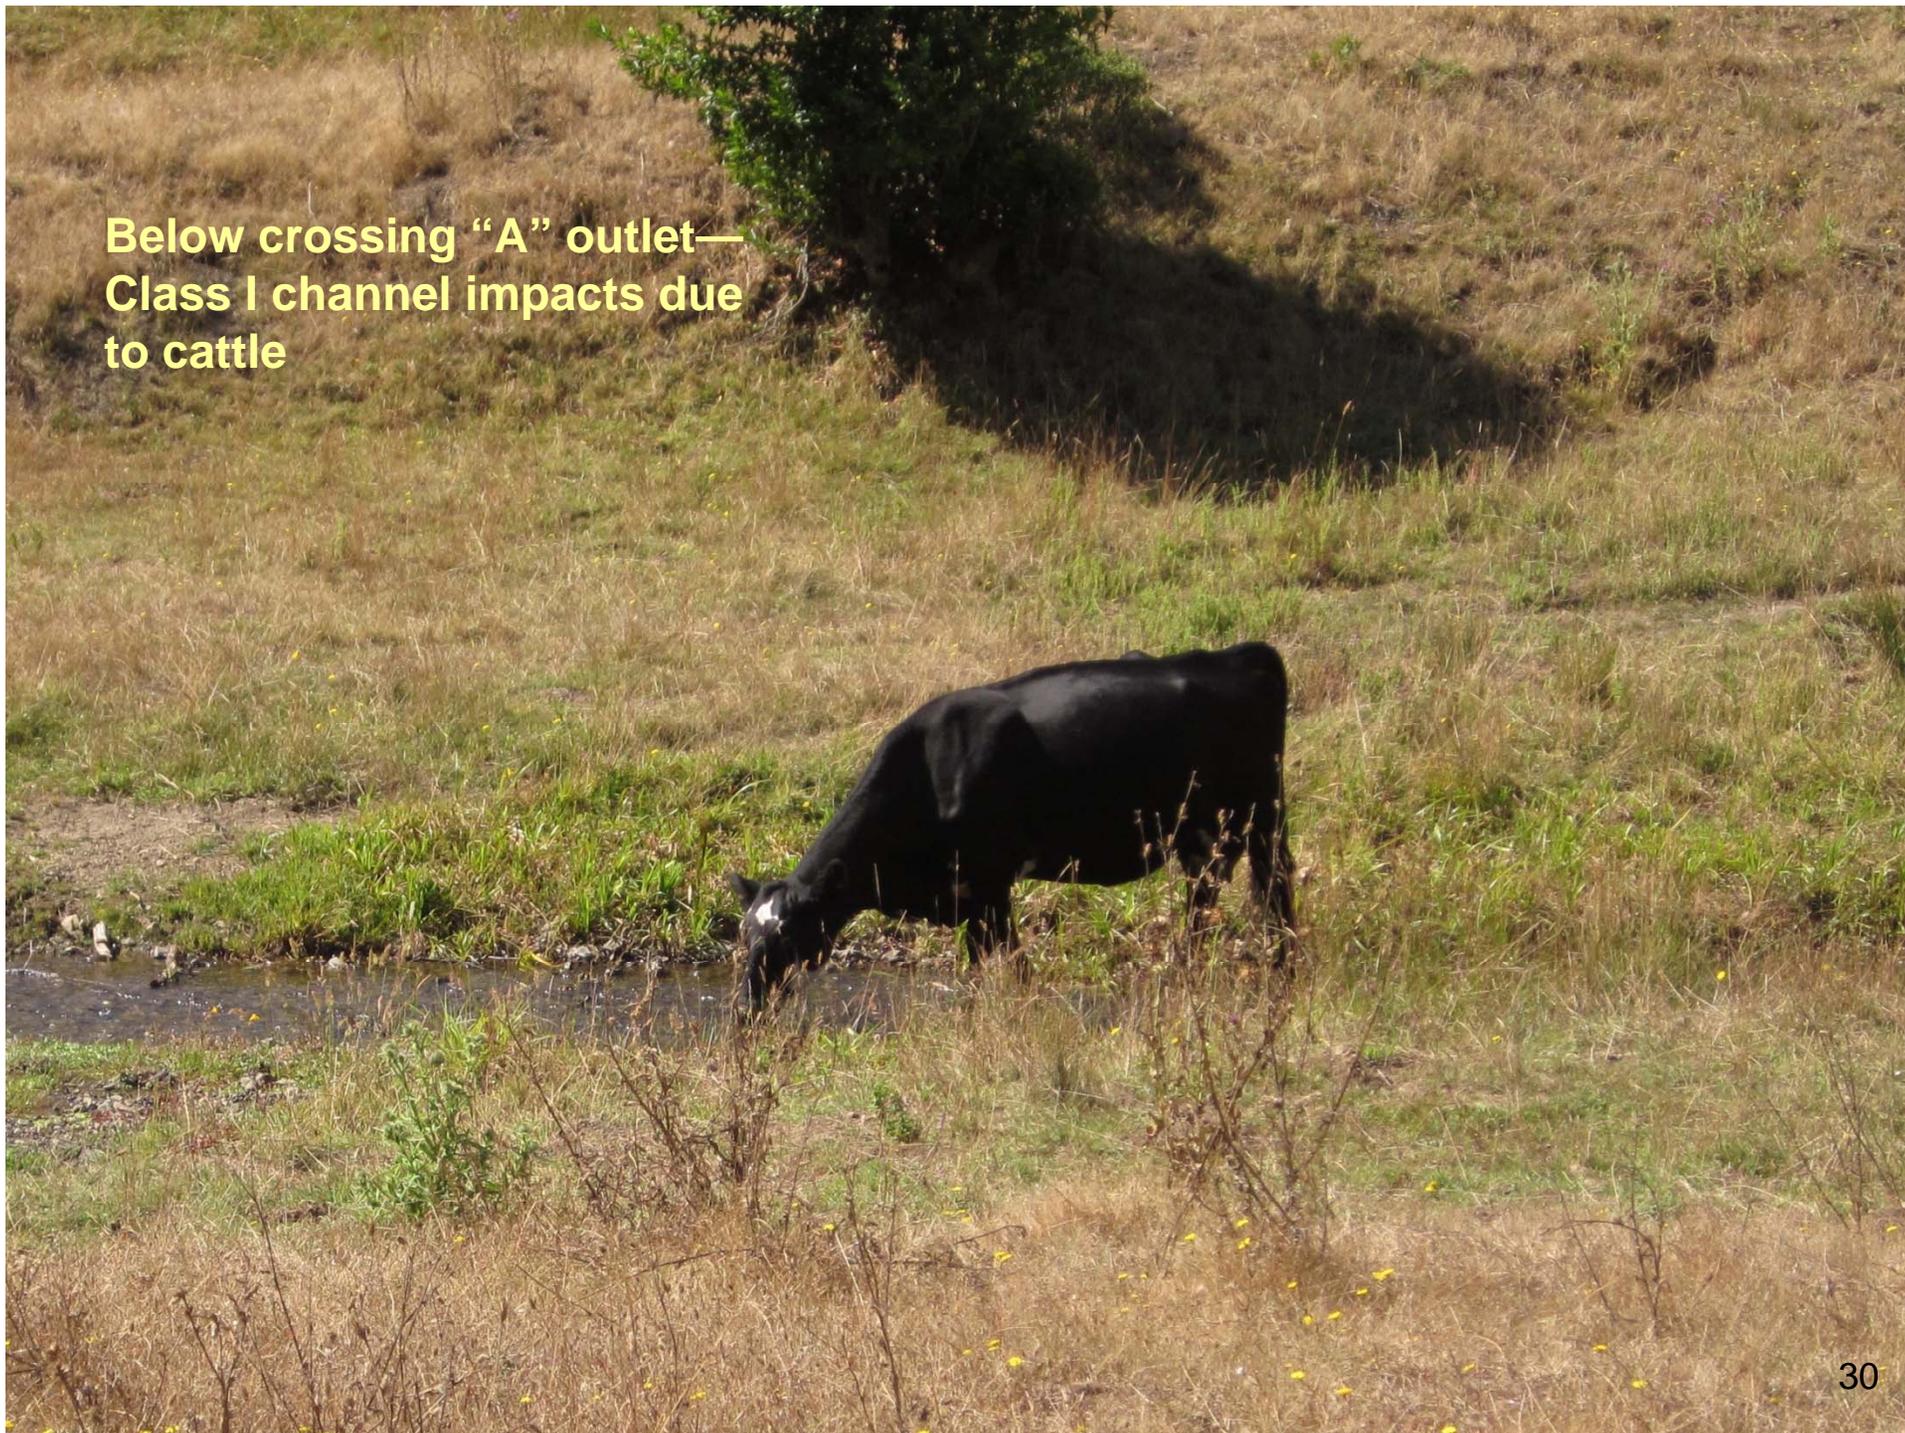
**Below crossing “A” outlet—
Class I channel impacts due
to cattle**

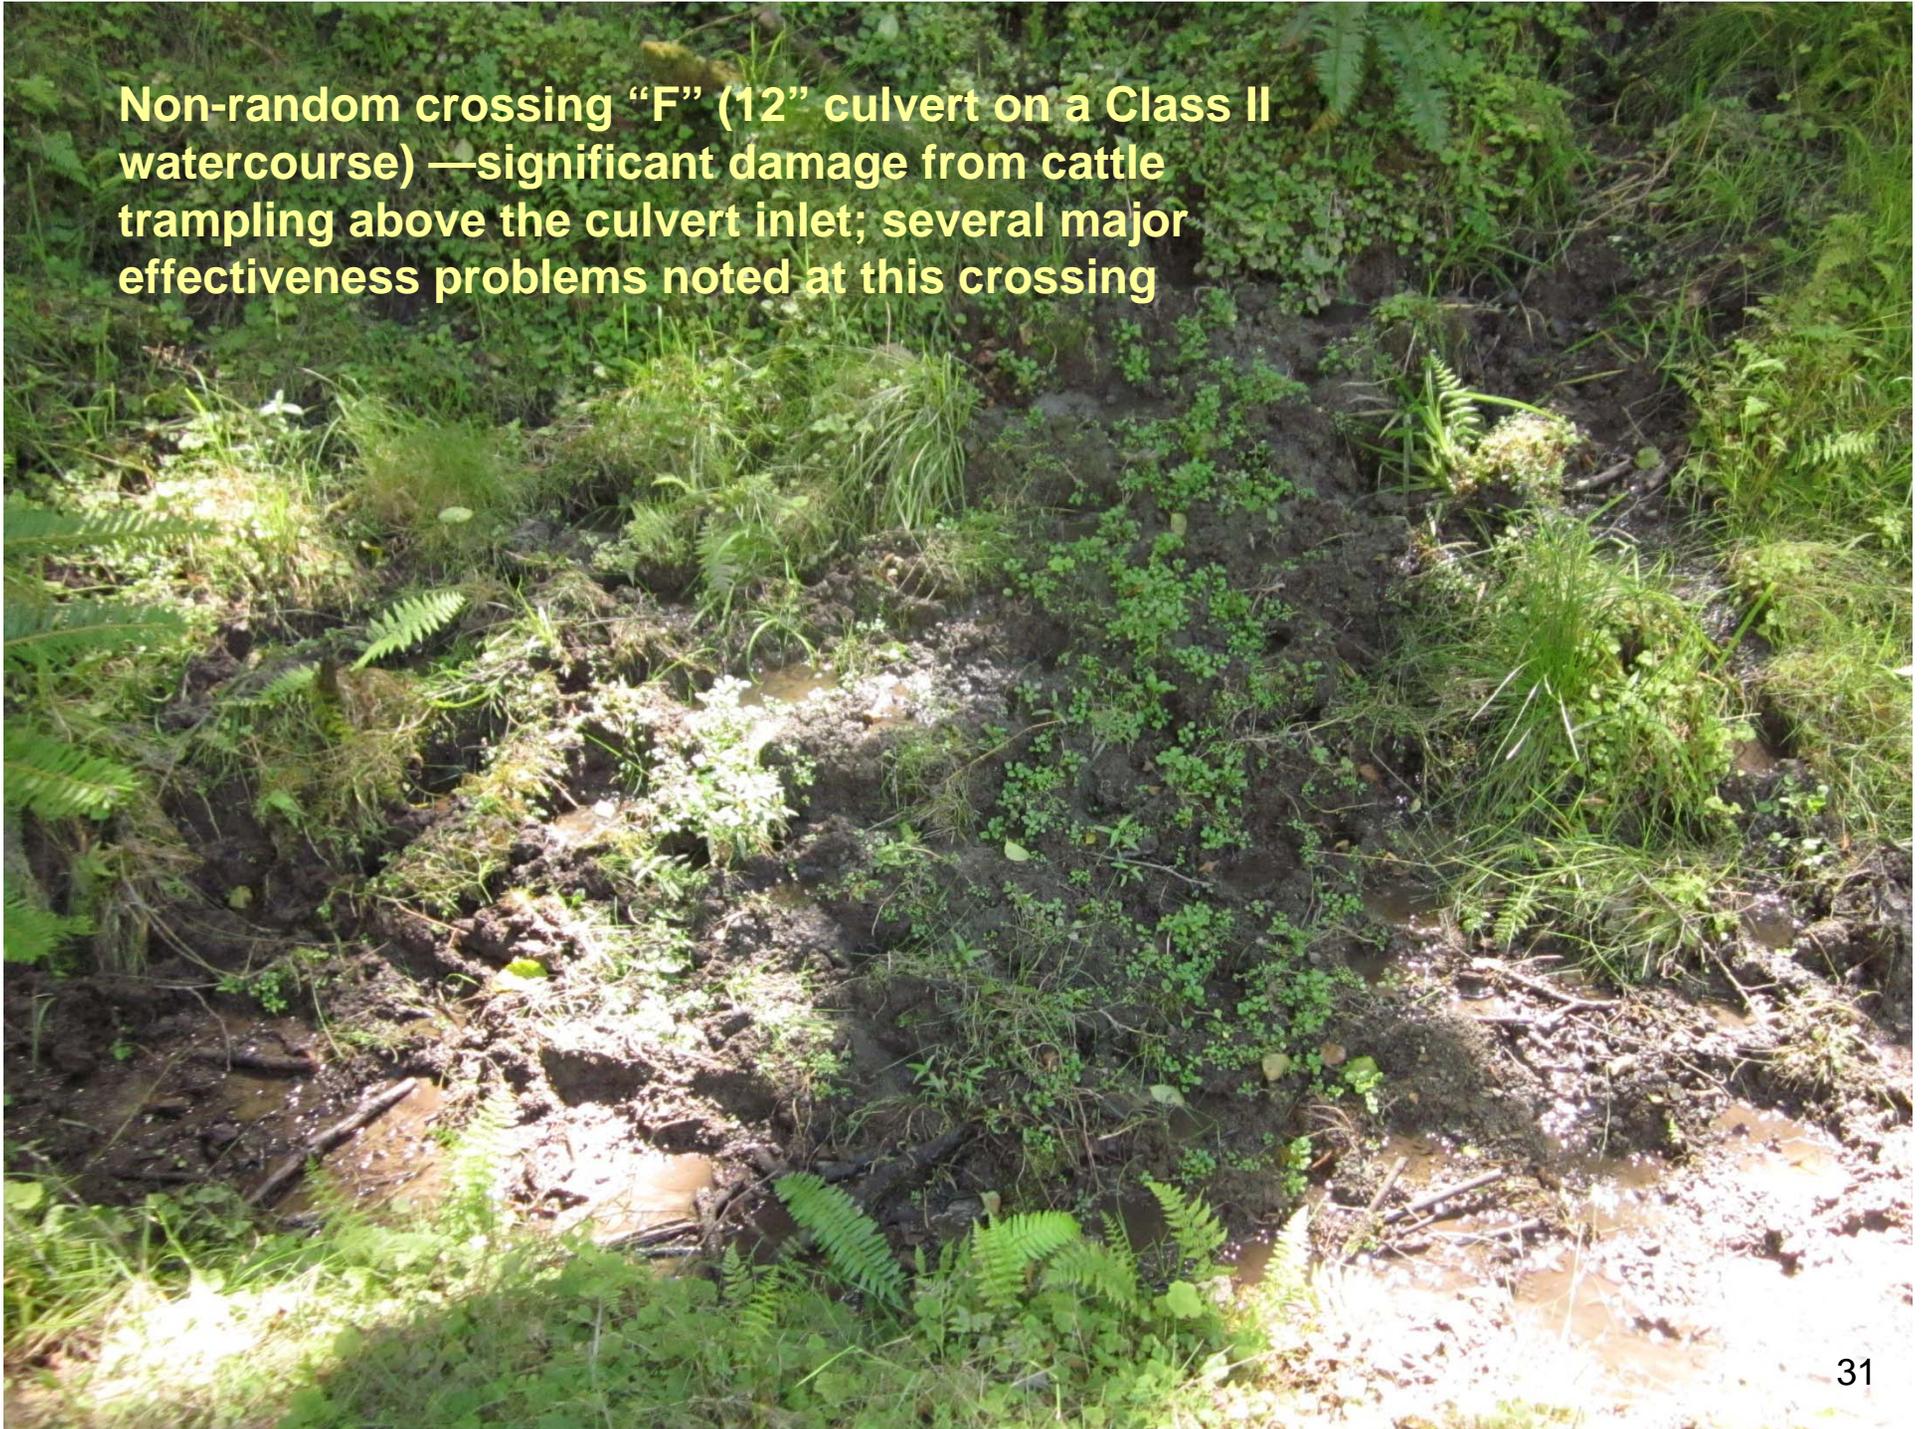
Non-random crossing “F” (12” culvert on a Class II watercourse) —significant damage from cattle trampling above the culvert inlet; several major effectiveness problems noted at this crossing

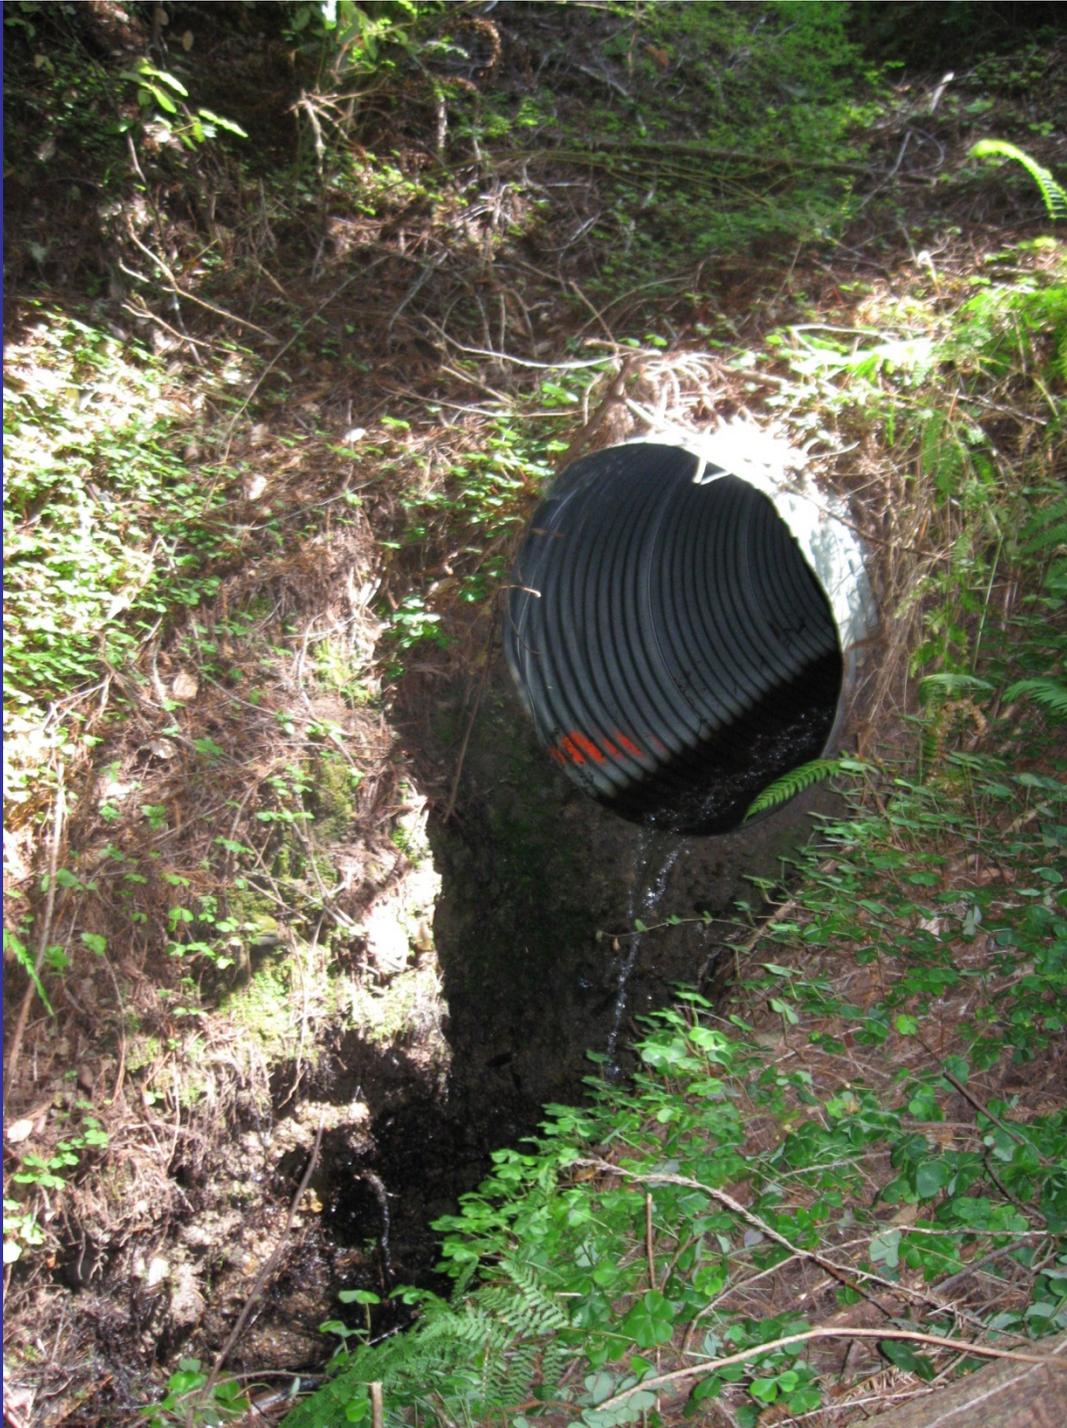
**Random
crossing “D” –
36 inch CMP**

**Major
problems:**

**-Significant
scour at the
outlet**

**-Diversion
potential**
