NTMP Monitoring

**NCRWQCB and CAL FIRE
MSG Meeting
November 16, 2011**

**1-97NTMP-001 HUM August 10, 2011
Diamond R Ranch NTMP near Rio Dell and Scotia**

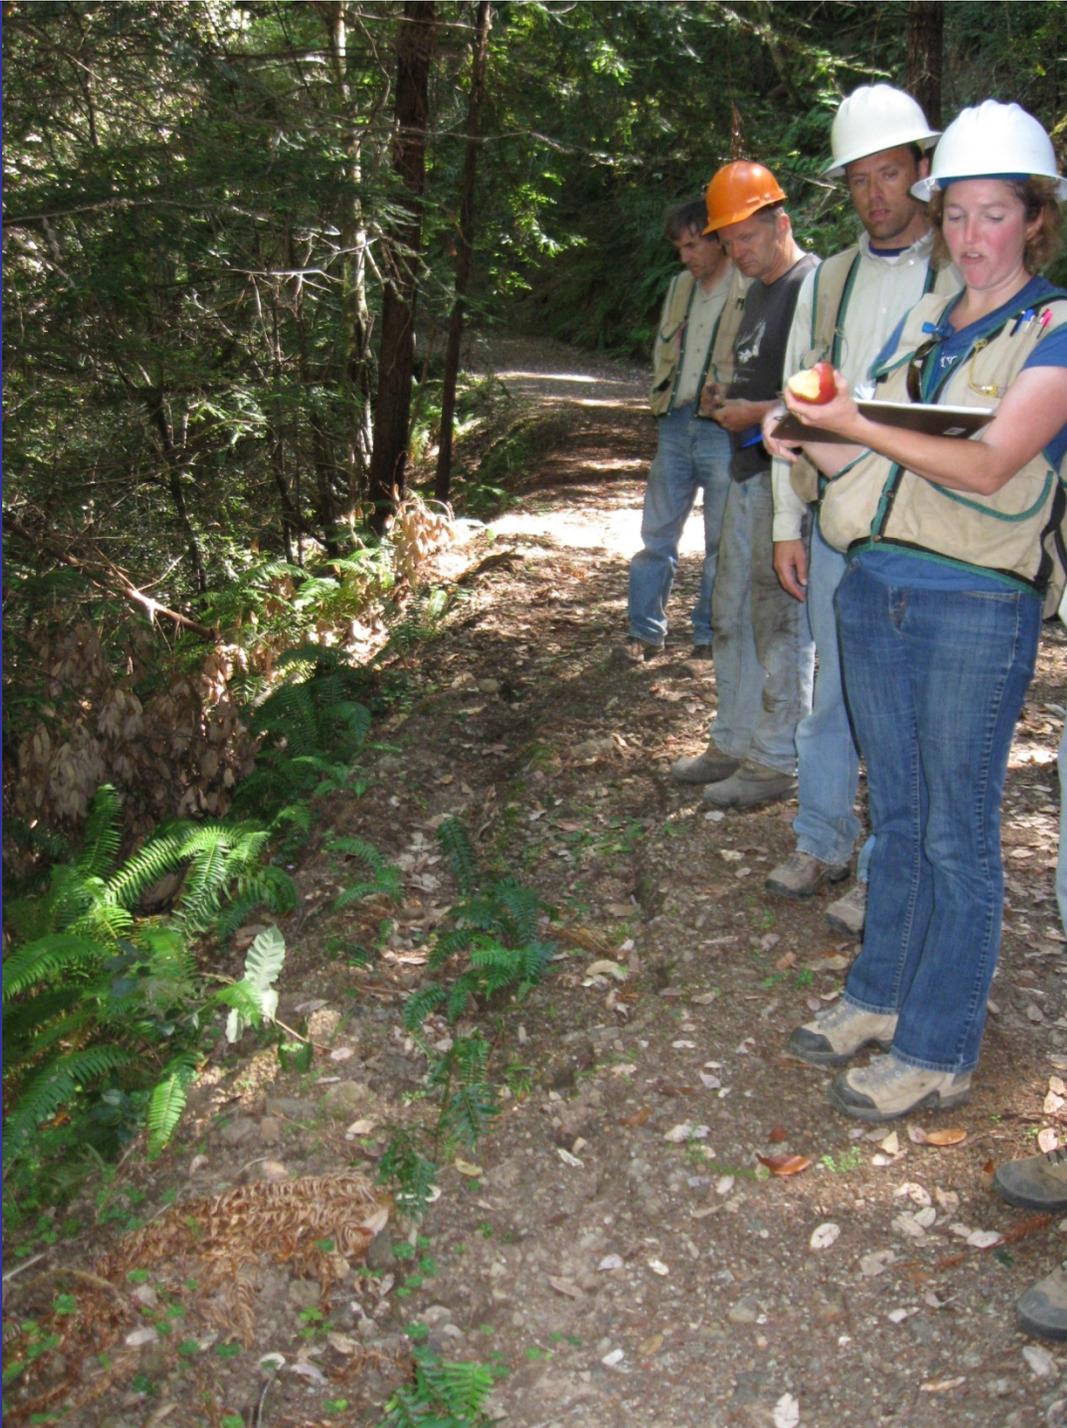
Fill slope tension cracks noted on road segment beyond crossing "D."

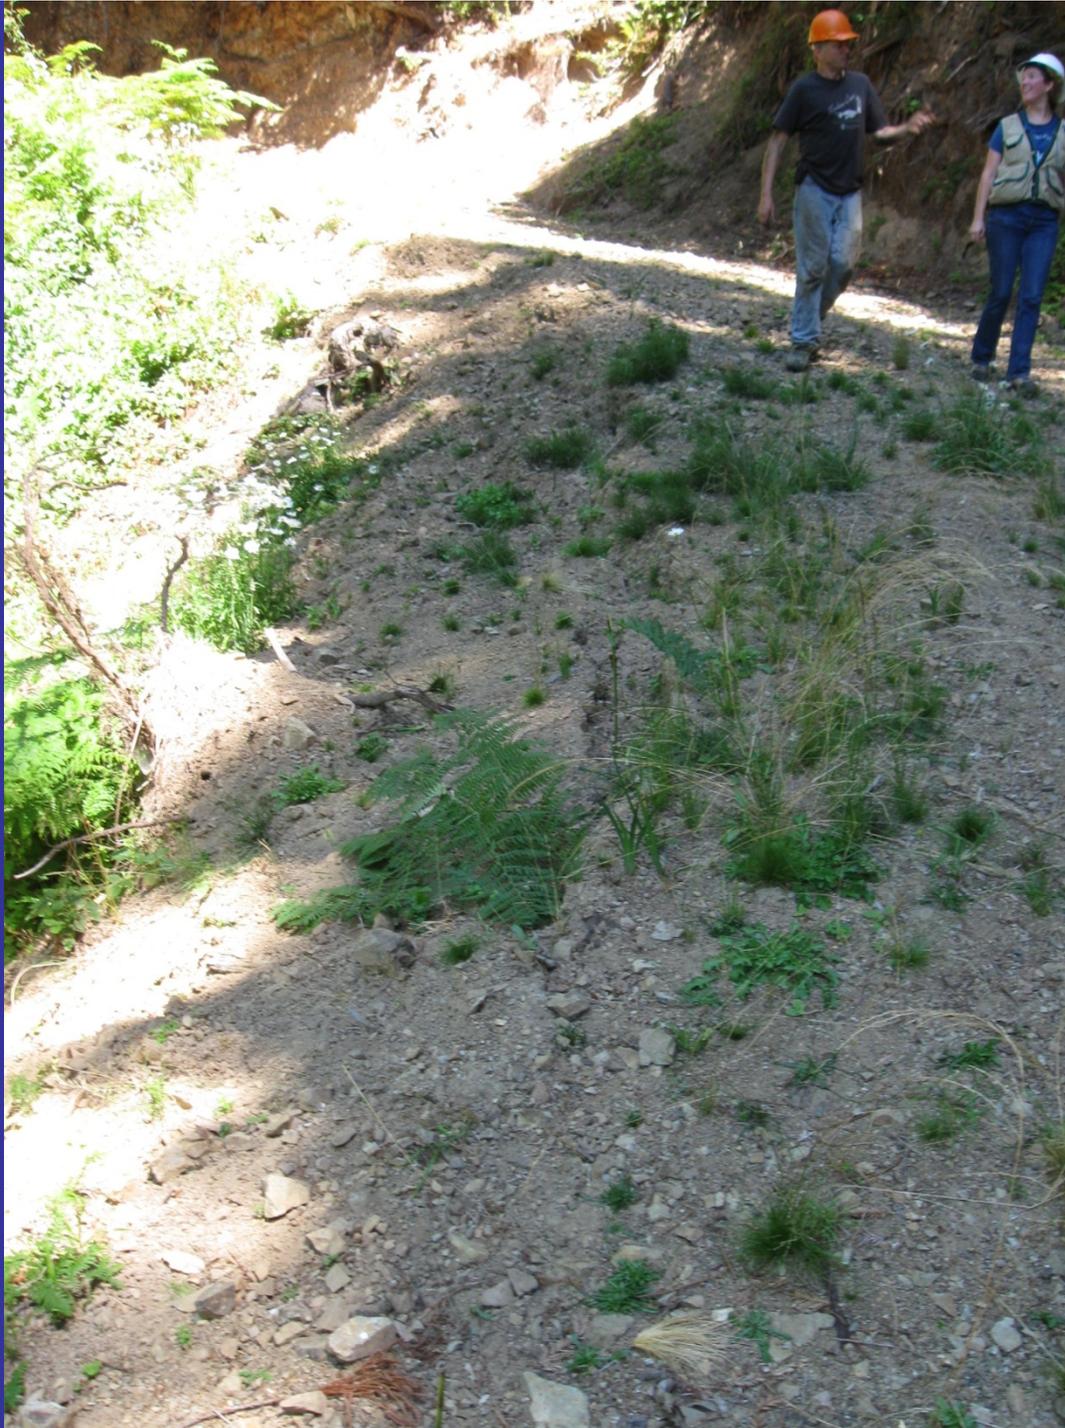
Road fill slope erosion (60 ft) noted along the 660 ft randomly located road segment for FORPRIEM

Low risk of delivery to a watercourse due to road location

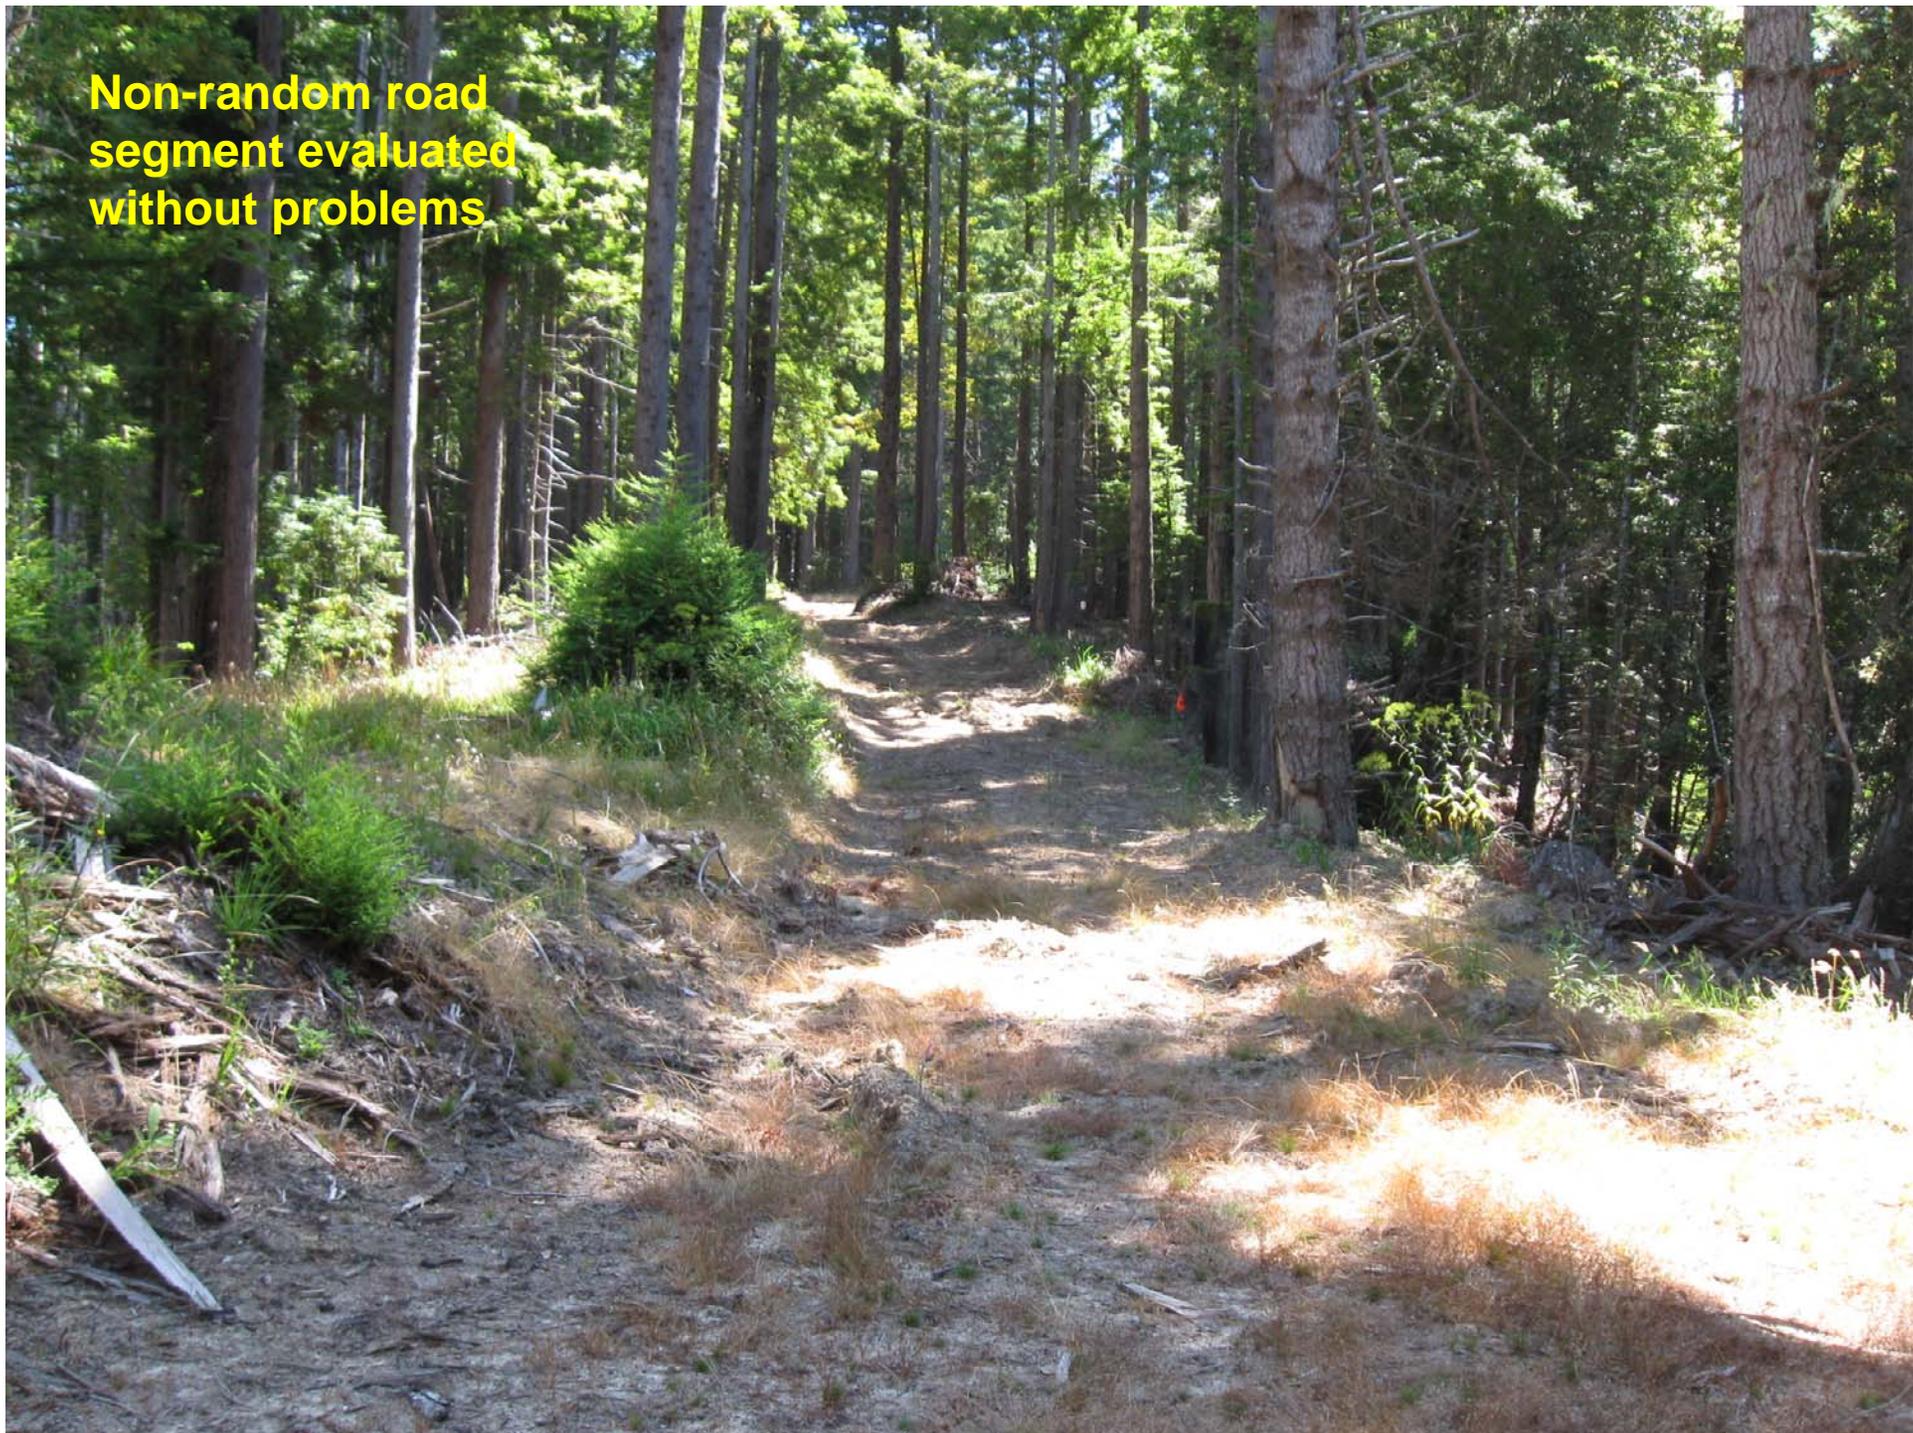
**Non-random road
segment evaluated
without problems**

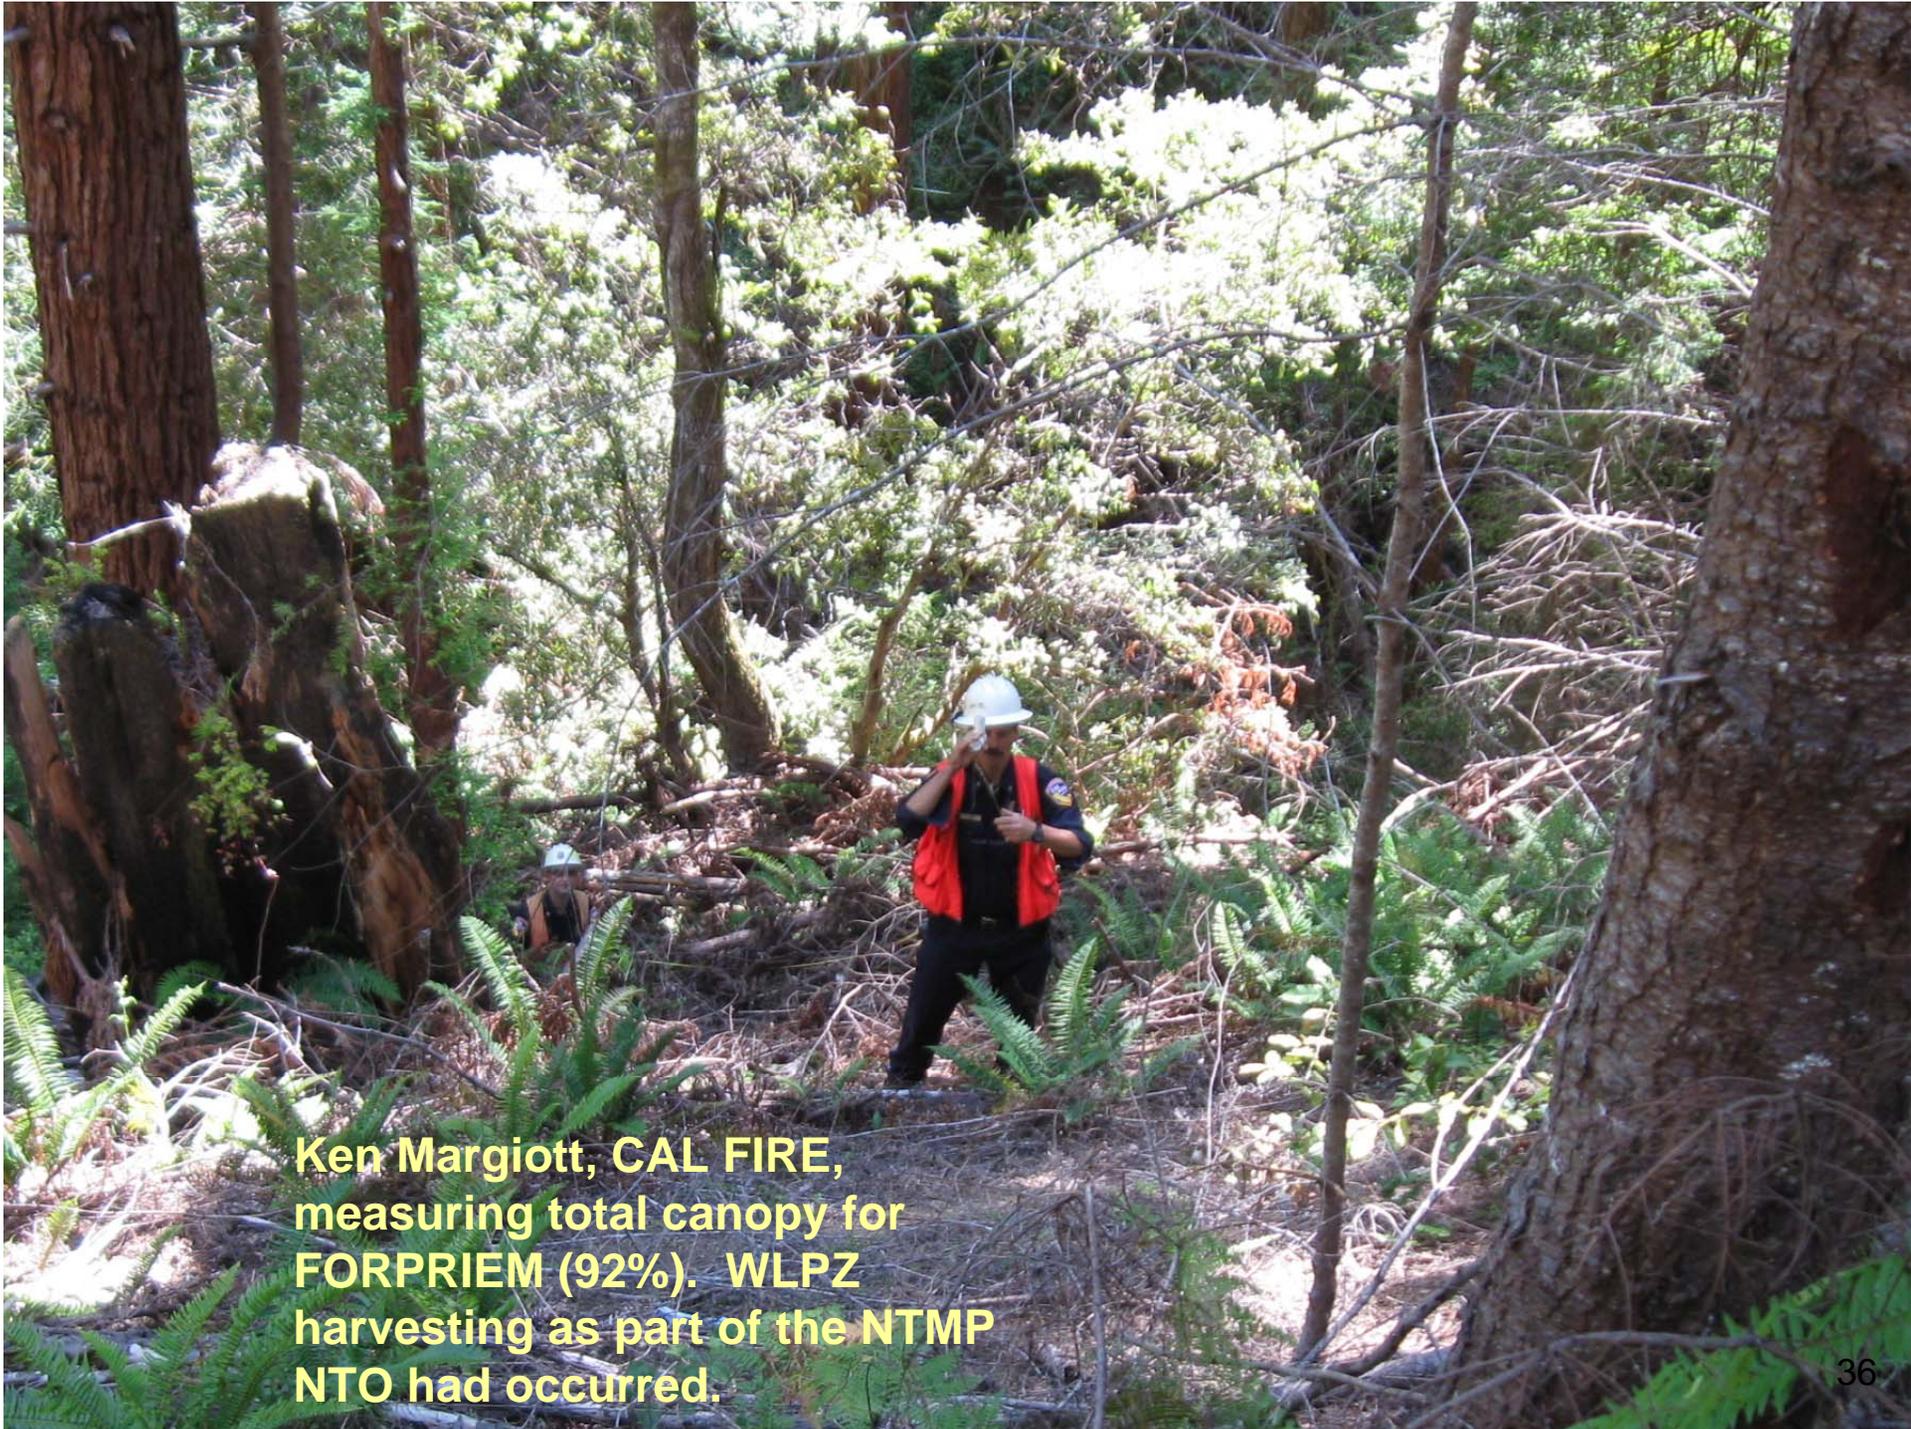
**Ken Margiott, CAL FIRE,
measuring total canopy for
FORPRIEM (92%). WLPZ
harvesting as part of the NTMP
NTO had occurred.**

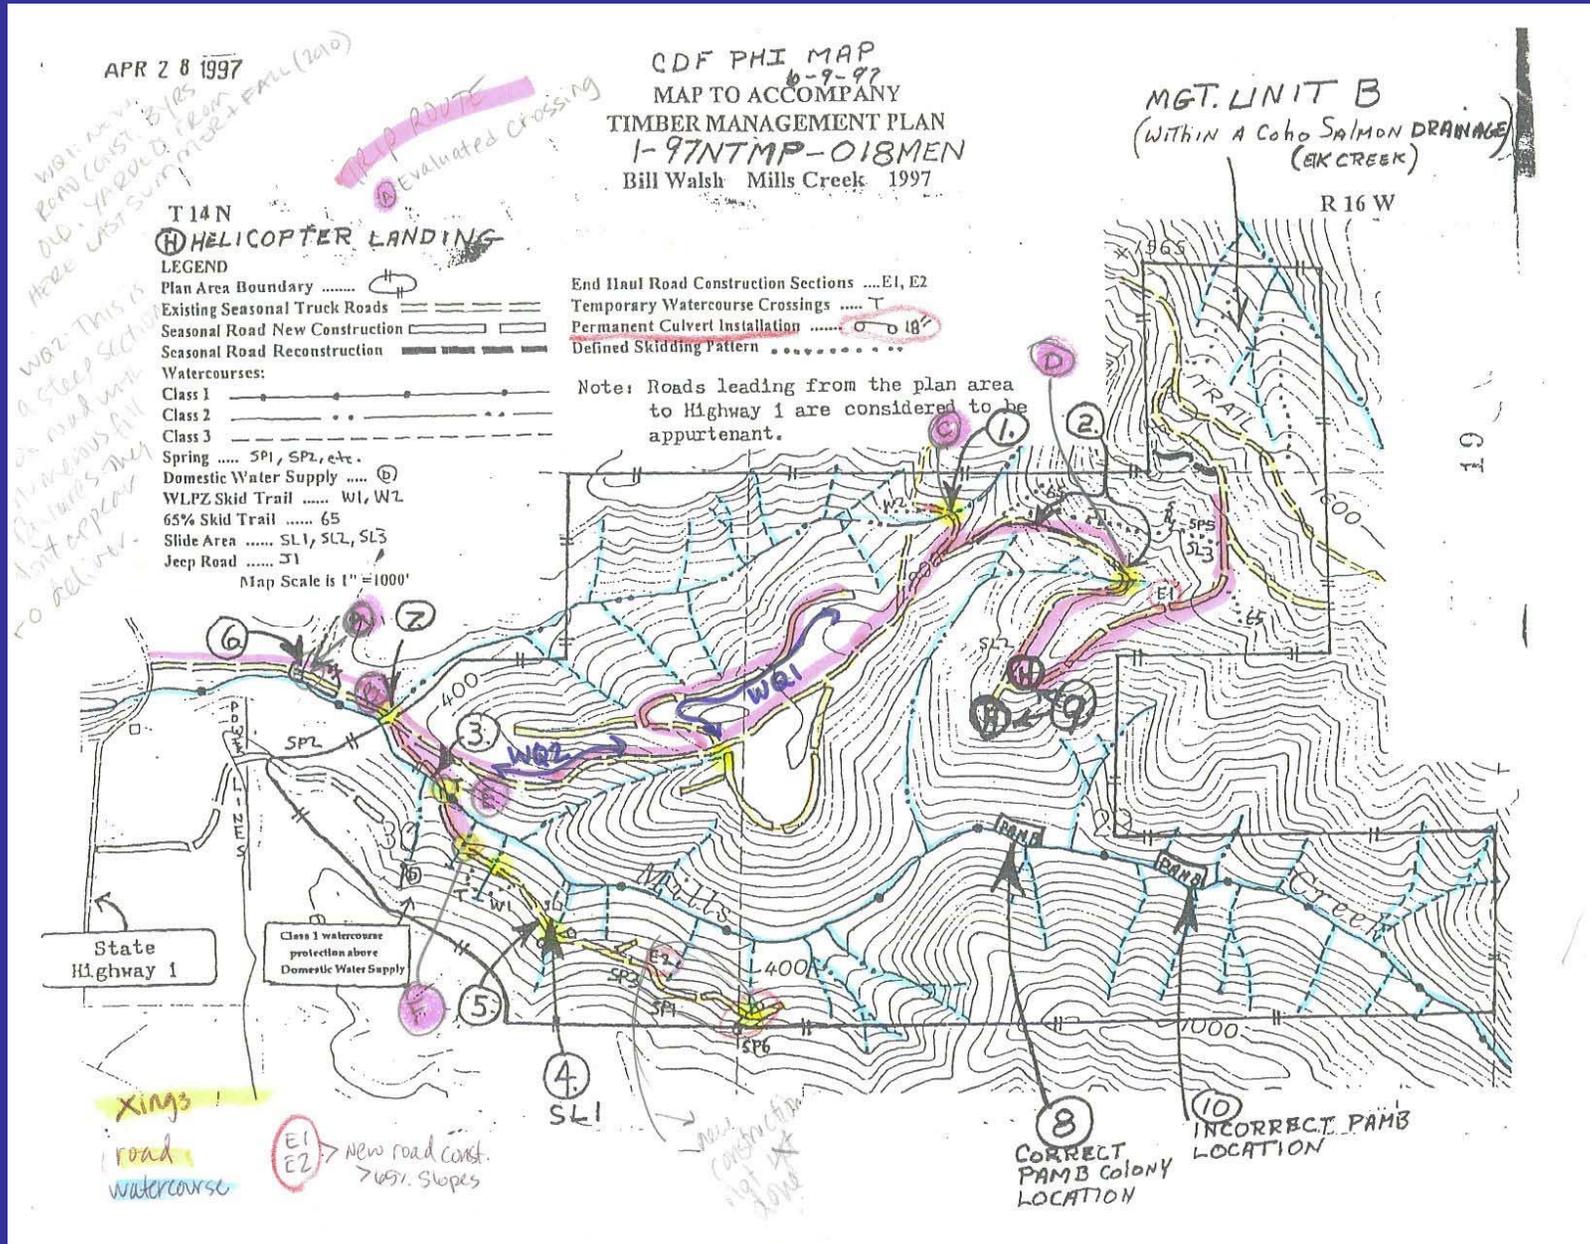
**NTMP map showing the road segments and crossings evaluated;
Roads were rated as a minor problem to water quality and crossings were
found to be a moderate problem**

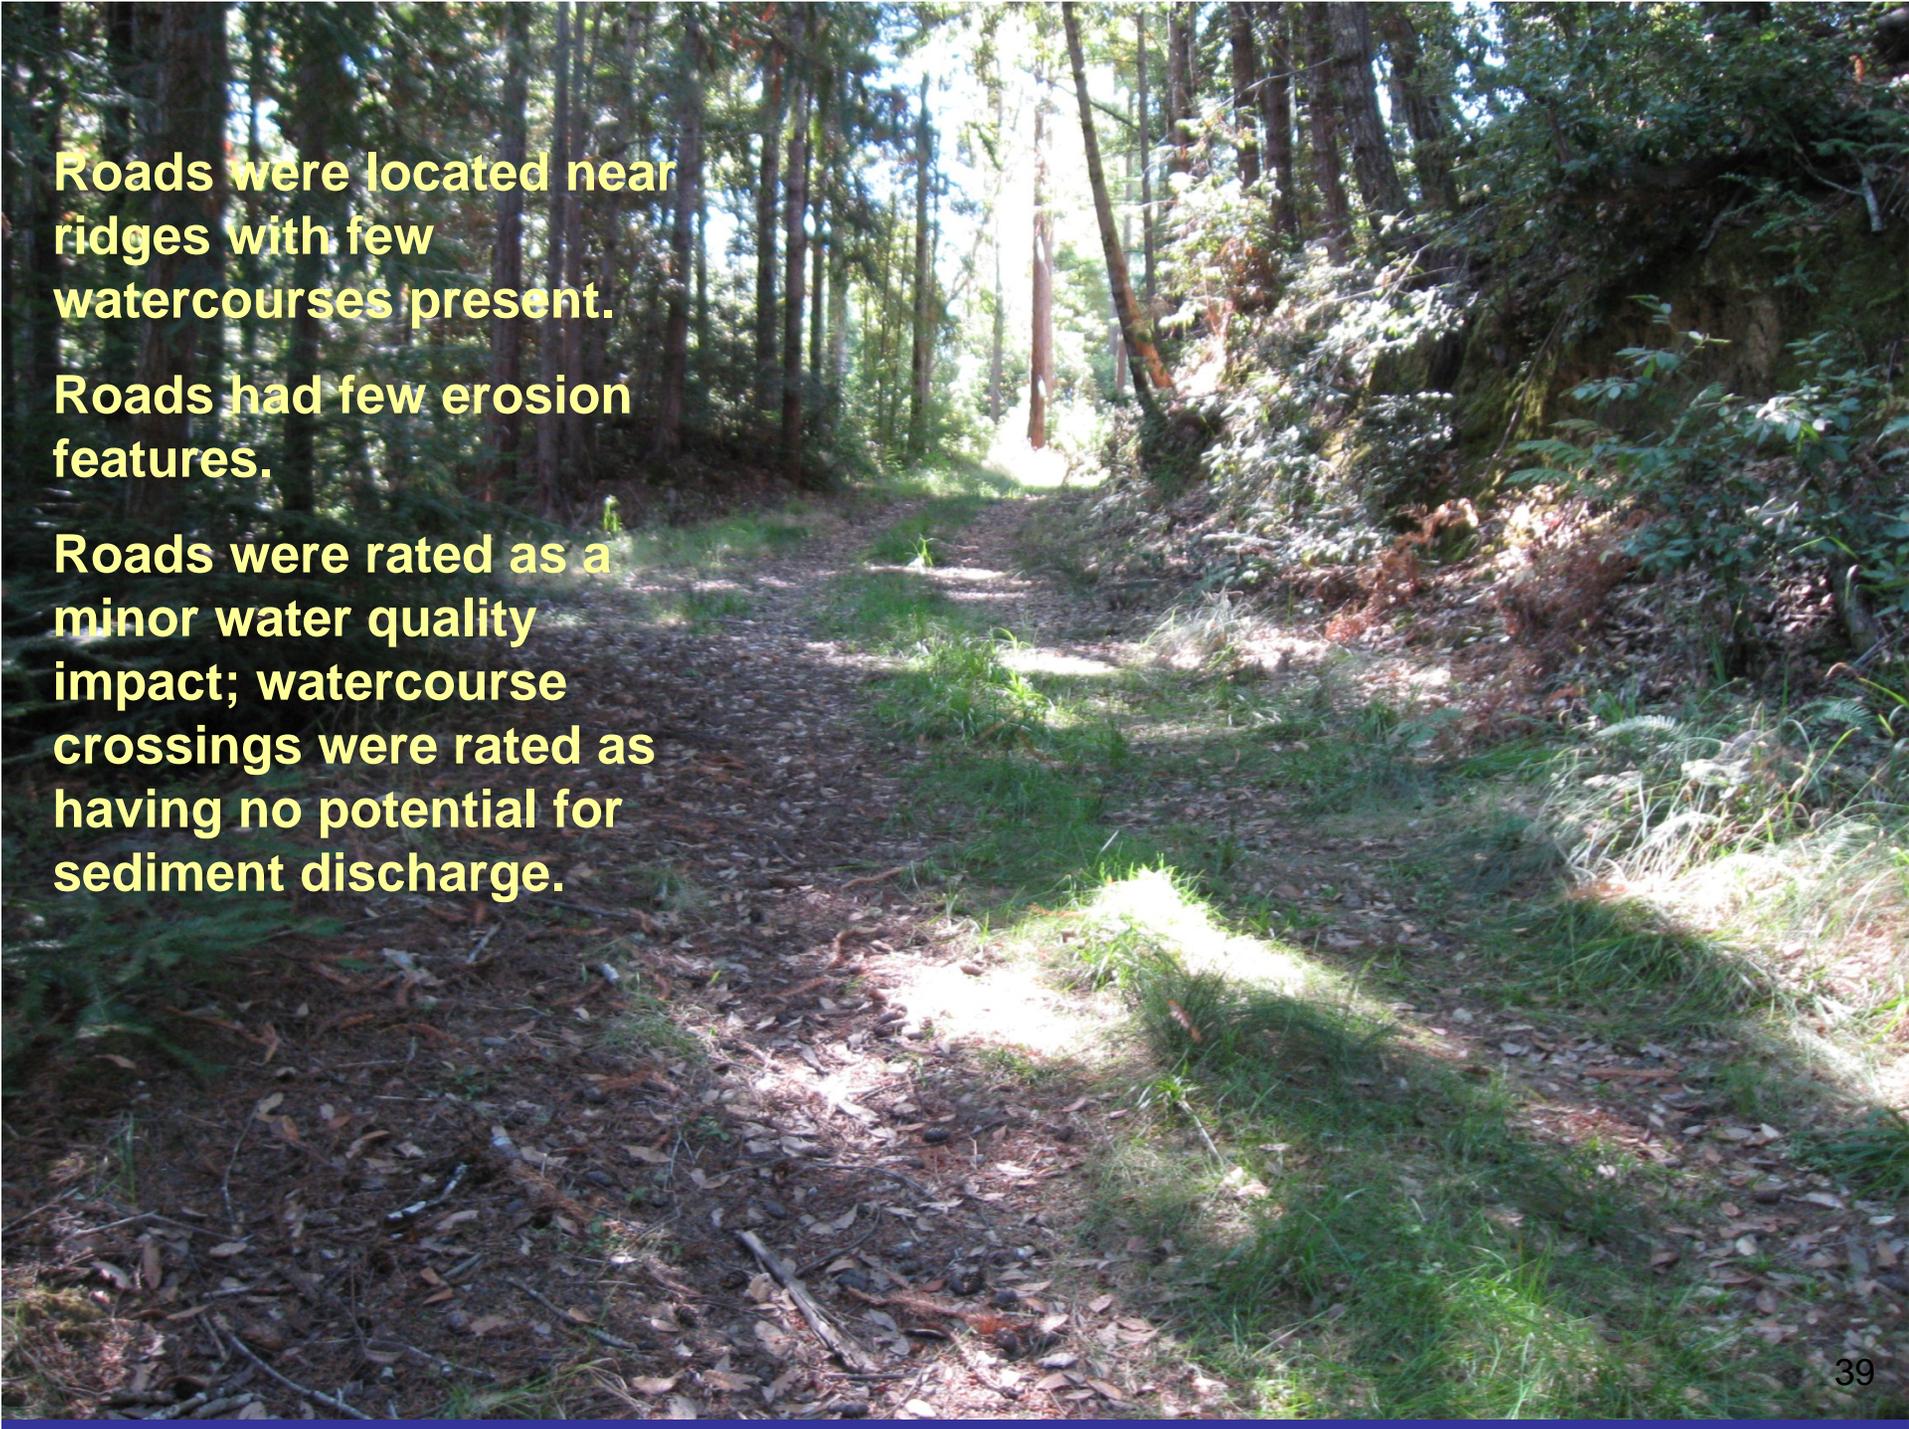
**Observing a road
segment**

Roads were located near ridges with few watercourses present.

Roads had few erosion features.

Roads were rated as a minor water quality impact; watercourse crossings were rated as having no potential for sediment discharge.

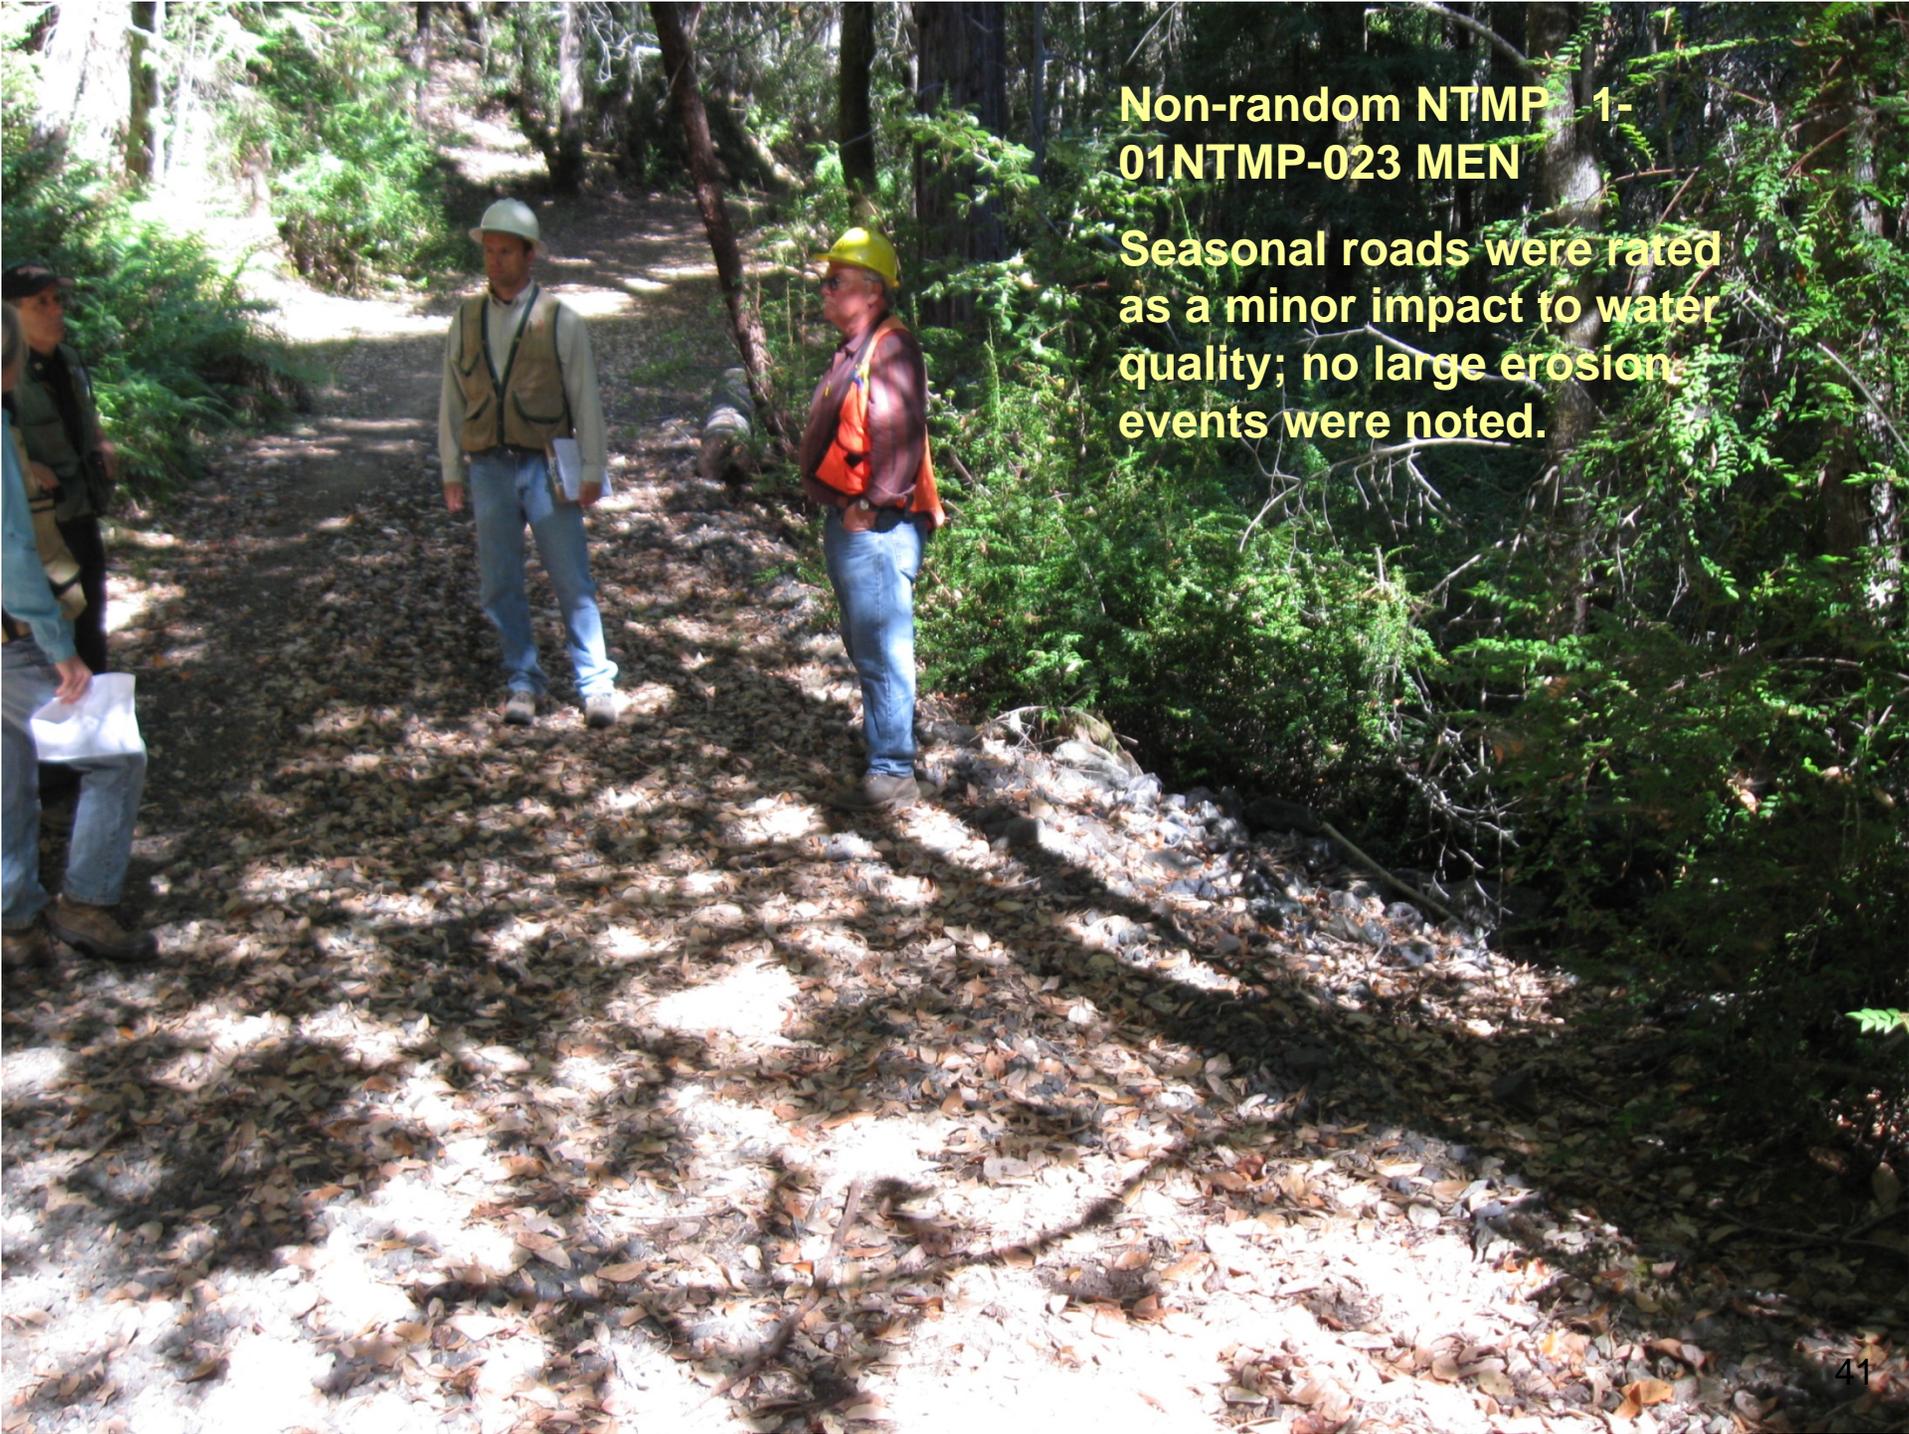
**8 watercourse
crossings were
evaluated, with
only minor
impacts to water
quality.**

**Seasonal roads were rated
as a minor impact to water
quality; no large erosion
events were noted.**

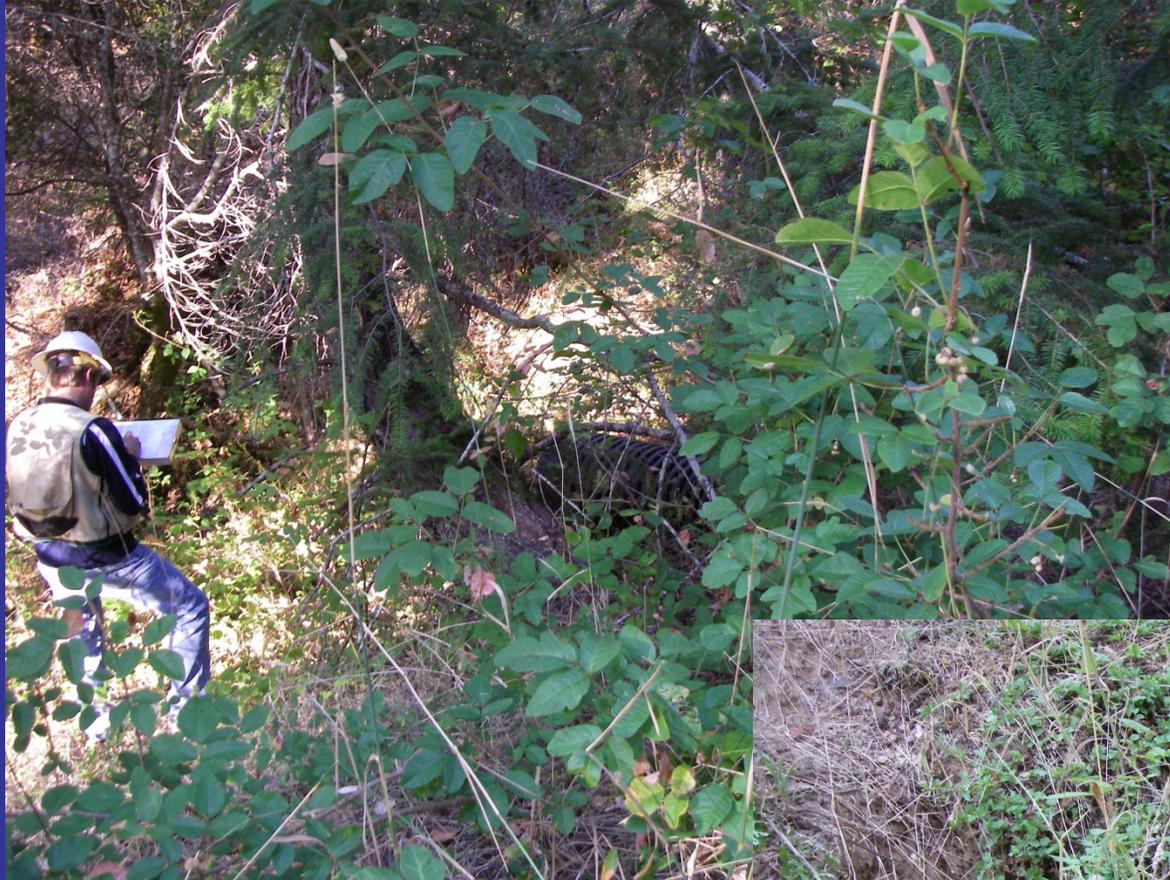
18" Plastic Pipe, Class III

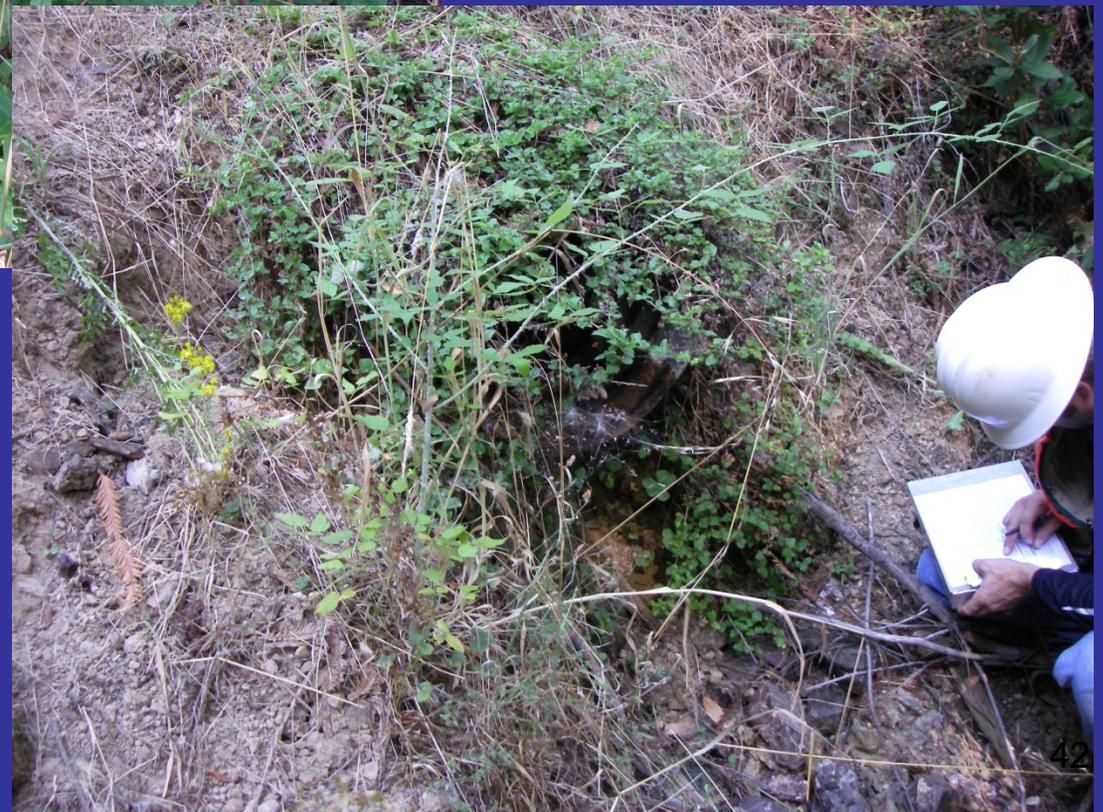
18" Metal Pipe, Class III

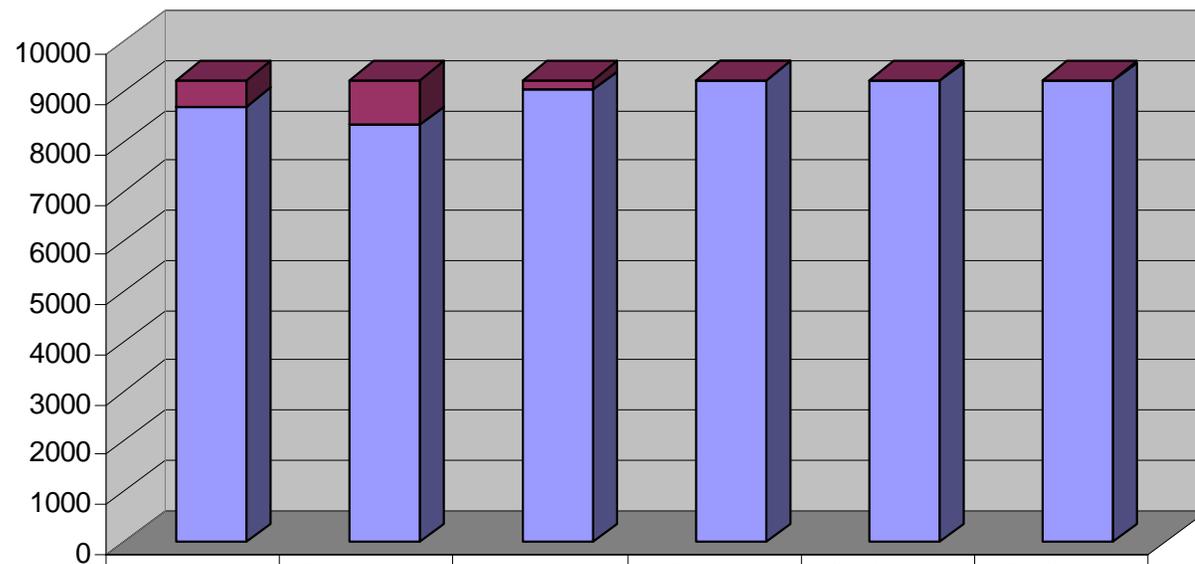
Erosion/Sediment Transport

Erosion on Cut Slope	Erosion on Road Surface	Erosion on Fill Slope	Erosion on Downslope of Fill	Sediment Transport Beyond	Sediment Transport to Channel
Linear Feet With Erosion	530	890	200	0	10	10
Linear Feet Without Erosion	8710	8350	9040	9240	9230	9230

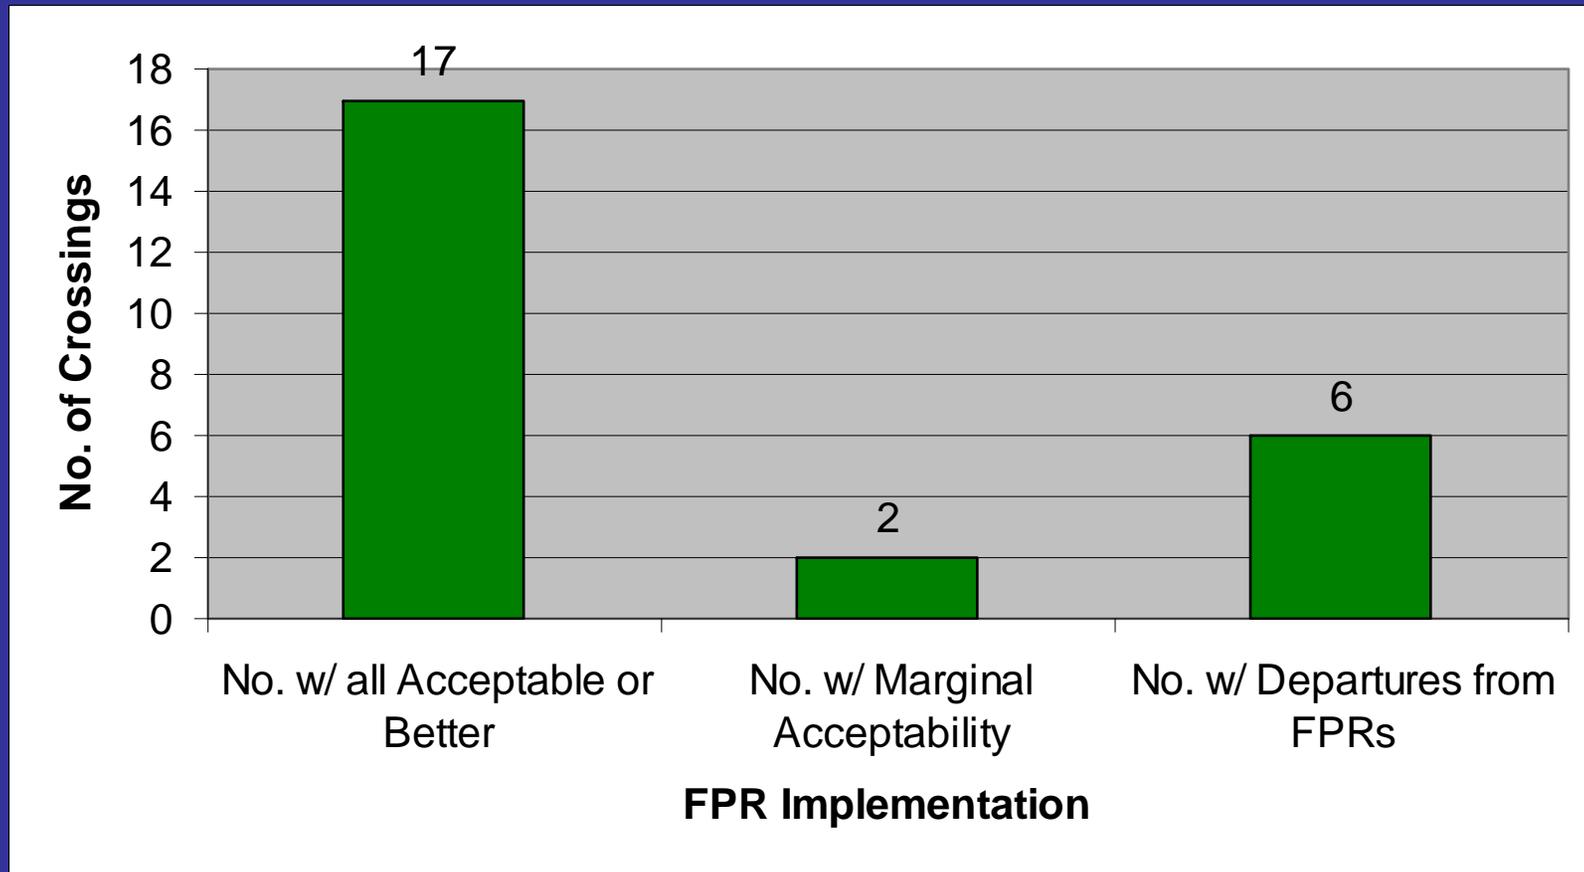
Watercourse Crossings: Rule Implementation

68% all acceptable implementation; 8% with marginal only; 24% with Rule departures

MCR: 64% all acceptable; 19% marginal only; 17% one or more Rule departures 58

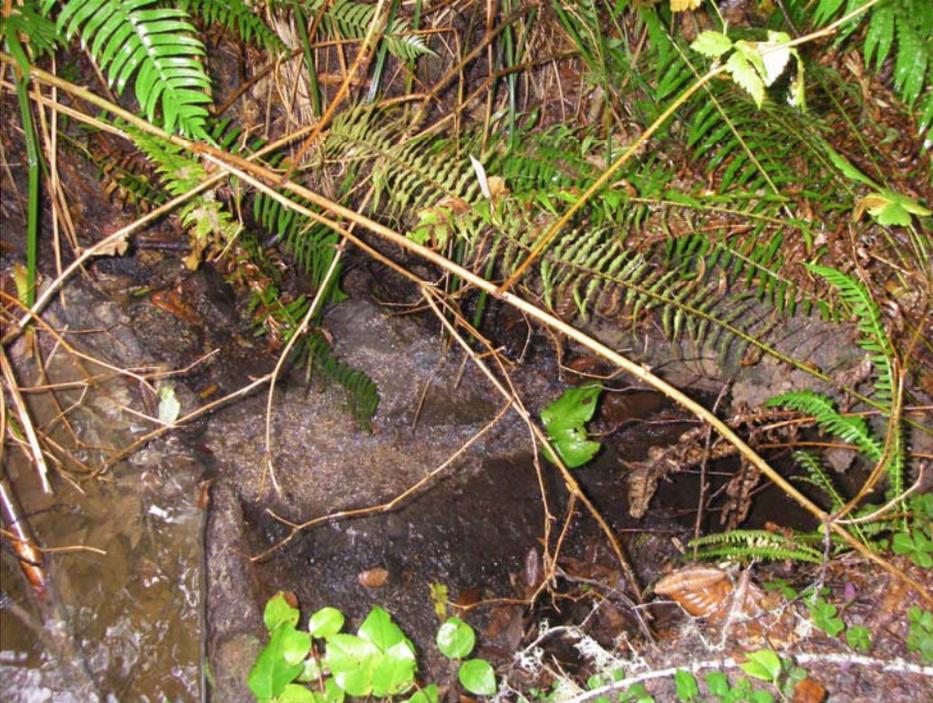
Crossing No. 2 -- Humboldt Crossing

Crossing Inlet

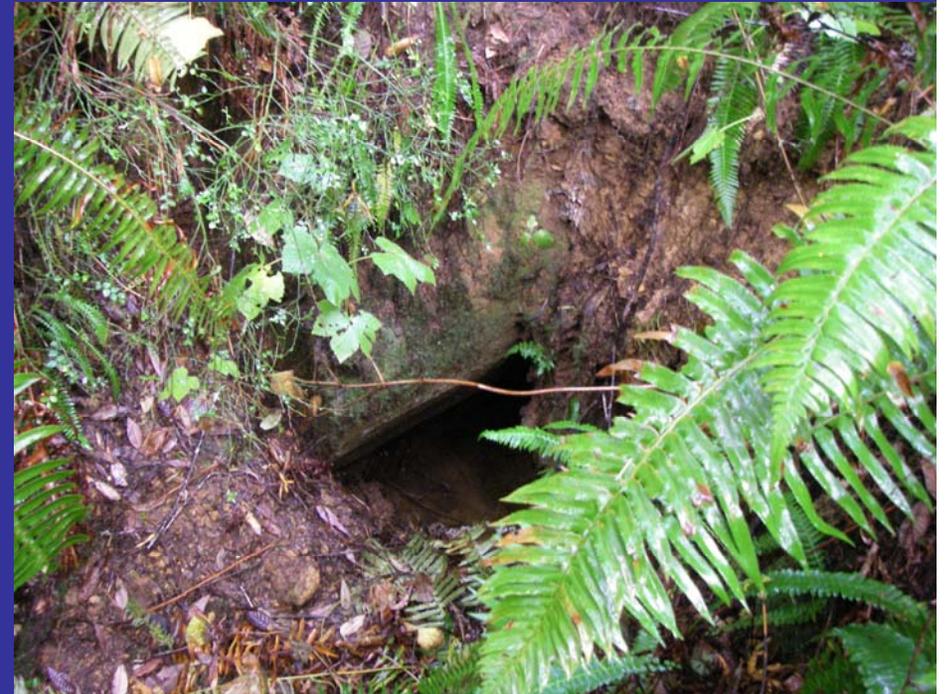
Crossing Outlet

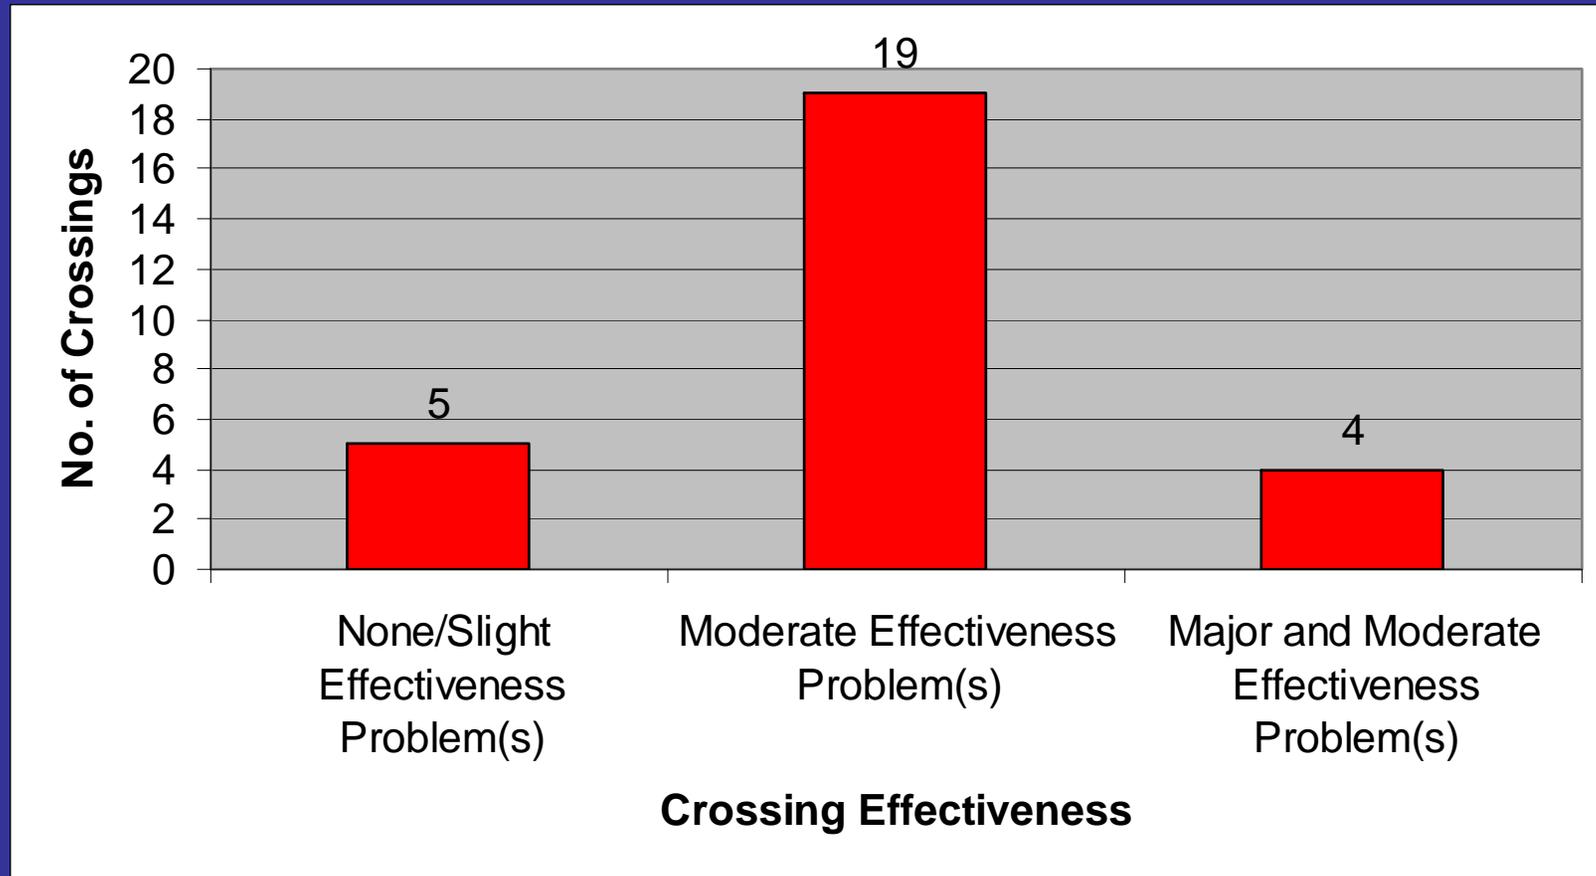
Watercourse Crossings: Effectiveness

21% no effectiveness problems; 79% with moderate problems; 17% with major problems

MCR: 18% of crossings had one or more major problems

- **Frequent Effectiveness Problems:**
 - **Scour at Outlet (9)**
 - **Plugging (5)**
 - **Road Rutting (5)**
 - **Cut-off Drainage Structure (4)**
 - **Diversion Potential (4)**
