# **Forest Practice Rules Implementation and Effectiveness Monitoring (FORPRIEM) Program**

## **MONITORING RESULTS FROM 2008 THROUGH 2013**

# **Forest Practice Rules Implementation and Effectiveness Monitoring Program (FORPRIEM): MONITORING RESULTS FROM 2008 THROUGH 2013**

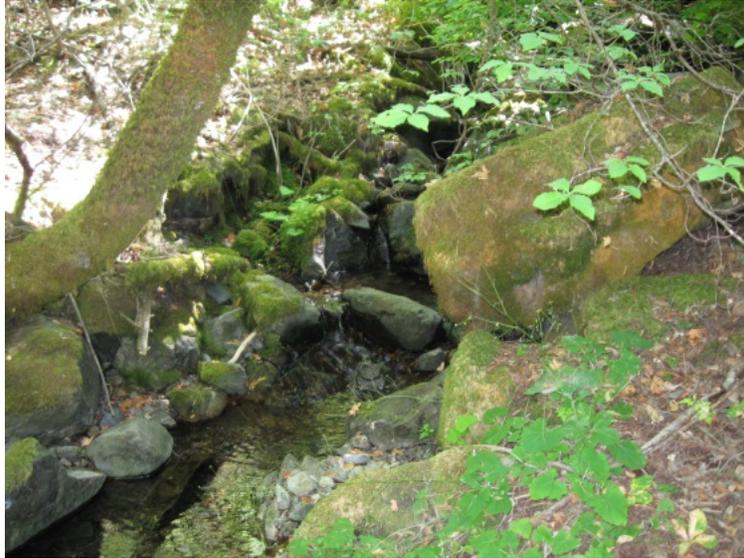
Figure 1. A small watercourse or stream in a FORPRIEM-sampled THP located in northern California and a typical example of the watercourses the California Forest Practice Rules are designed to protect.

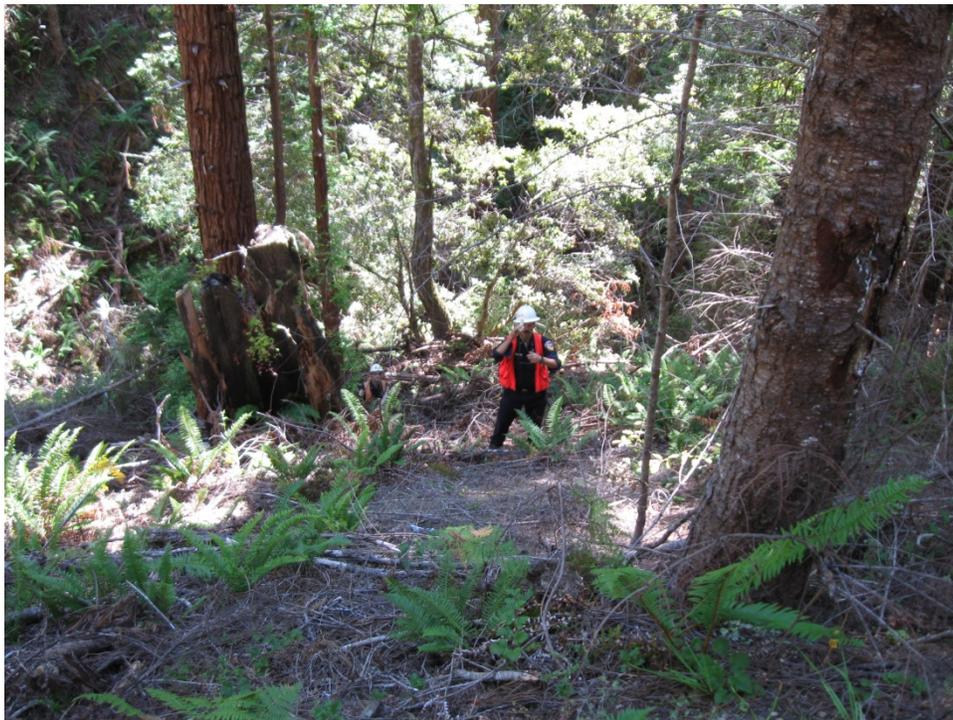
Figure 7. Ken Margiott, CAL FIRE, measures total canopy for FORPRIEM (92%) on August 16, 2011. WLPZ harvesting had occurred as part of this NTMP-NTO (1-97NTMP-018 MEN #6, Mill Creek NTMP).

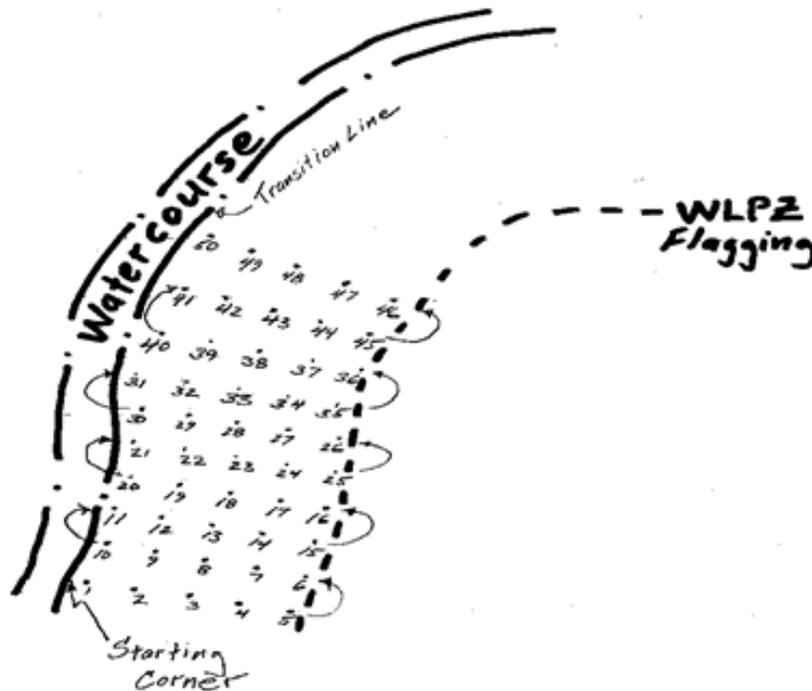
Figure 8. Typical pattern of canopy measurement points with a vertical sighting tube and groundcover observation points within a randomly sampled Class I or II WLPZ segment.

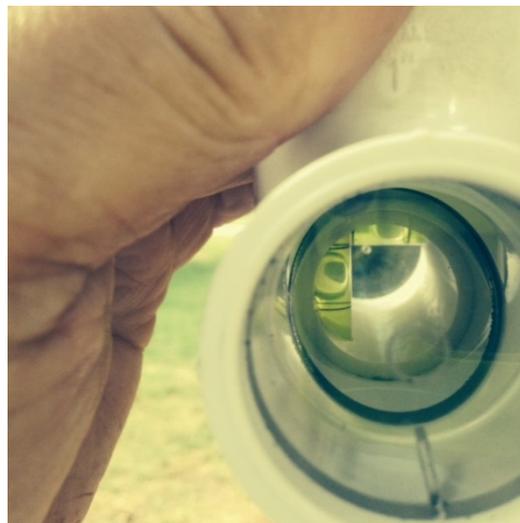
Figure 10. Standard procedures for use of the sighting tube included bringing the instrument up to the observer's eye, centering the two leveling bubbles, moving the observer's head slightly to center the dot in the circle, determining if canopy exists above the instrument, and recording a hit or miss on the data form.

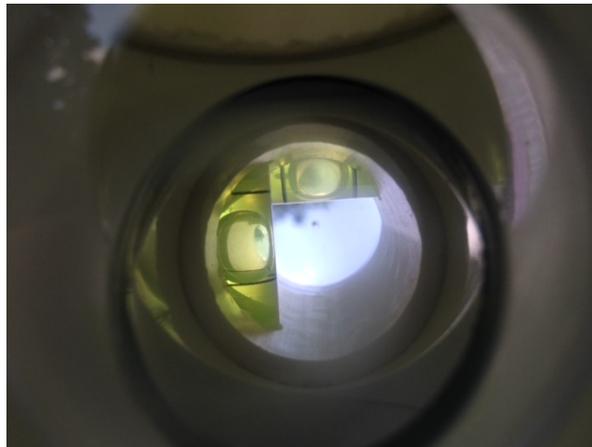
Figure 12. Example of a sighting tube “miss,” one of 50 hits and misses recorded in a total canopy WLPZ monitoring segment.

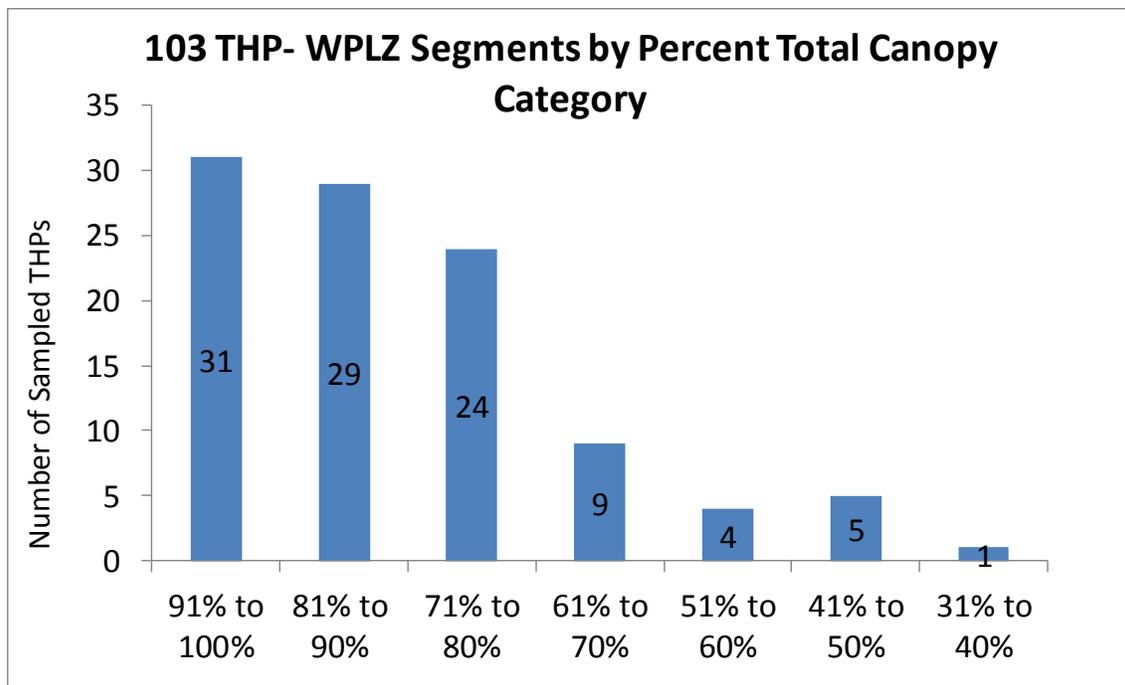
Figure 13. Distribution of the 103 THP WLPZ segments by percent total canopy category. There are more segments at the high end of the distribution than at low end. As a consequence, the median is slightly higher than the mean.

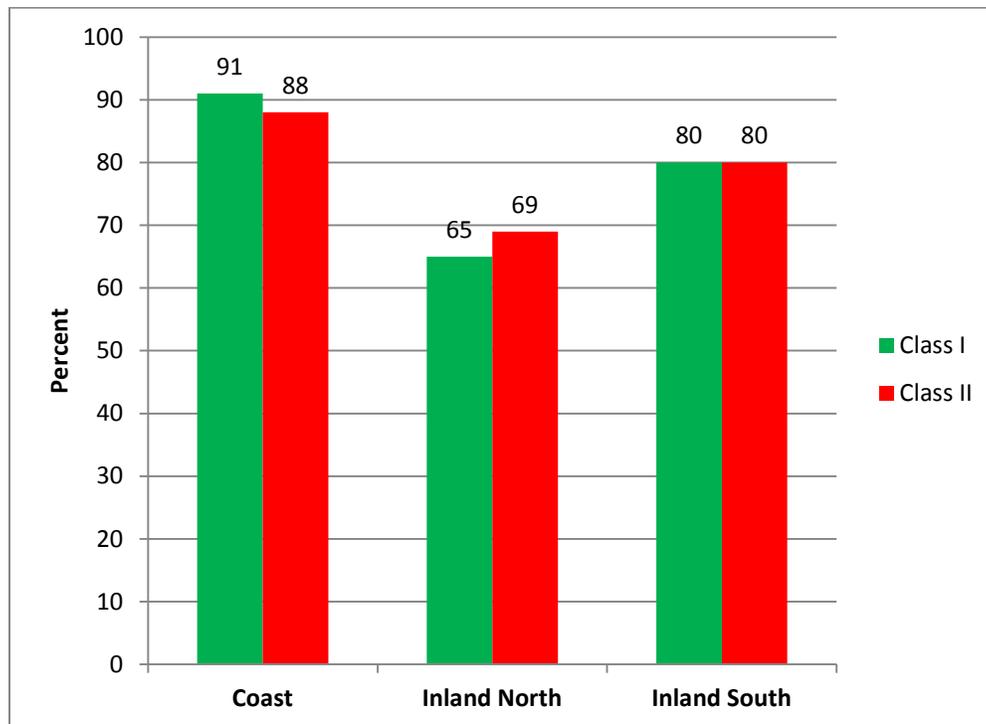
Figure 15. THP WLPZ percent total canopy by CAL FIRE Administrative Area, comparing Class I and Class II watercourses.

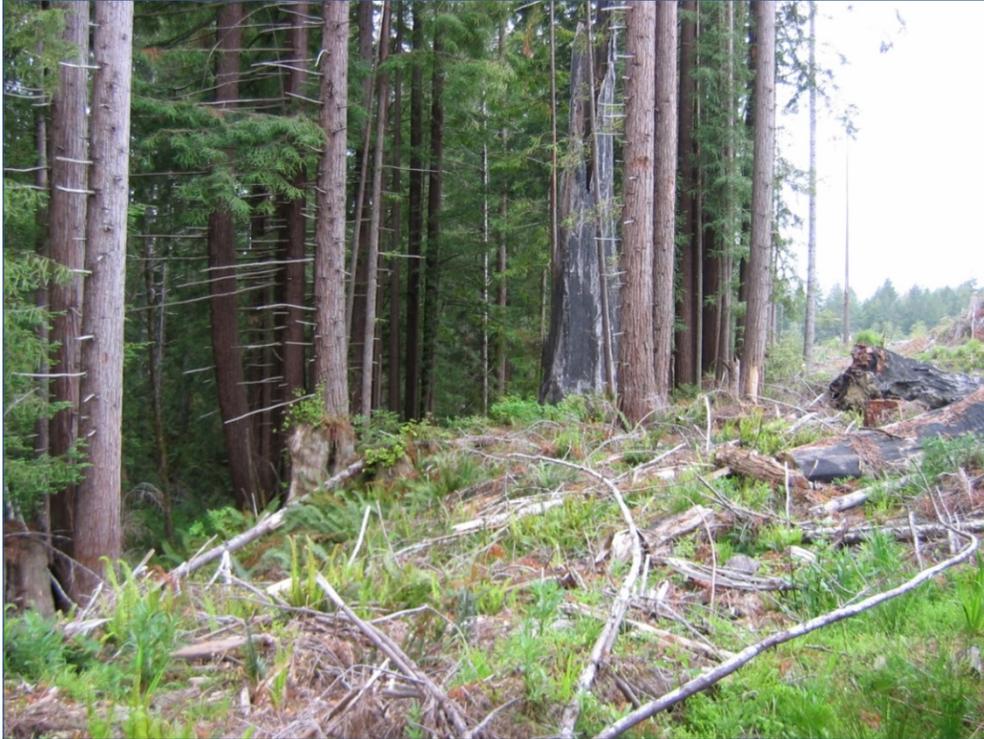
Figure 16. Example of a Coast Region Class II WLPZ in the FORPRIEM THP sample. Total canopy was 82% (THP 01-05-246 HUM).

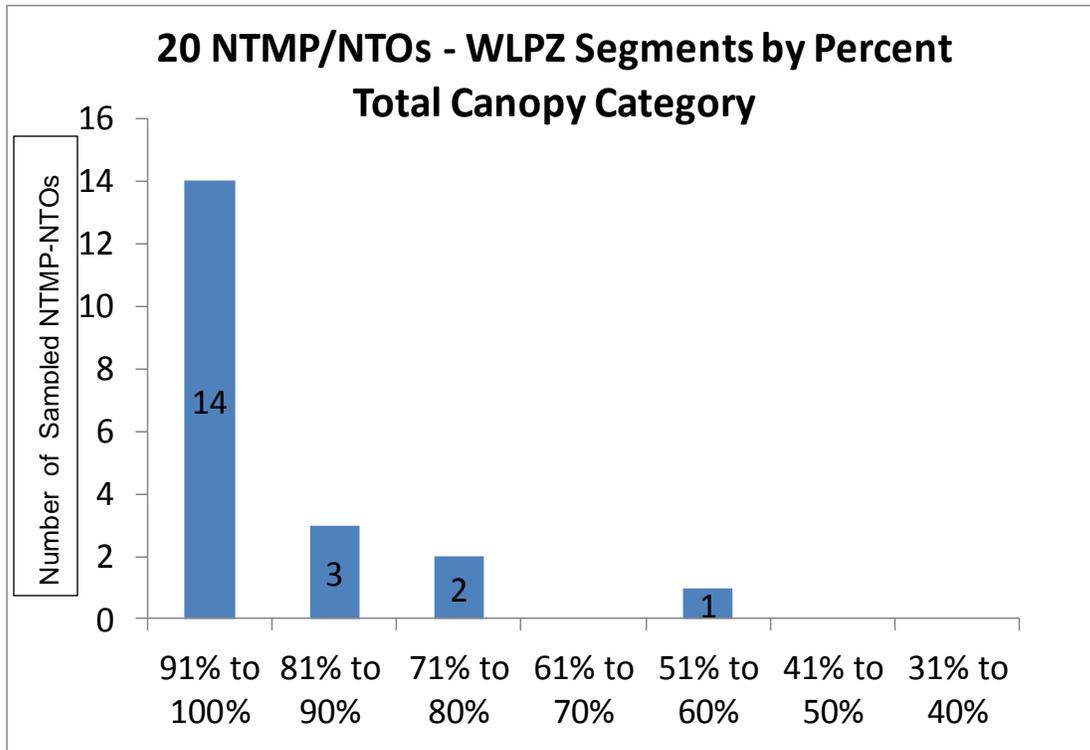
Figure 17. Distribution of the 20 NTMP-NTO WLPZ segments by percent total canopy category. There are more segments at the high end of the distribution than at low end. As a consequence, the median is slightly higher than the mean.

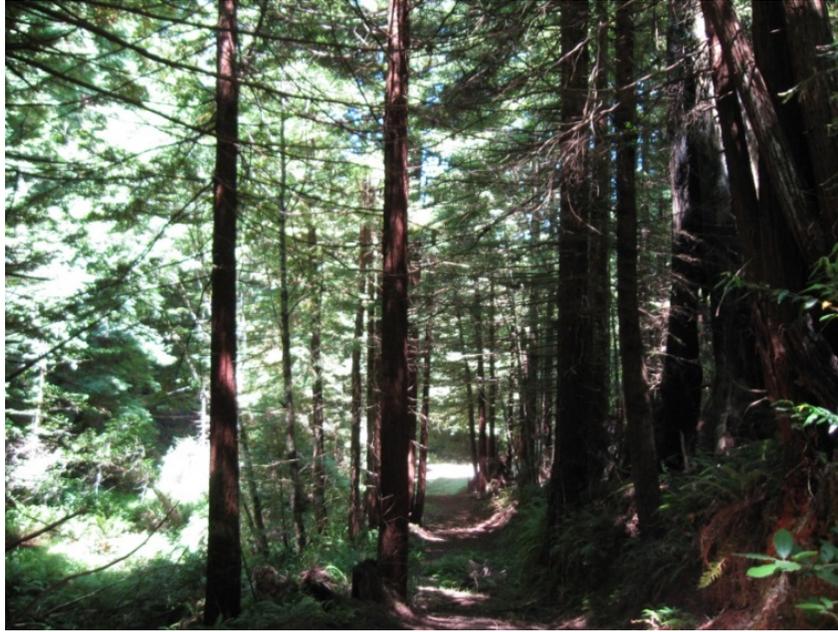
Figure 18. Example of an NTMP-NTO Class II WLPZ measured for total canopy in Humboldt County (01-97NTMP-001).

total canopy was consistently higher for NTMP-NTOs than for similar THP categories (Figure 18). It should be noted that the sample size (n) for some of these categories is very small.

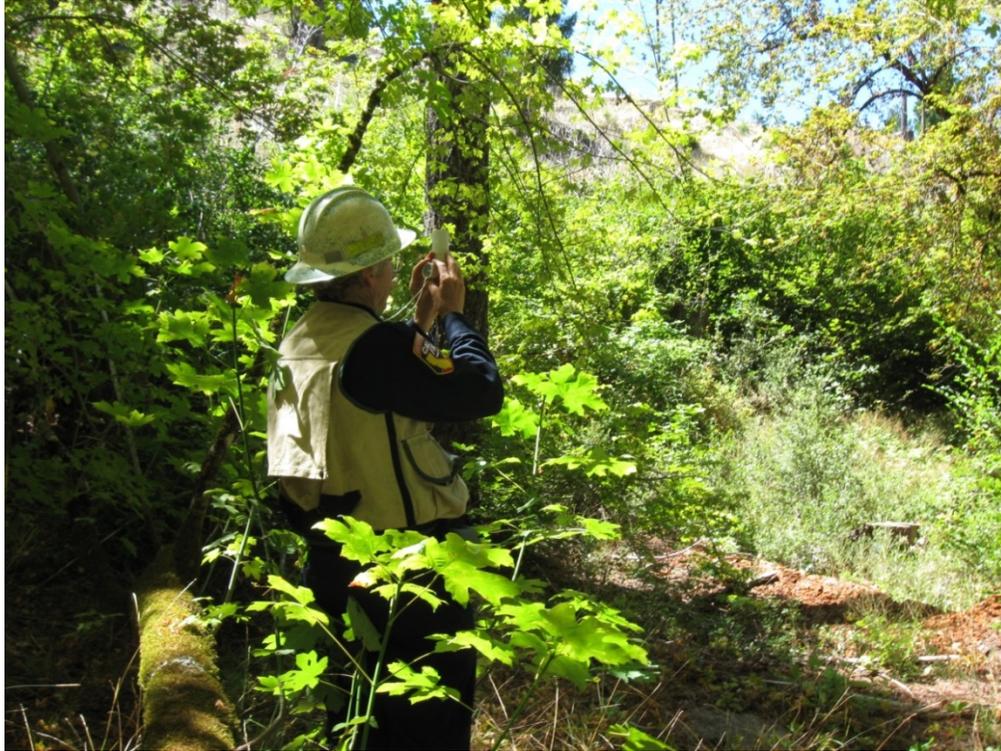
Figure 19. Measurement of total canopy in a Class II WLPZ as part of the QA/QC re-measurement for THP 2-04-193.

Five FORPRIEM-monitored THPs were picked at random for re-monitoring. Four of the five THPs had monitored WLPZ segments. The THPs were revisited and the same four WLPZ segments were re-monitored (Figure 19). The results for WLPZ percent total canopy were similar for the first (original) site visit and the second (QA/QC) site visit.

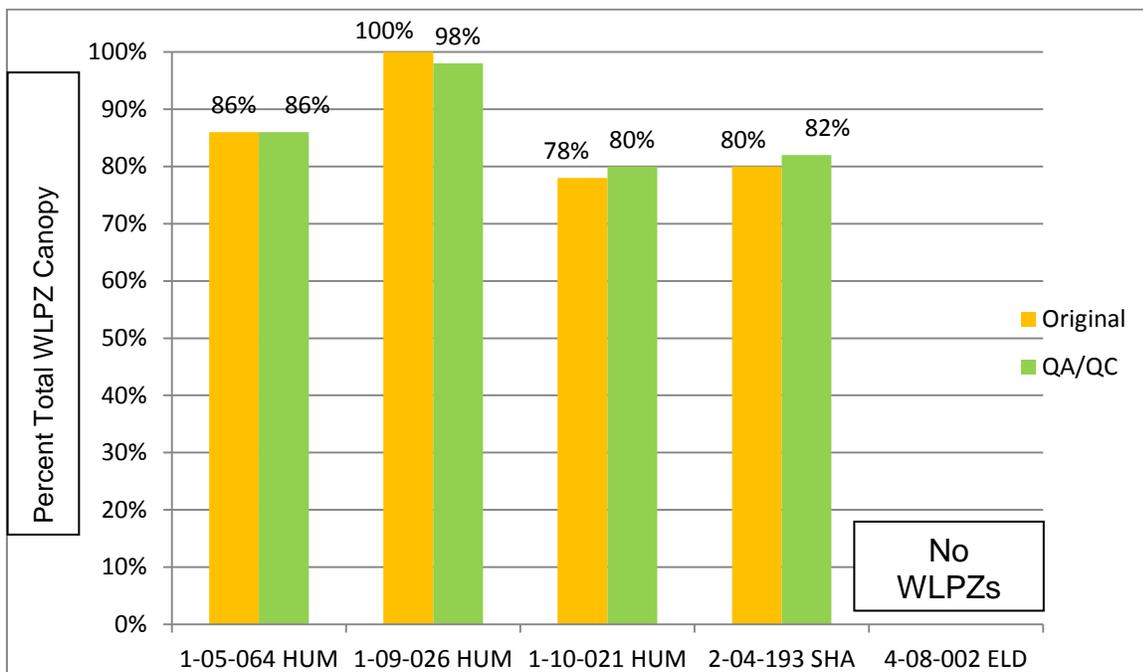
Figure 20. QA/QC – THP WLPZ percent total canopy. Five FORPRIEM-monitored THPs were picked at random for re-monitoring. Four of the five THPs had monitored WLPZ segments.

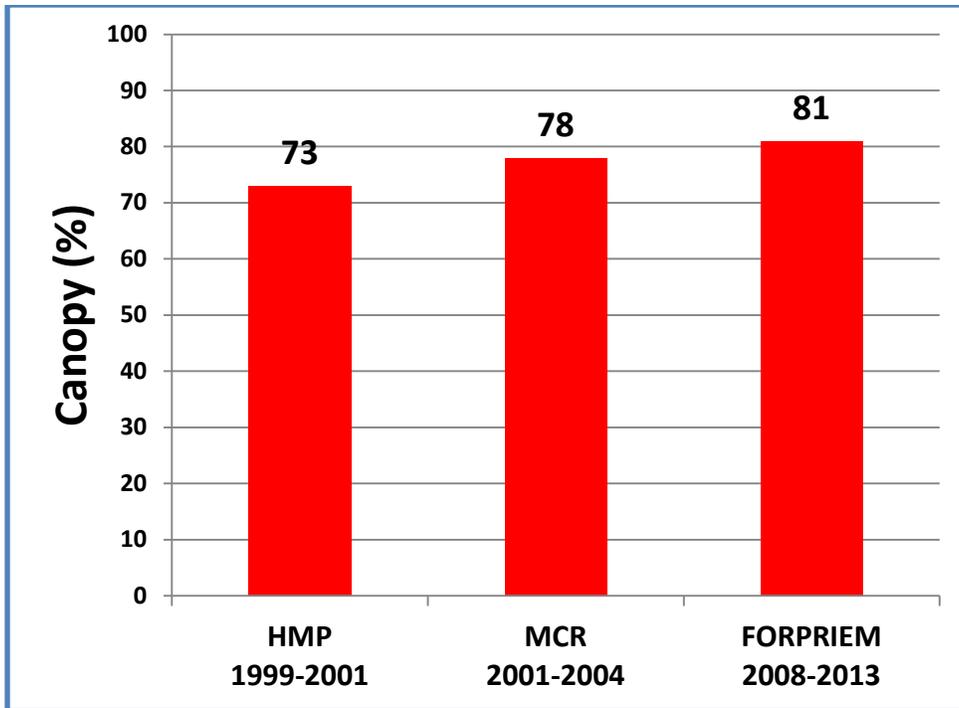
Figure 21. Comparison of THP Class I WLPZ percent total canopy measured with a sighting tube for three studies (HMP 1999-2001, MCR 2001-2004 and FORPRIEM 2008-2013).

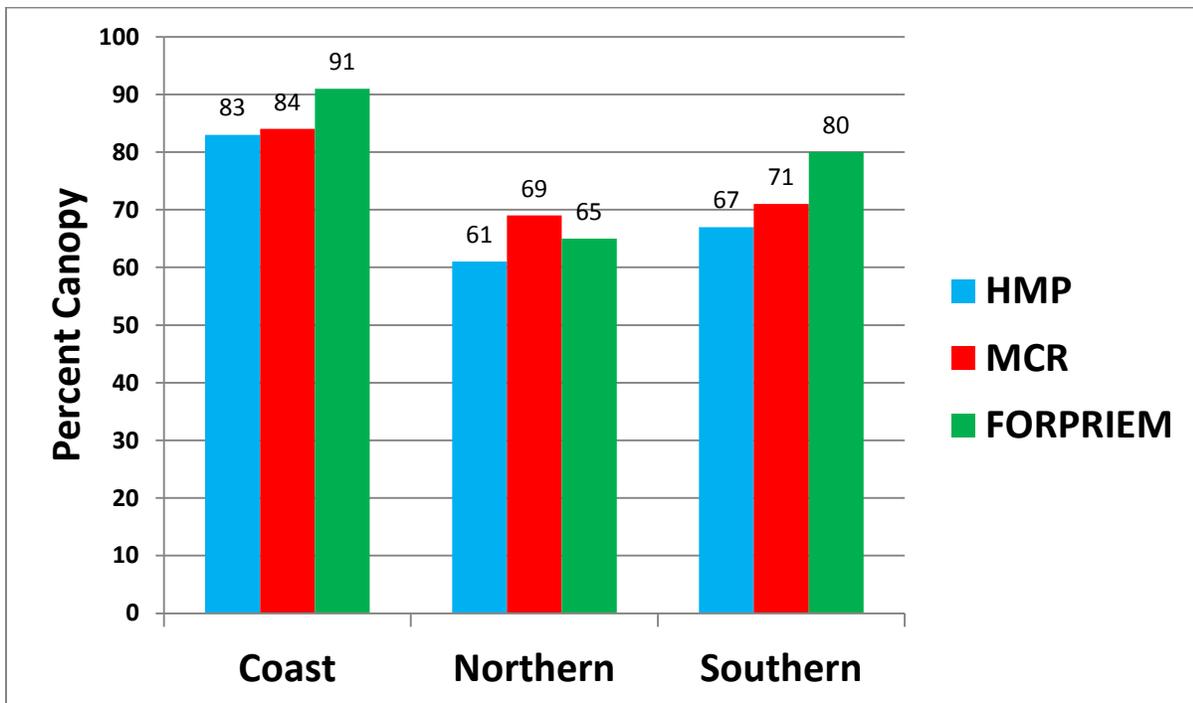
Figure 22. Comparison of THP Class I WLPZ percent total canopy by monitoring program and Region.

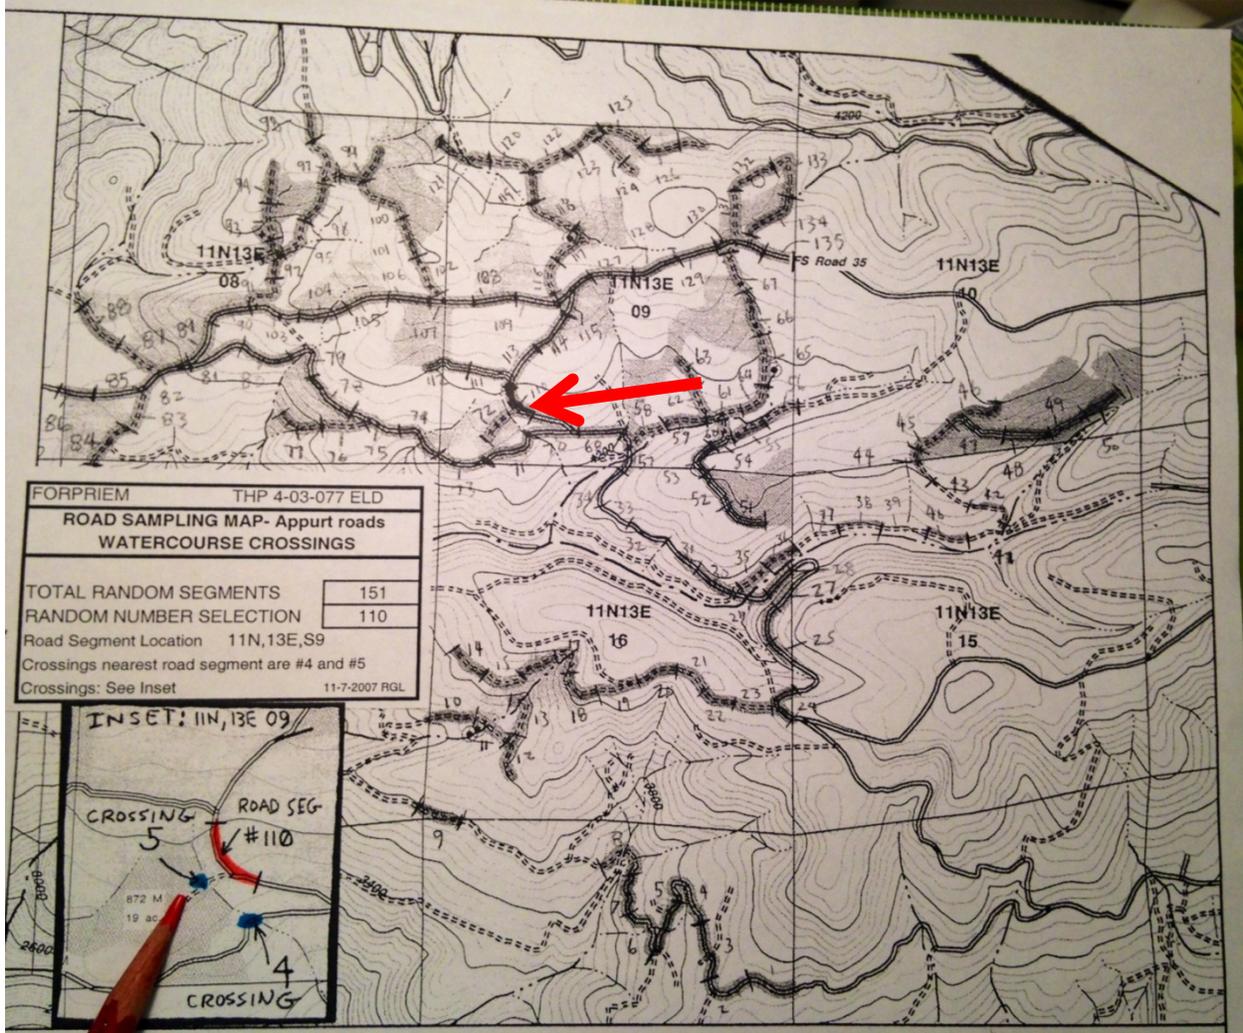
Figure 23. Example of a THP road map used in the FORPRIEM sample showing logging roads segmented and numbered. Road segment #110 (see arrow and inset) was randomly selected for monitoring using a random number generator. The two randomly selected watercourse crossings (Numbers 4 and 5) are also shown in the insert (see the Watercourse Crossing section of this report for additional information).

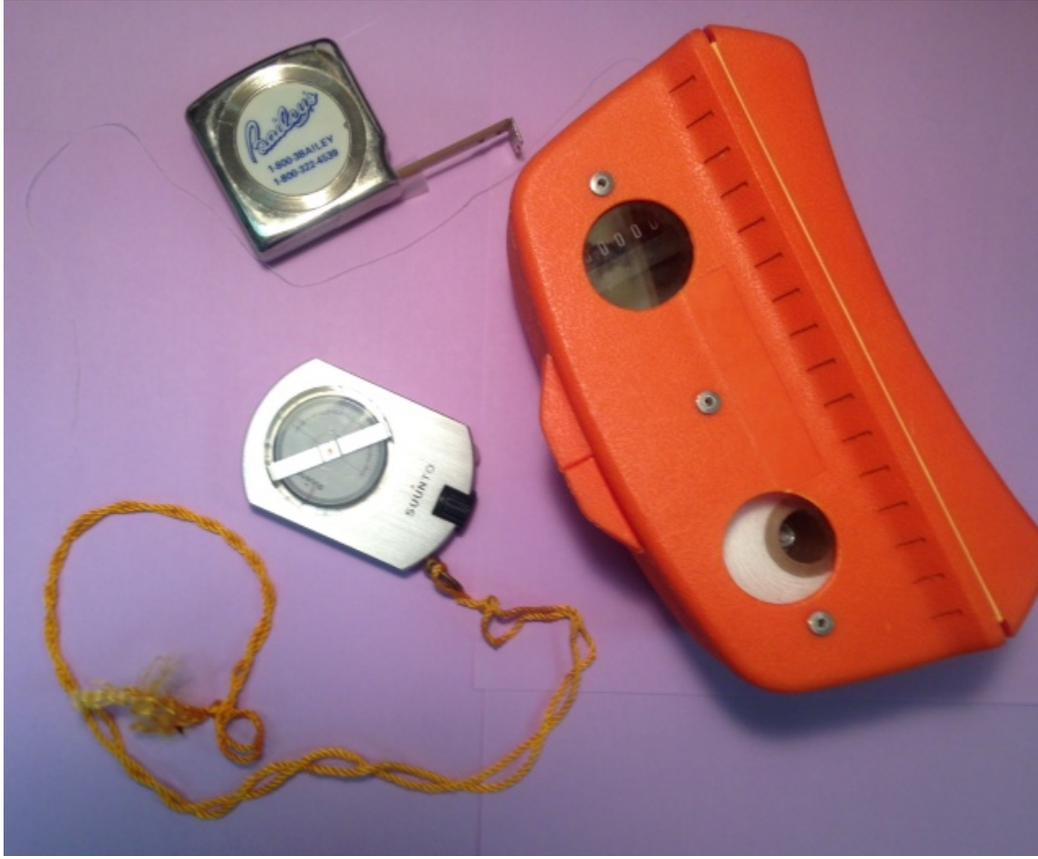
Figure 25. The tools needed to complete road monitoring included (1) pocket tape measure (erosion void dimensions), (2) string box (distances), and 3) clinometer (gradients). Also needed were the FORPRIEM road forms and a digital camera (optional).

The tools needed to complete FORPRIEM road monitoring were (1) a pocket tape measure for documenting lengths, widths, and depths of erosion voids; (2) a string box (hip chain) for measuring distances; and (3) a clinometer for measuring road and side slope gradients (Figure 25). A roll of white flagging and a marking pen were used for marking and identifying both ends of the road segment. A set of FORPRIEM road monitoring forms and a clipboard were required for recording measurements and observations. A digital camera was optional for taking photographs of the road segment.<sup>15</sup>

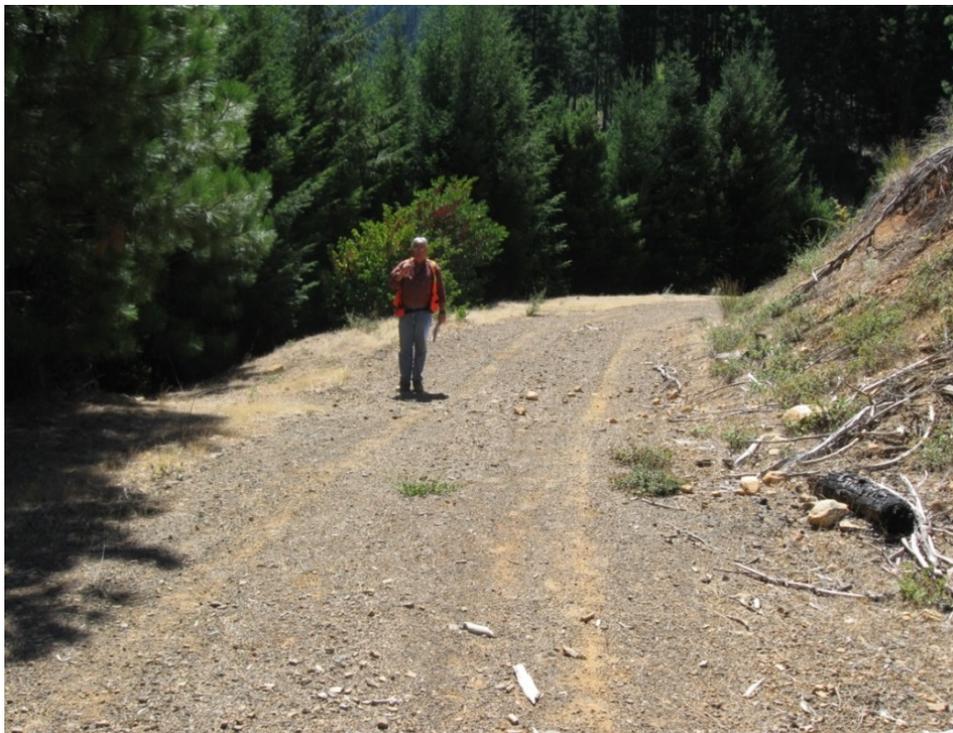
Figure 26. Clay Brandow recording road rule implementation and effectiveness data along a randomly located 660-foot road segment included in the FORPRIEM THP sample.

After locating the start of the 660-foot road segment, distances along the reach were measured with the string box (hip chain) (Figure 26). The 660-foot road segment was divided into 10-foot increments for recording data (66 increments per 660 foot segment) (Figure 27). The location and type of road drainage facilities, generically referred to as waterbreaks (WBs) in this study, and drainage structures (e.g., ditch relief culverts) were recorded on the implementation forms where they were found along the segment.<sup>16</sup>

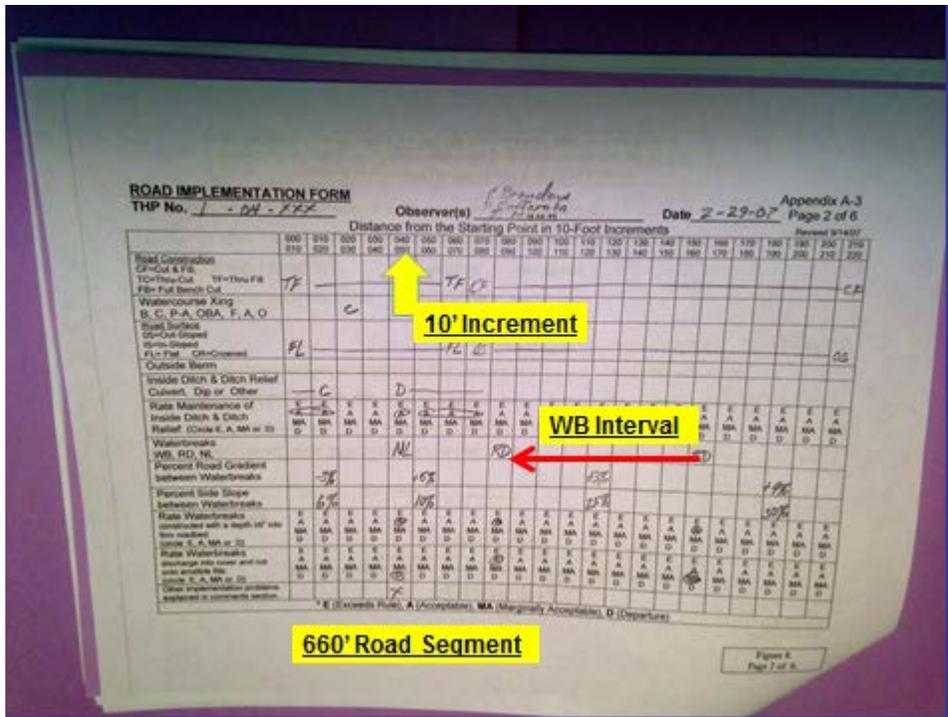
Figure 27. Three key road terms used in FORPRIEM road monitoring: 660-foot road segment divided into 10-foot increments, and waterbreak (WB) intervals between road drainage structures. This form is page 2 of 6 of the FORPRIEM road form package.

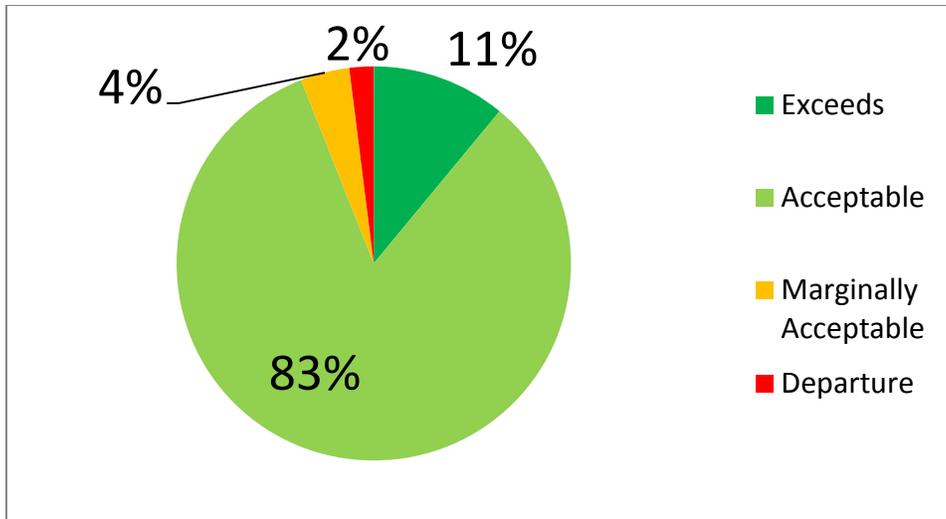
Figure 29. FORPRIEM THP waterbreak ratings for discharge into cover. Forest Practice Rule 14 CCR §§ 914.6 [934.6, 954.6] (f) and 923.2 [943.2, 963.2] (o).

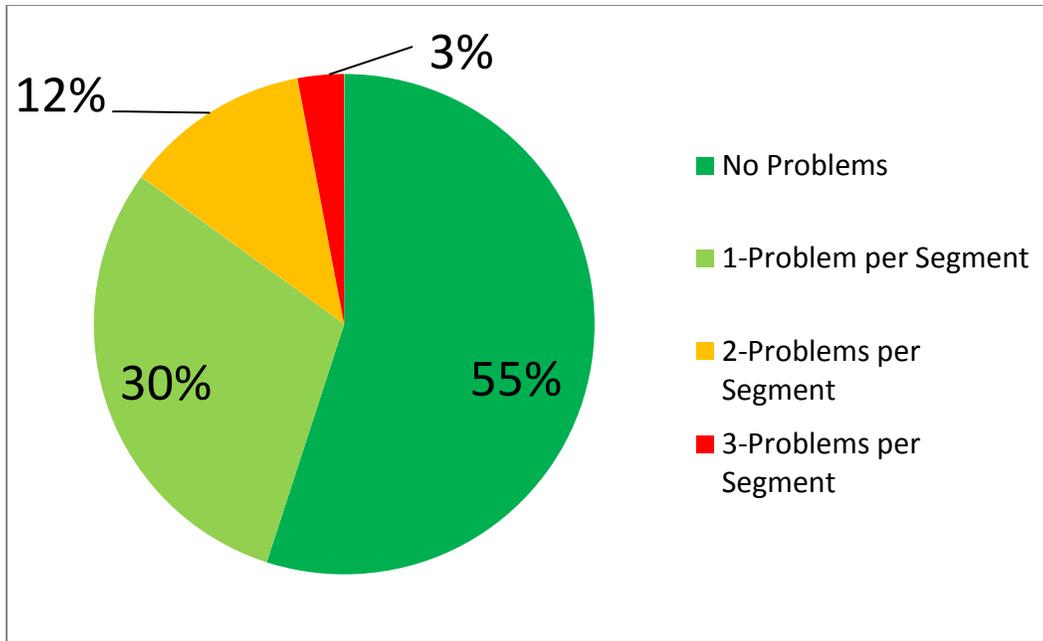
Figure 31. Distribution of THP waterbreak spacing problems by sampled road segment. Forest Practice Rule 14 CCR § 914.6 [934.6, 954.6] (c).

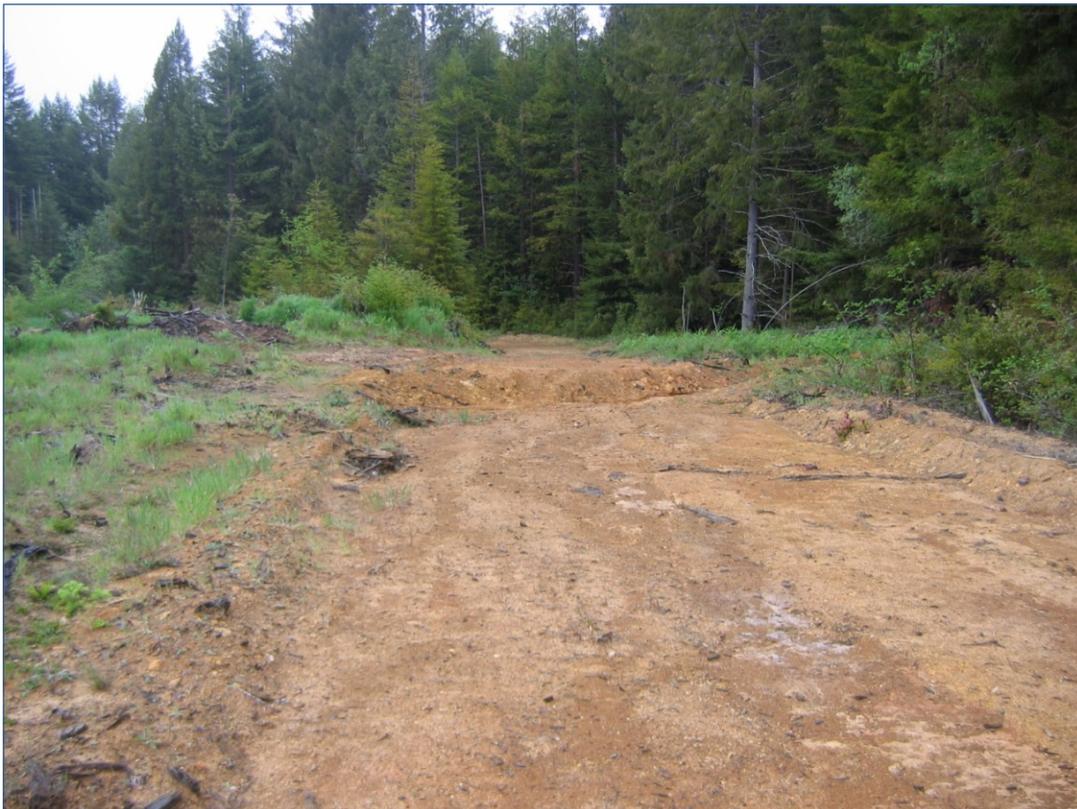
Figure 32. Example of a seasonal road with a properly installed waterbreak (THP in the FORPRIEM sample in Humboldt County).

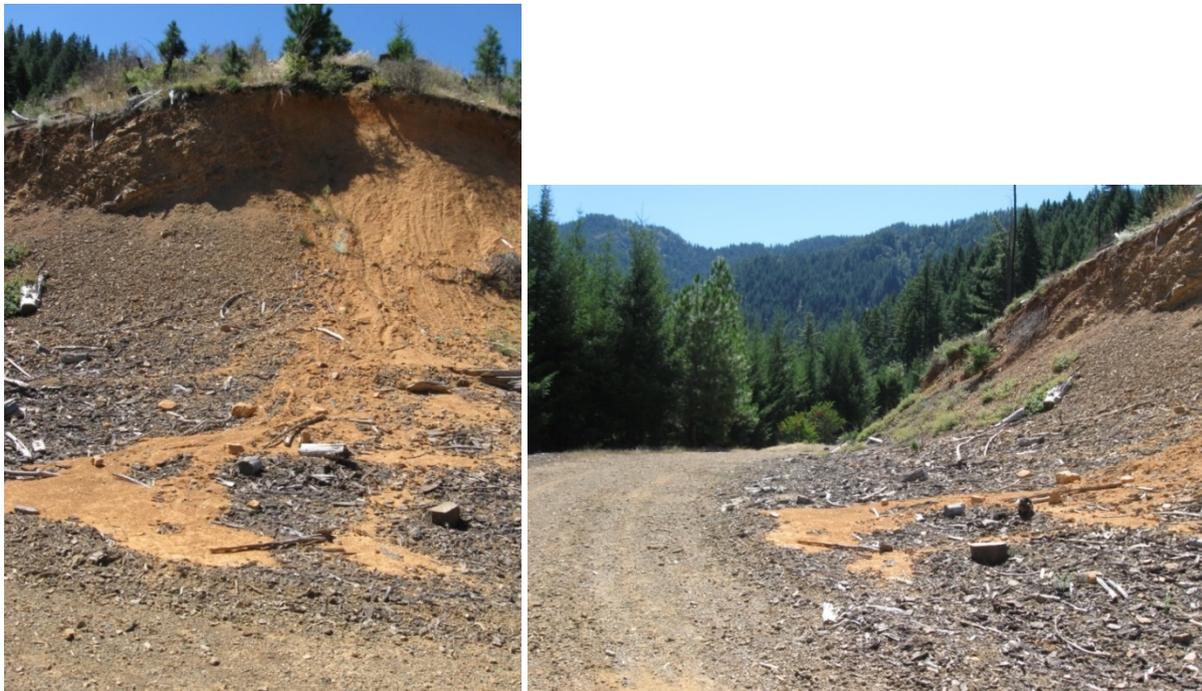
Figure 33. Example of sediment deposition onto a randomly located THP road segment in the FORPRIEM sample.

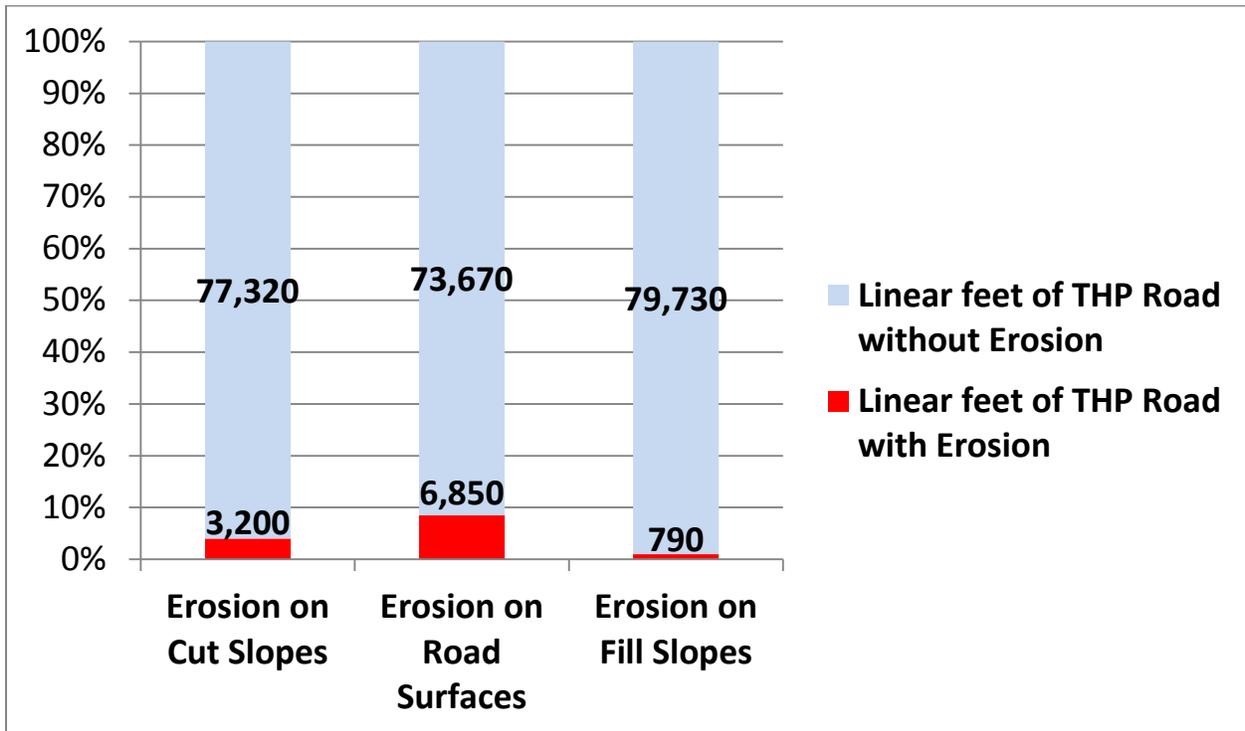
Figure 34. Percentage of the total THP road length monitored with erosion on the cut slope, erosion on the road surface, and erosion on the fill slope.

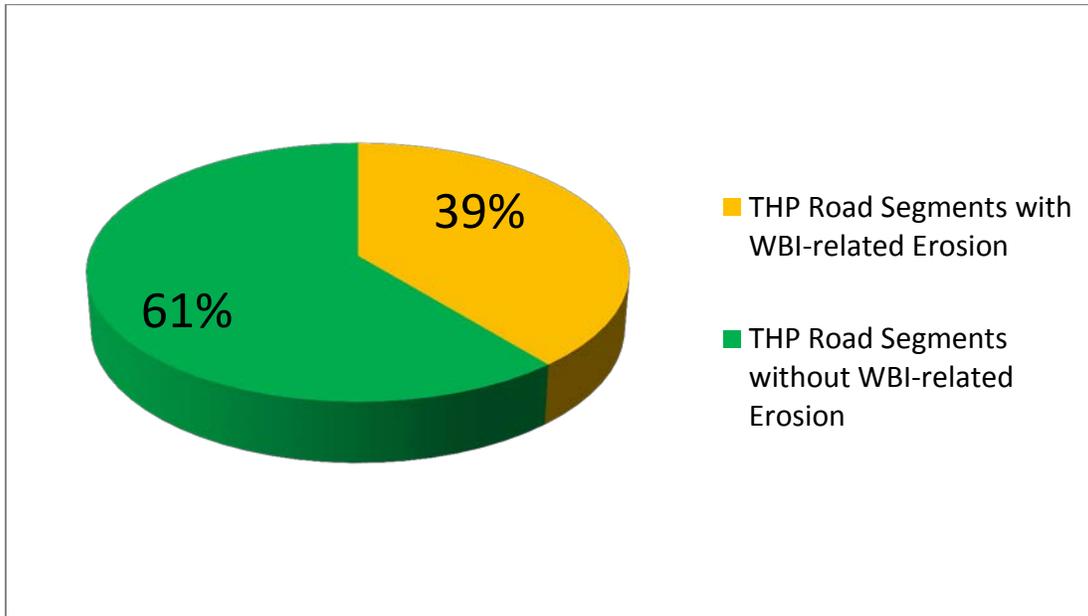
Figure 35. THP road segments with and without WBI-related erosion. WBI-related erosion includes erosion on the road surface (except rutting) and on fill slopes. WBI-related erosion does not include erosion on cut slopes.

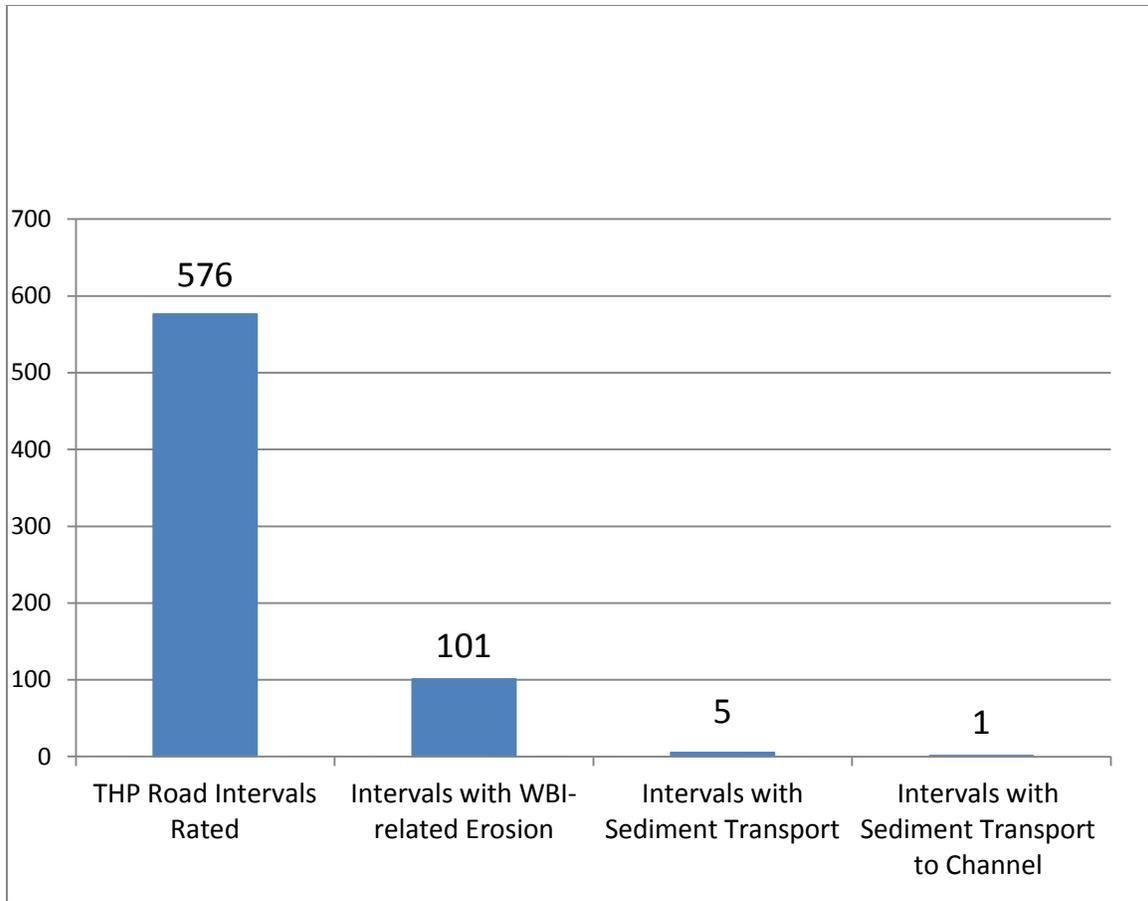
Figure 36. THP road intervals monitored (including both intervals drained by waterbreaks and those drained by inside ditches with insloping) compared to the number with erosion, with sediment transport, and sediment transport to the channel.

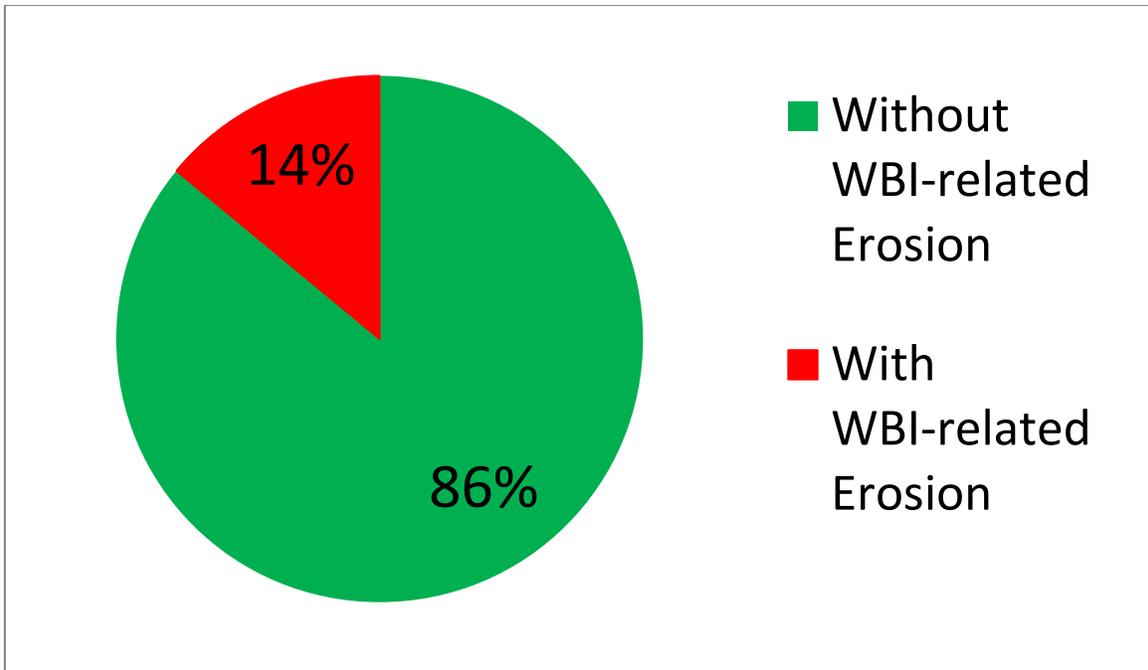
Figure 37. THP random road segments with correct waterbreak-interval spacing, and resulting percentages of segments with and without WBI-related erosion features. Does not include five segments primarily insloped and drained with inside ditches.

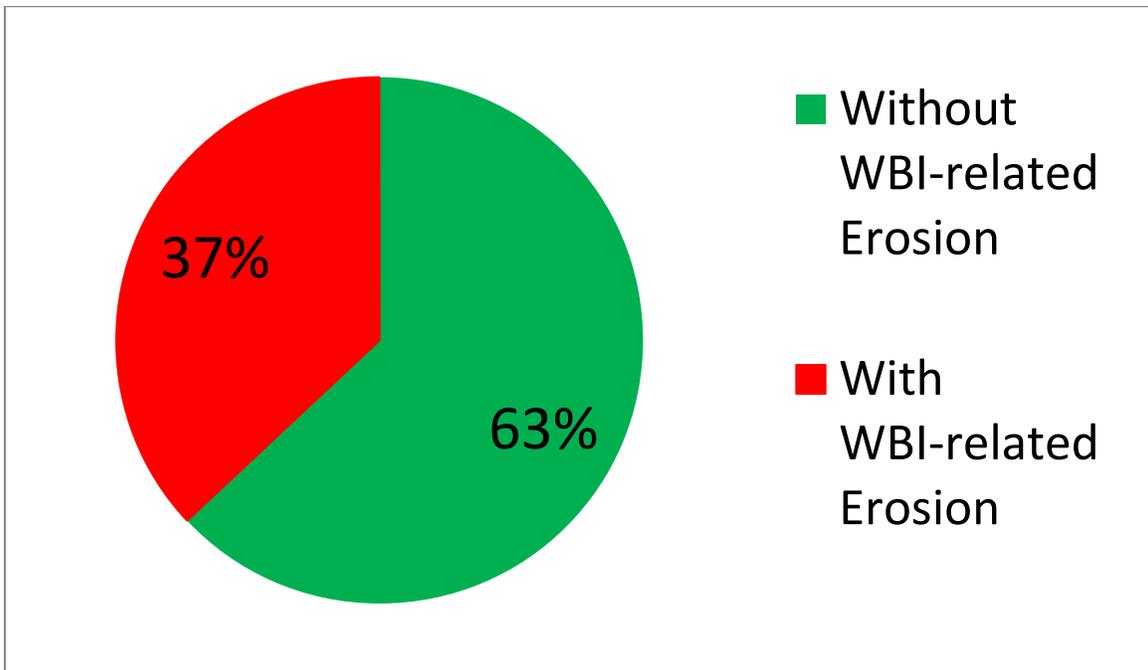
Figure 38. THP random road segments with incorrect waterbreak-interval spacing, and resulting percentages of segments with and without WBI-related erosion features. Does not include five segments primarily insloped and drained with inside ditches.

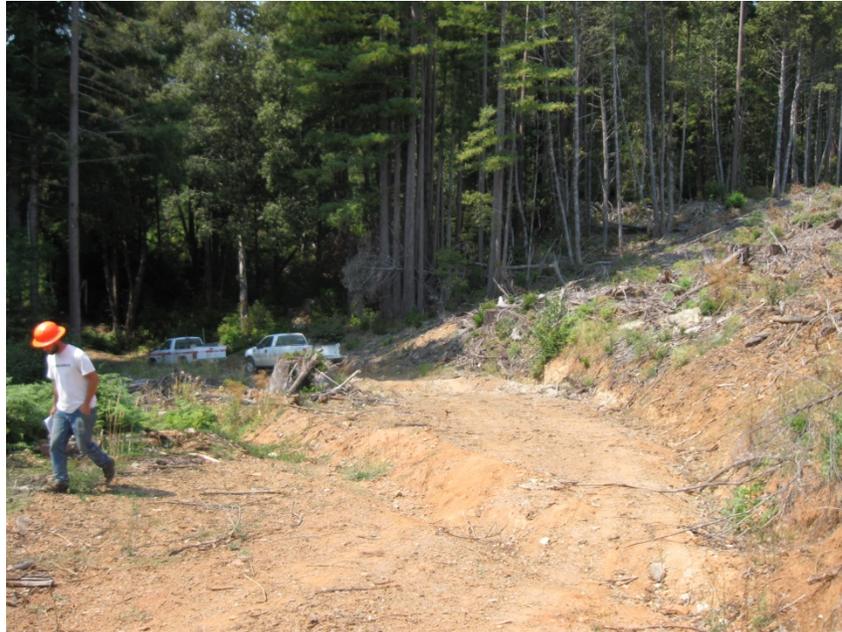
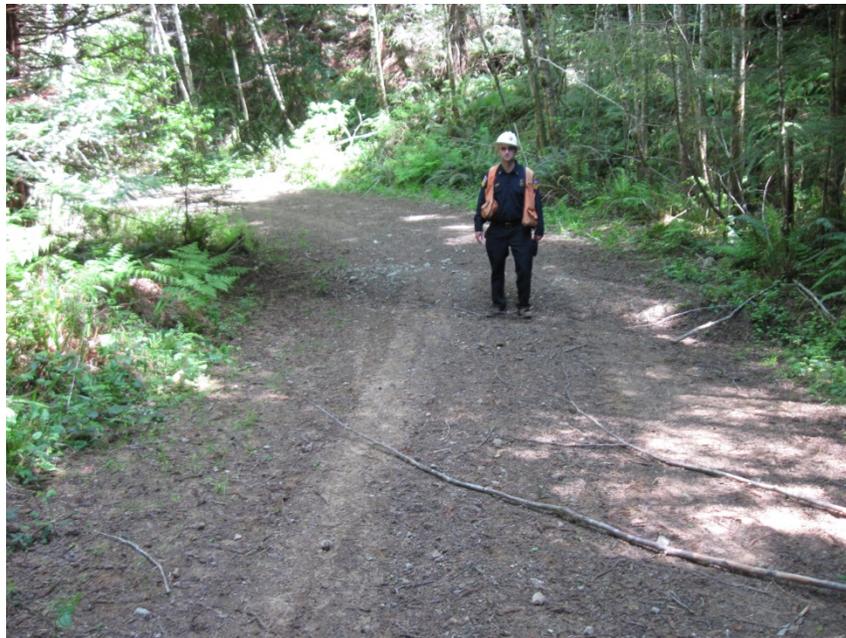
Figure 39. Examples of road segments in the FORPRIEM sample with appropriate road drainage facility spacing and without erosion features.

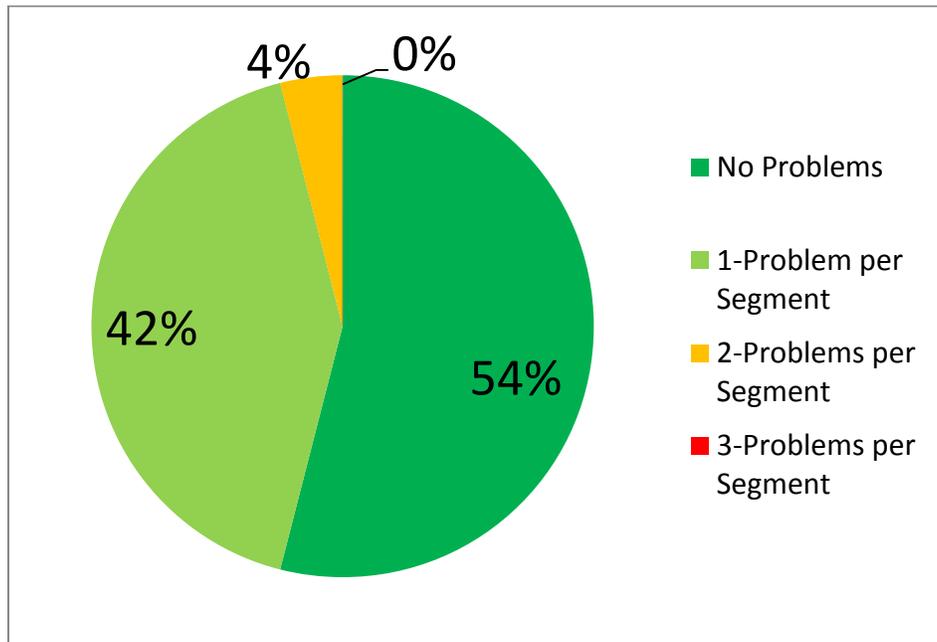
Figure 43. Distribution of NTMP-NTO waterbreak spacing problems by sampled road segment. Forest Practice Rule 14 CCR § 914.6 [934.6, 954.6] (c).
