# **Forest Practice Rules Implementation and Effectiveness Monitoring (FORPRIEM) Program**

## **MONITORING RESULTS FROM 2008 THROUGH 2013**

# **Forest Practice Rules Implementation and Effectiveness Monitoring Program (FORPRIEM): MONITORING RESULTS FROM 2008 THROUGH 2013**

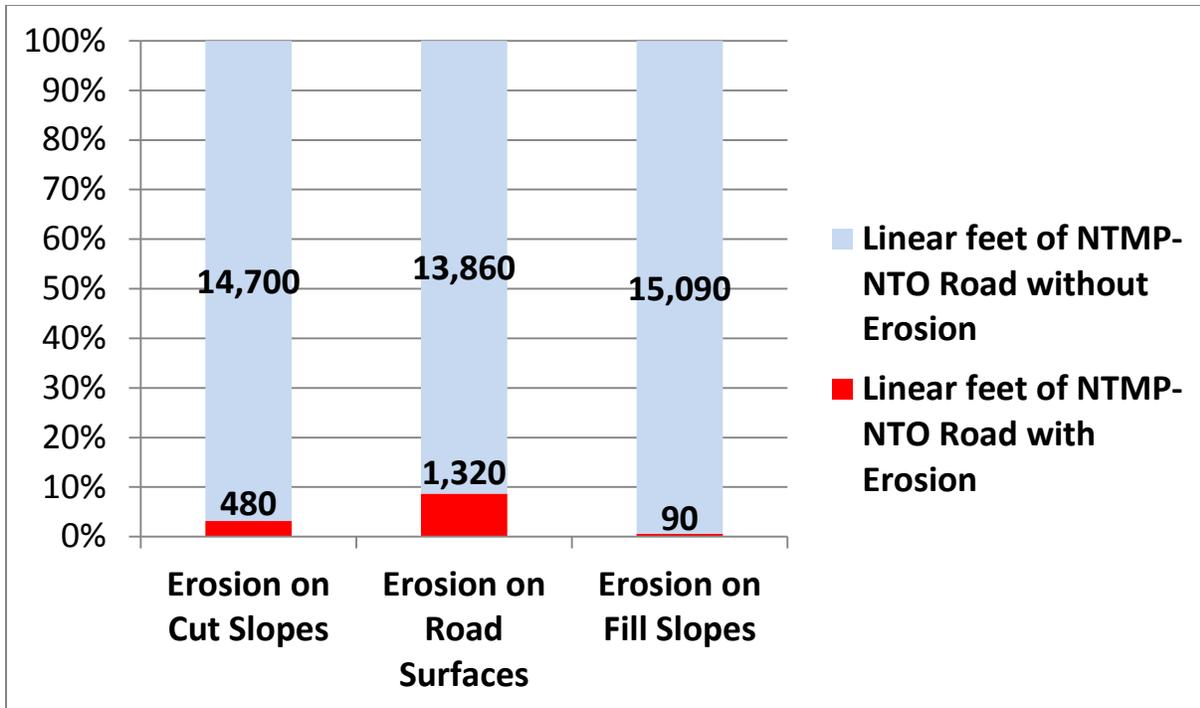
Figure 44. Percentage of the total NTMP-NTO road length monitored with erosion on the cut slope, erosion on the road surface, and erosion on the fill slope.

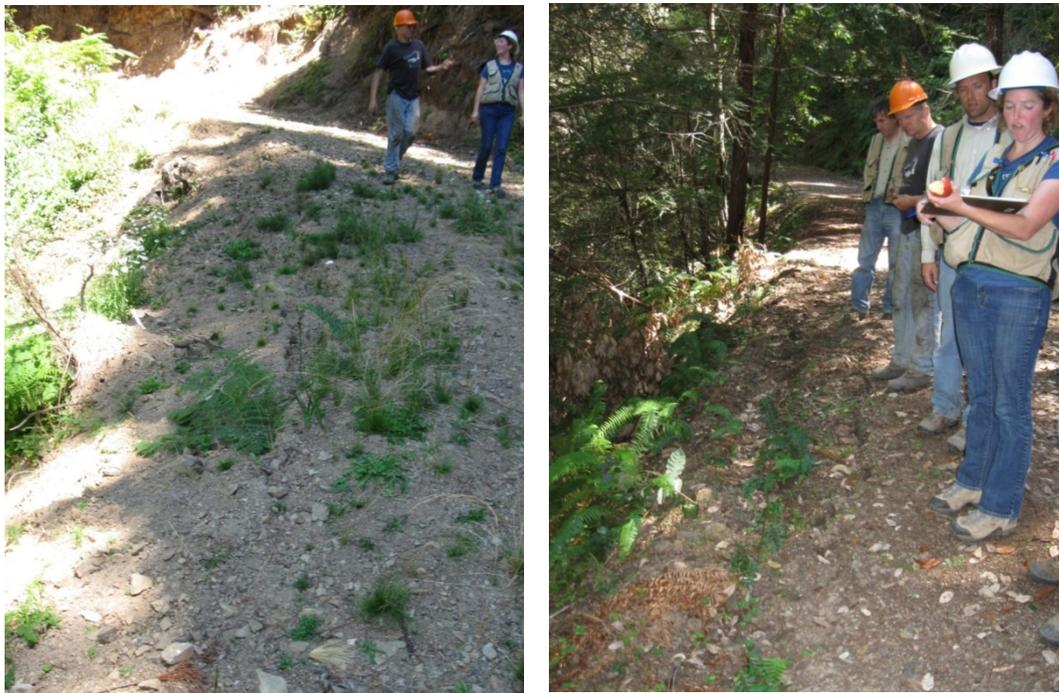
Figure 45. Some of the FORPRIEM monitoring, particularly the NTMP-NTO monitoring, was done jointly with staff from sister agencies, such as the NCRWQCB. These photos show 60 feet of road fill slope erosion on a monitored road transect (left) and tension cracks on the road surface (right).

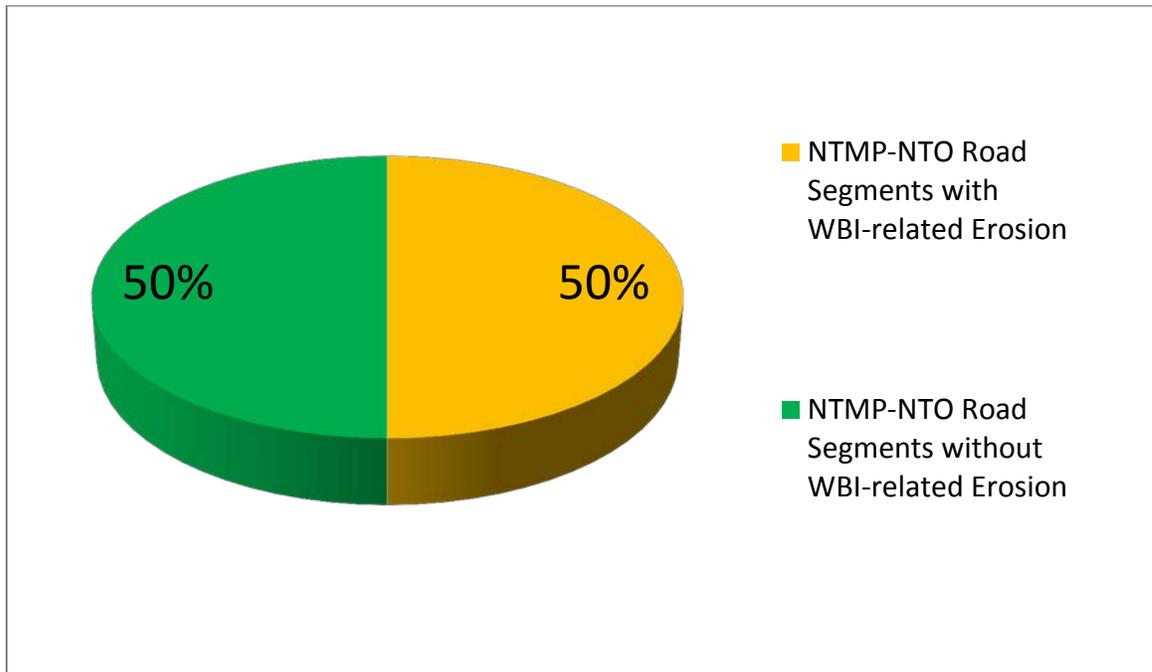
Figure 46. NTMP-NTO road segments with and without WBI-related erosion. WBI-related erosion includes erosion on the road surface (with the exception of rutting) and fill slopes. It does not include erosion on the cut slopes.

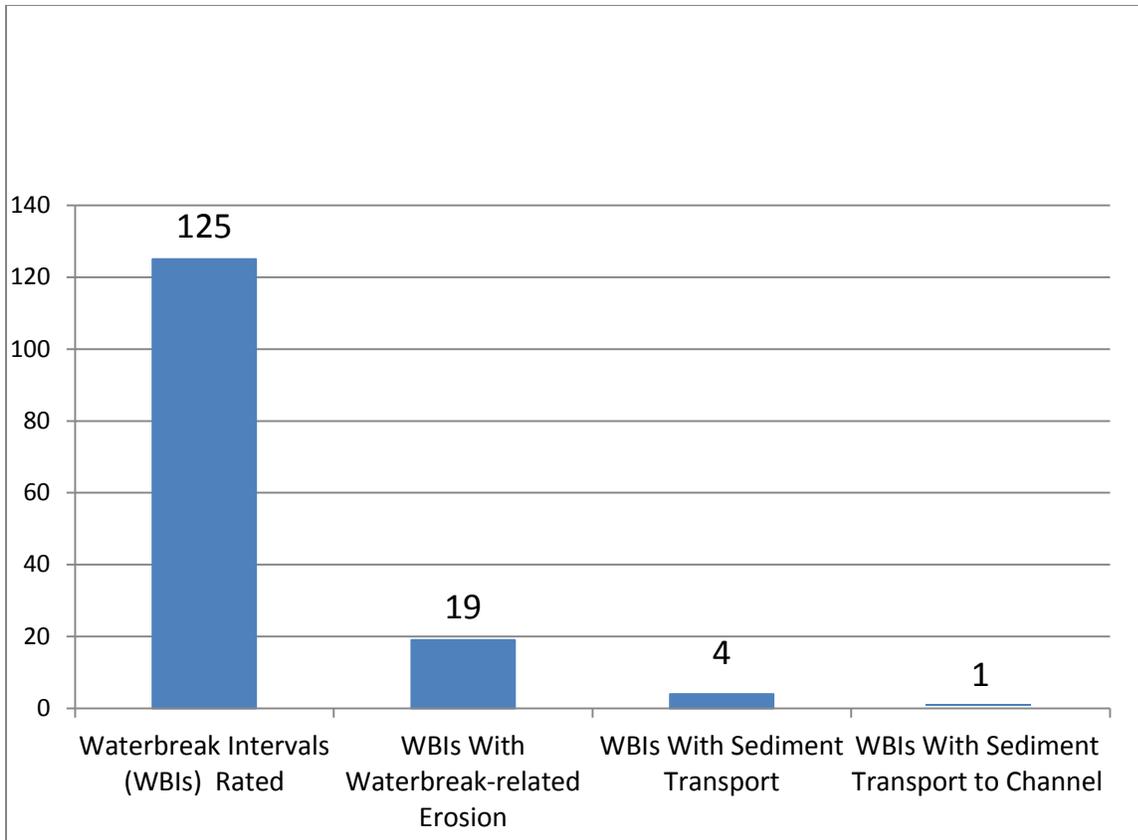
Figure 47. NTMP-NTO road intervals monitored compared to the number with erosion, with sediment transport, and sediment transport to the channel. The WBI with sediment transport to a channel was not related to a problem with waterbreak spacing (Table 11).

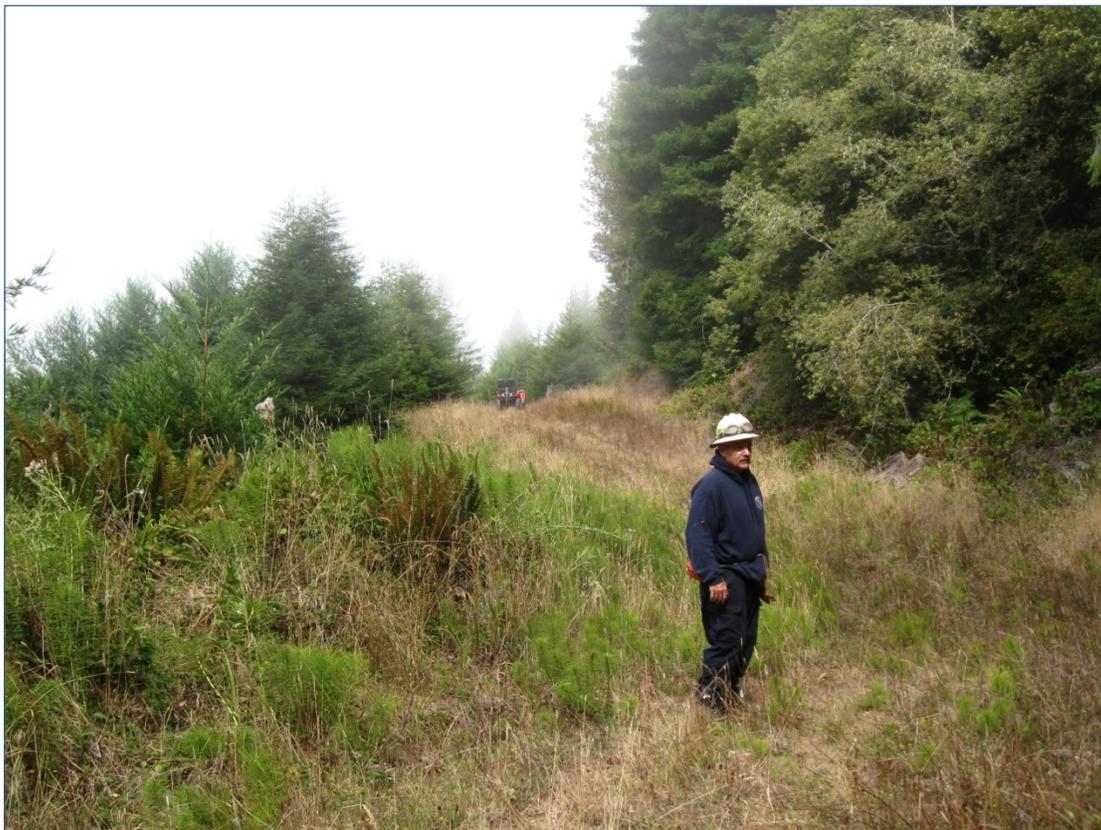
Figure 51. Seasonal road segment monitored a second time during a QA/QC monitoring inspection in Humboldt County in 2013.

Five FORPRIEM-monitored THPs were picked at random for re-monitoring (Figure 51). All five THPs had monitored road segments. The THPs were revisited during 2013 and the five road segments were re-monitored. The shortest period between the original monitoring and re-monitoring was three months; the longest was two years and 10 months. On one of the re-monitored roads, an additional waterbreak was monitored

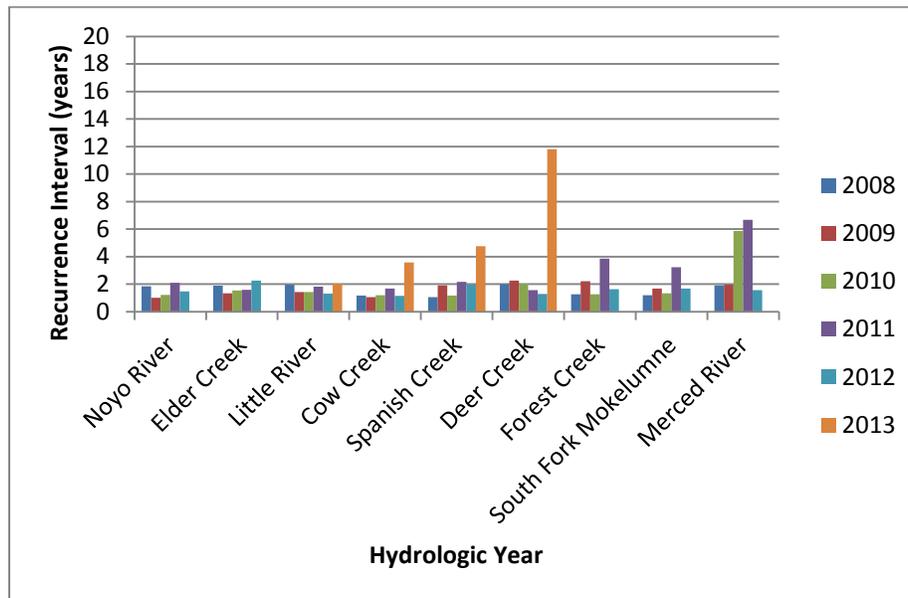
Figure 52. Annual instantaneous peak flows during the FORPRIEM monitoring period were generally low, based on peak flow recurrence intervals for a number of rivers covering the FORPRIEM monitoring area. One exception was the 12-year recurrence interval discharge that occurred on Deer Creek in Tehama County during the 2013 hydrologic year.

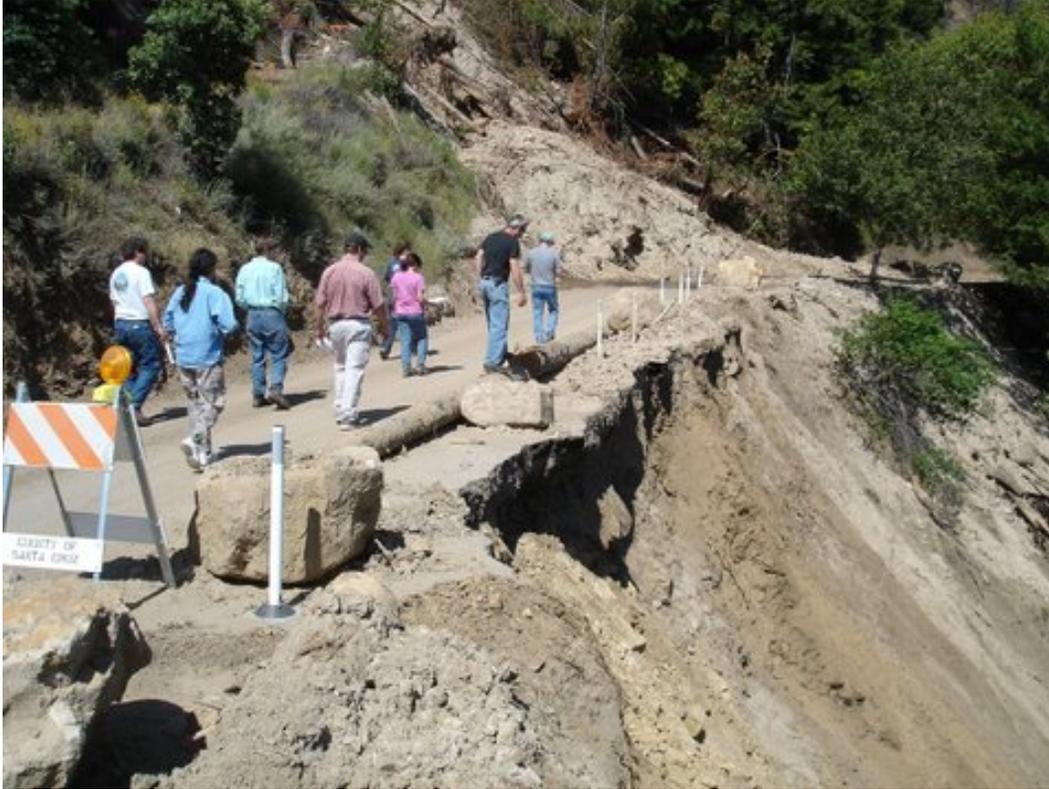
Figure 53. Public roads, such as this road in Santa Cruz County with a major landslide feature, were not included in the FORPRIEM sample.

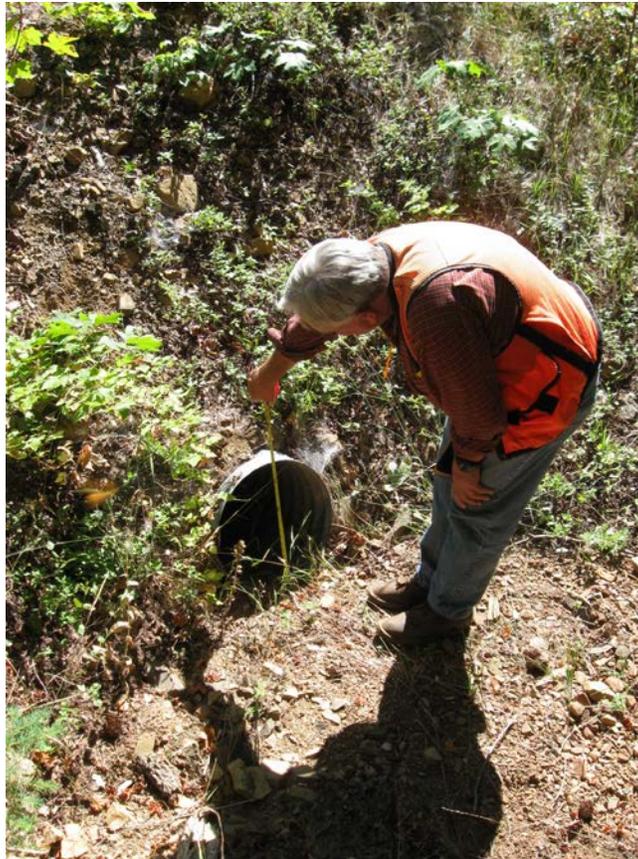
Figure 54. Clay Brandow measuring the pipe diameter on a FORPRIEM THP located in the upper Sacramento River Canyon.

It was requested that culvert diameters be measured with a pocket tape measure (Figure 54). The watercourse crossing site information and implementation field forms are displayed in the Appendix.

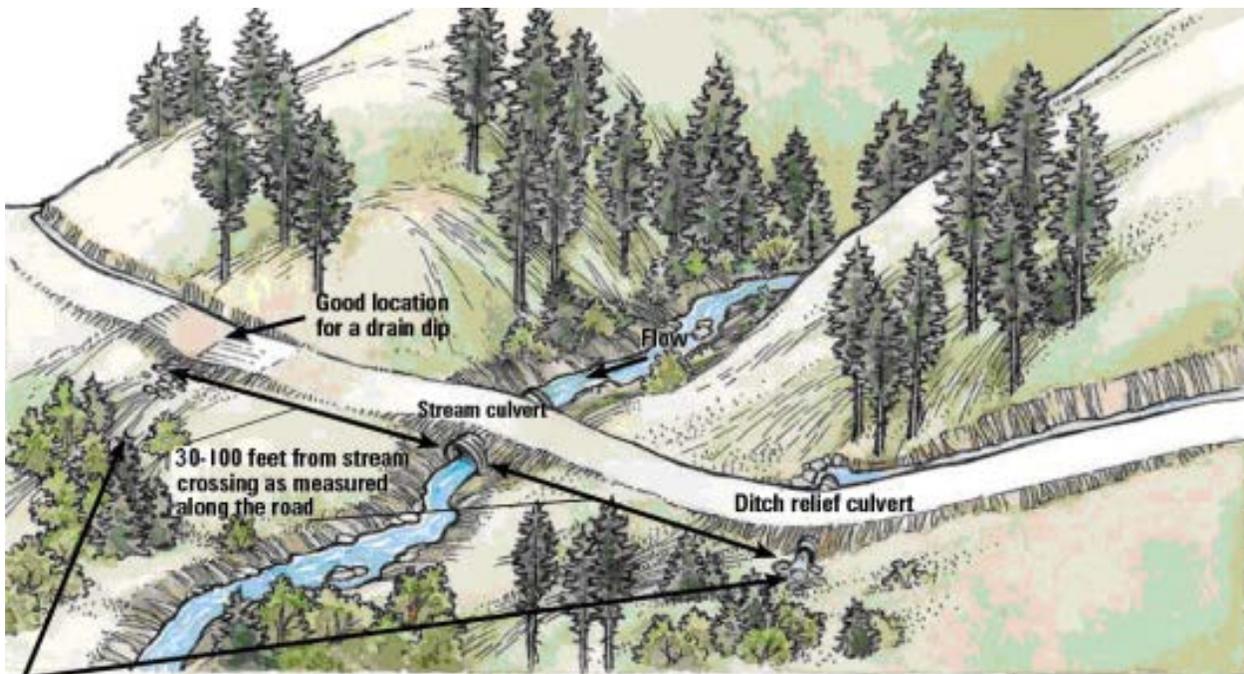
Figure 55. Diagram illustrating functioning cutoff drainage structures preventing water from reaching the watercourse crossing (modified from Oregon Forest Resources Institute 2011, 2<sup>nd</sup> Ed.).

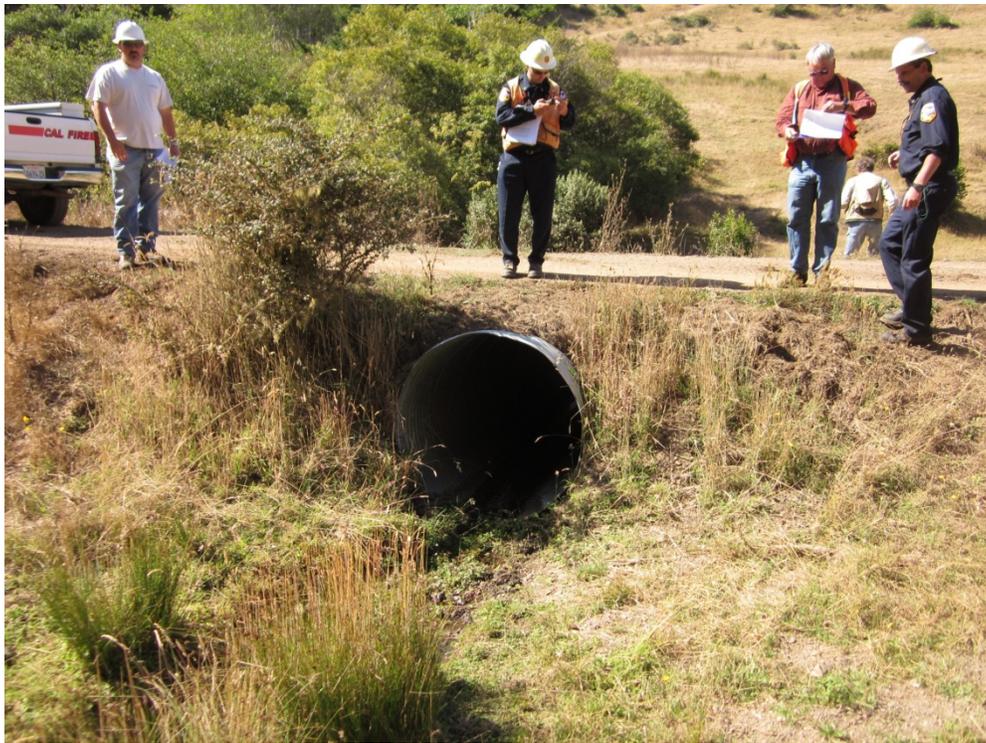
Figure 56. Joint CAL FIRE and NCRWQCB staff inspection of a watercourse crossing evaluated in August 2011 (1-97NTMP-018 MEN; NTO #6).

FORPRIEM includes the first comprehensive review of NTMP-NTOs. Only the North Coast Hydrologic Region was sampled in a joint monitoring effort with the NCRWQCB in 2011-2012 (Figure 56), with limited data collected statewide starting in 2013. Due to the heavy emphasis on sampling in the North Coast Hydrologic Region, about 90% of the NTMP-NTOs have come from the CAL FIRE Coast Region (R-1).

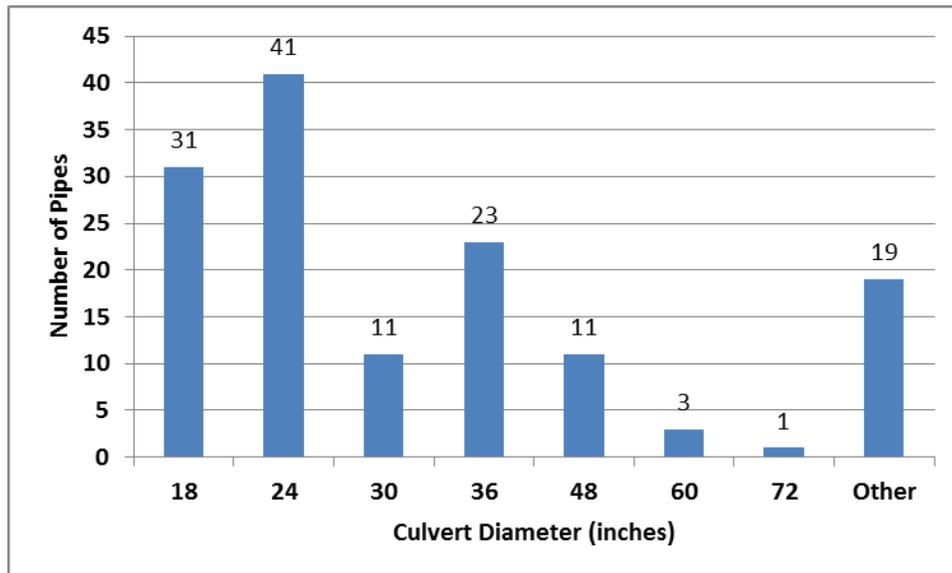
Figure 59. Culvert size distribution for THP watercourse crossings with pipes.

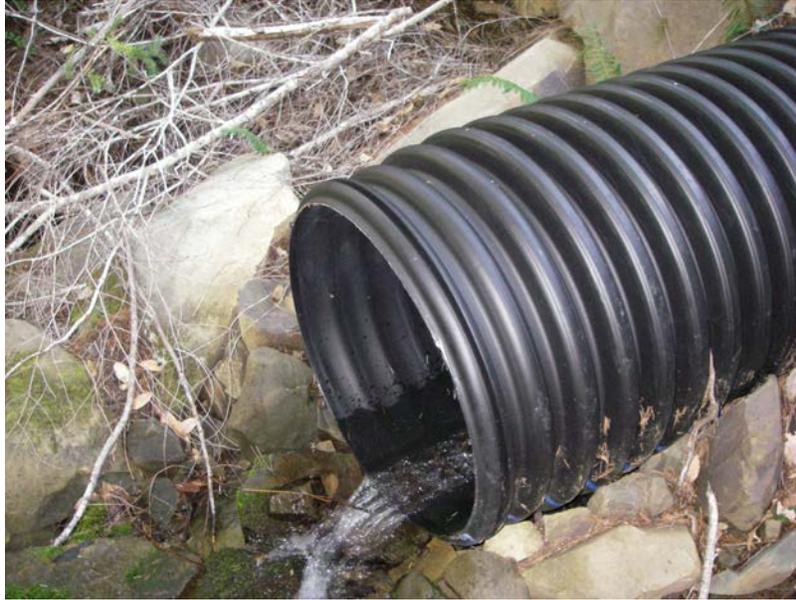
Figure 60. 30-inch corrugated plastic pipe outlet, THP 1-06-107 MEN.

The distribution of pipe sizes for crossings with culverts is displayed in Figure 59. This diagram shows that approximately 22% of the pipes were 18 inches in diameter, 29% were 24 inches, and 16% were 36 inches. Approximately 11% of the pipes were 48 inches or larger, and about 22% were other sizes or multiple pipe configurations. Approximately 50% of the culverts were 18 inch or 24 inch diameter pipes, since the majority of the crossings were located in small headwater streams. The majority of the culverts were steel, with a smaller component of plastic pipes (Figures 60 and 61).

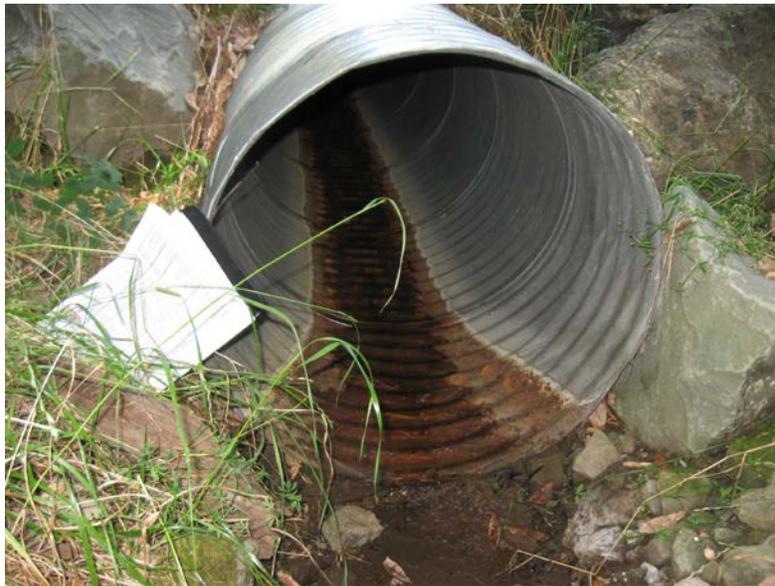
Figure 61. 36-inch galvanized steel culvert, THP 1-09-026 HUM.

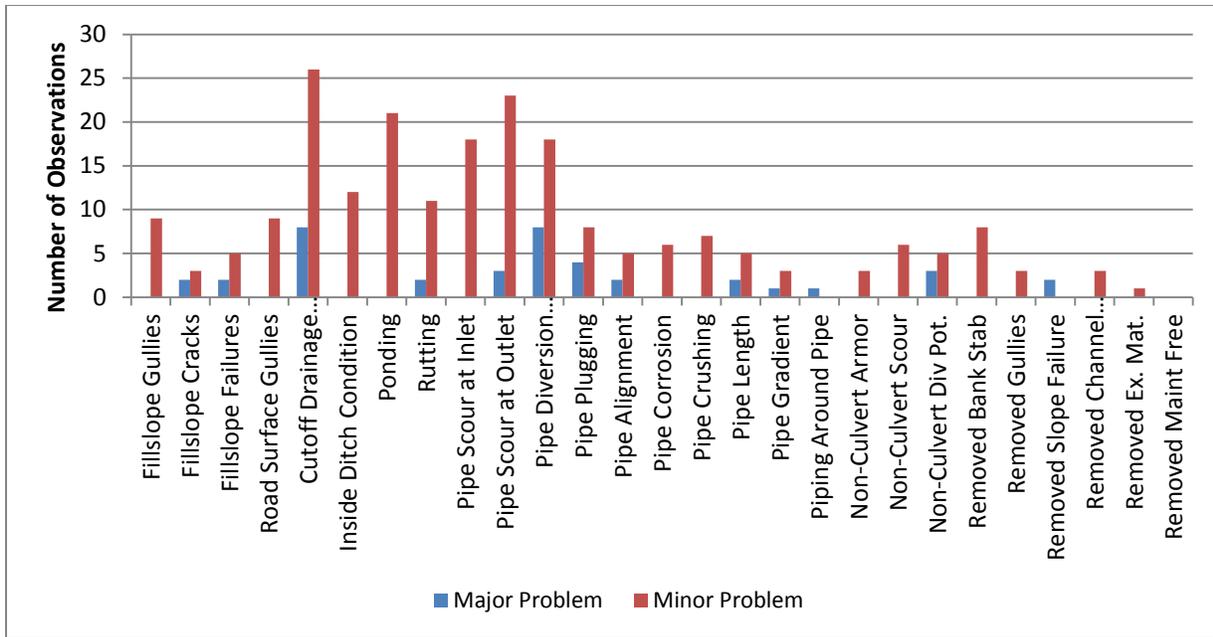
Figure 63. Major and minor effectiveness category problem counts for all crossing types associated with THPs.

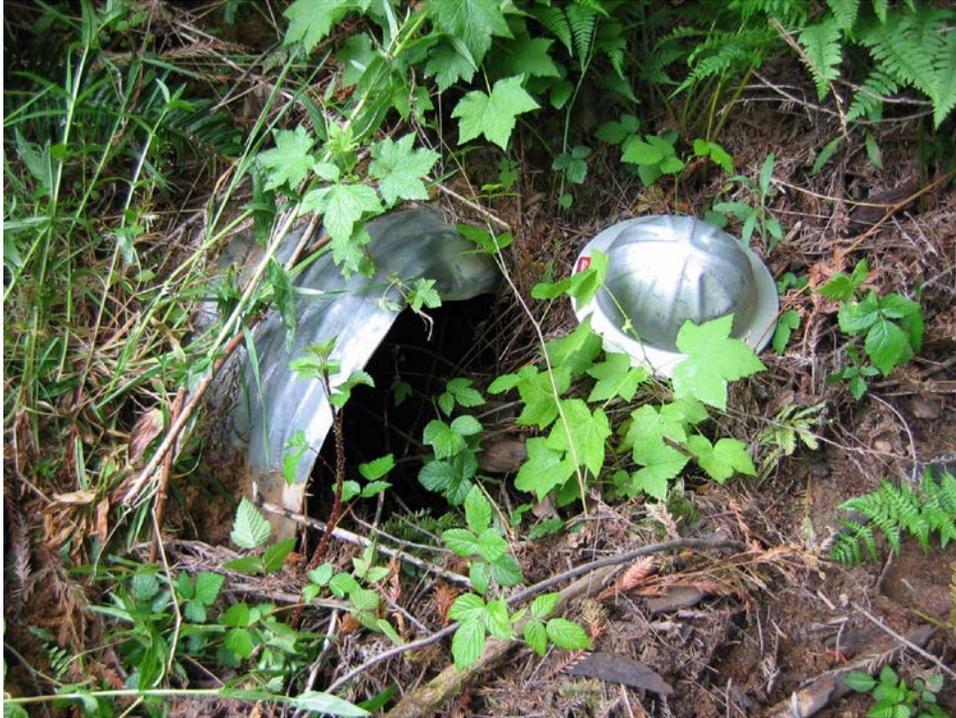
Figure 64. Culvert crossing with sediment and debris blocking more than 30% of the inlet (major problem), THP 1-05-246 HUM, crossing number 1.

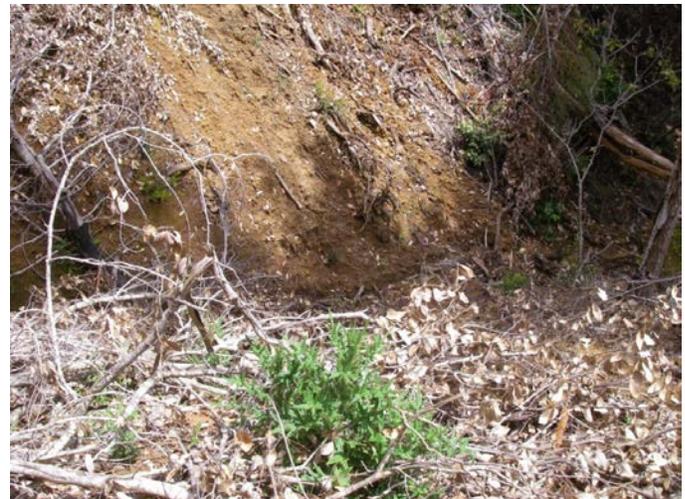
Figure 65. Abandoned crossing with significant sediment entering the channel due to slope failure (major problem), THP 1-08-176 MEN, crossing number 2.

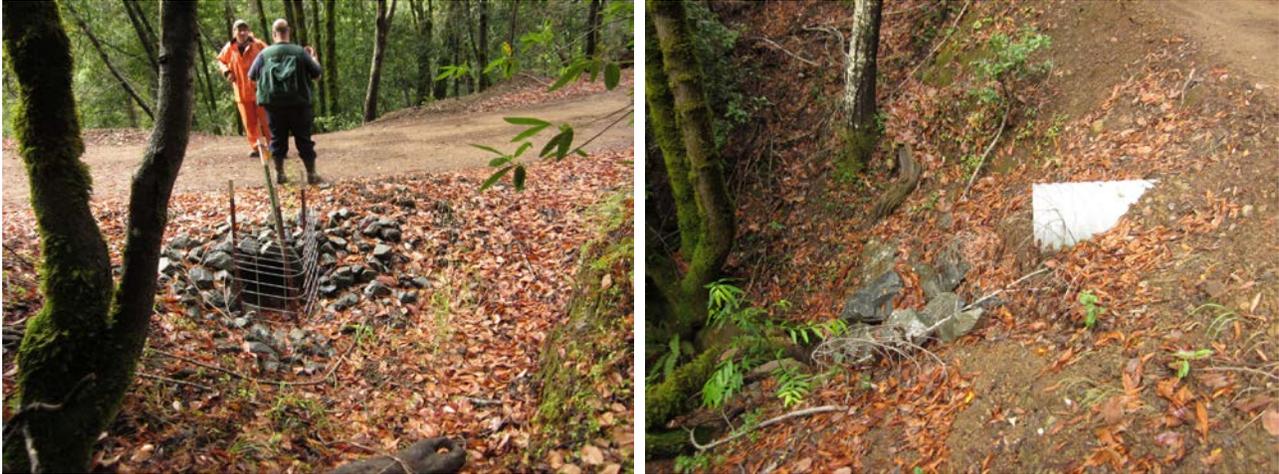
Figure 67. Typical 18 inch culvert (1-97NTMP-038). The crossing inlet is shown on the left; the outlet is on the right.

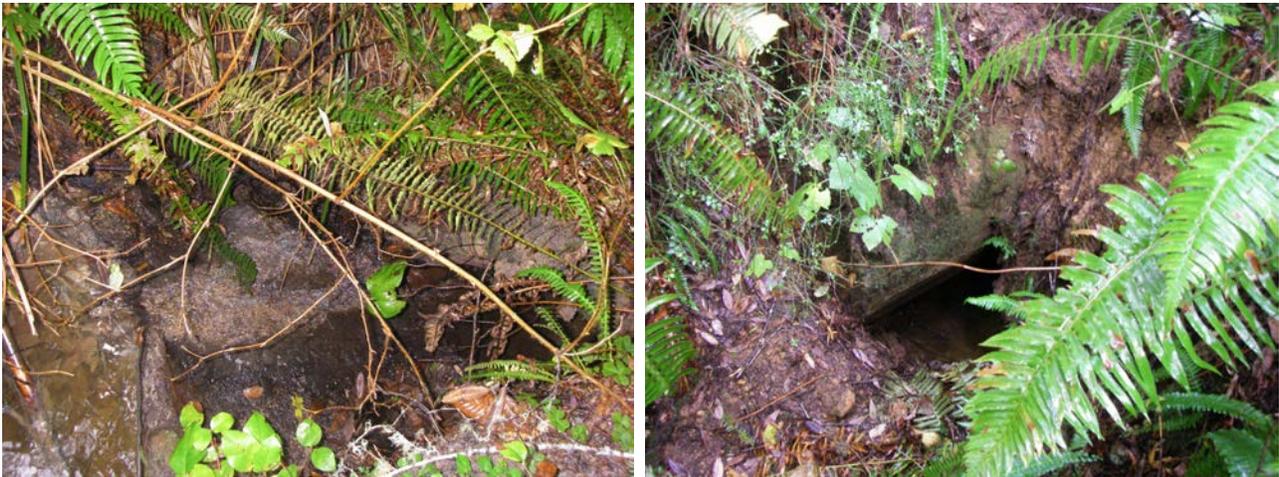
Figure 68. Photos of a Humboldt (log-filled) crossing in the sample from an NTMP-NTO in Mendocino County. The crossing inlet is shown on the left; the outlet is on the right.

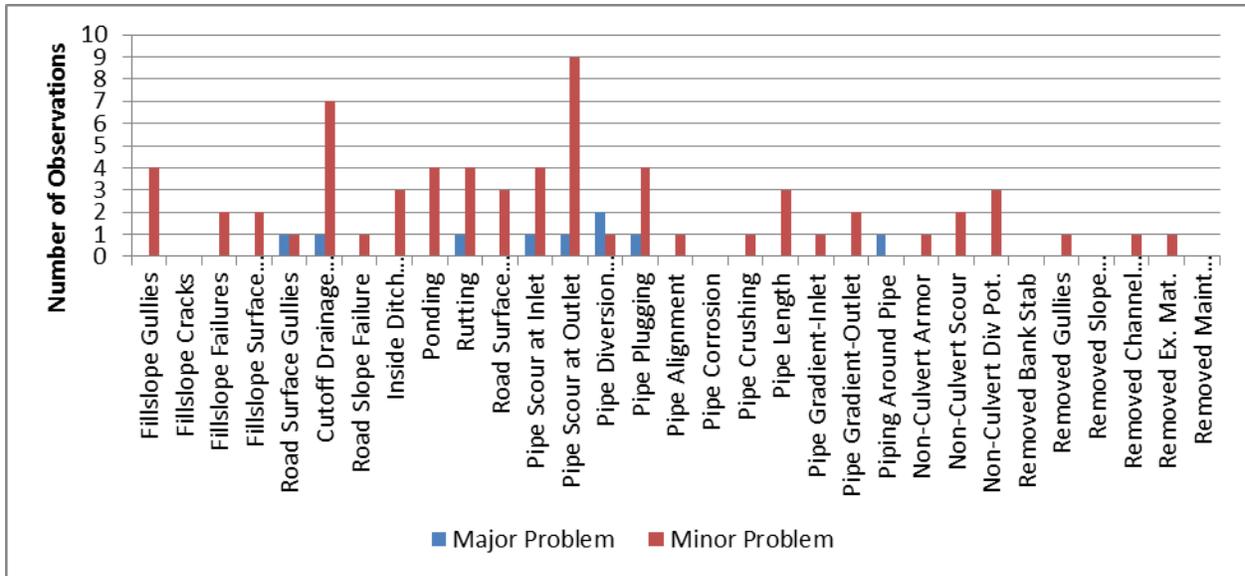
Figure 72. Major and minor effectiveness category problem counts for all crossing types associated with NTMP-NTOs.

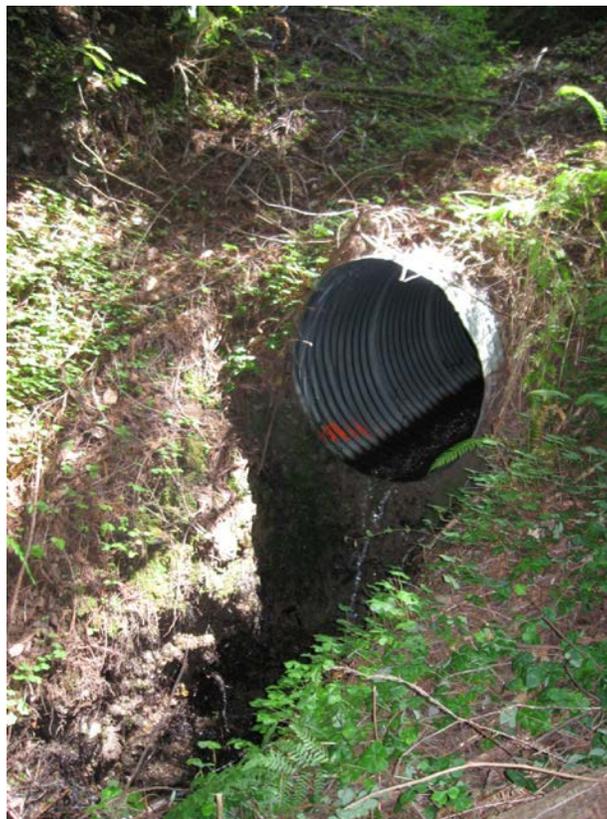
Figure 73. Steel culvert with significant scour at the outlet (shown), as well as diversion potential (not shown) (1-97NTMP-018 MEN).

Table 15 shows the percentage of major and minor effectiveness problems for all of the crossing types combined. Diversion potential was found to be a major problem for 8% of the culvert crossings evaluated. Scour at the inlet and outlet of culverts was denoted as a major problem for 4% of the crossings evaluated (Figure 73). Similarly, culvert plugging and piping were found to be a major effectiveness problem on 4% of the culverts evaluated.

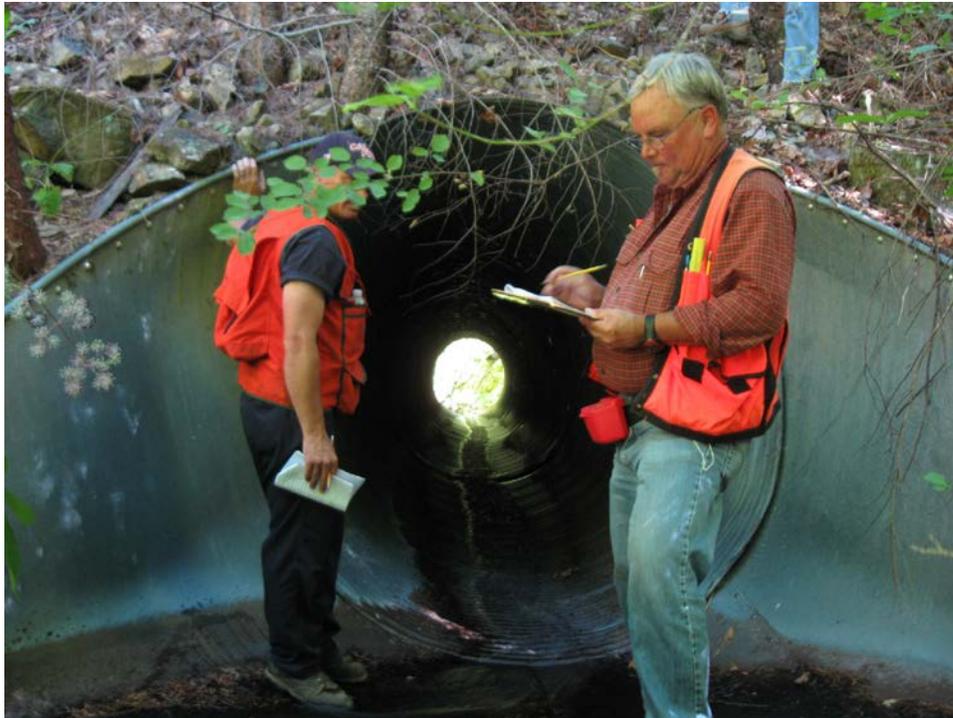
Figure 74. Clay Brandow and Gabe Schultz of CAL FIRE completing a QA/QC evaluation on a large culvert in the upper Sacramento River canyon during August 2013.

The five randomly selected THPs utilized for WLPZ canopy and road QA/QC evaluations were also resampled for watercourse crossing QA/QC (Figure 74). Four of the five THPs had crossings to evaluate. Each of these four plans had two culvert crossings, so a total of eight culvert crossings were evaluated twice.

There was good agreement for type of crossing, culvert size, and watercourse class. While the sample size was small, there was a higher rate of poor implementation and effectiveness ratings assigned during the first visit, both for implementation and

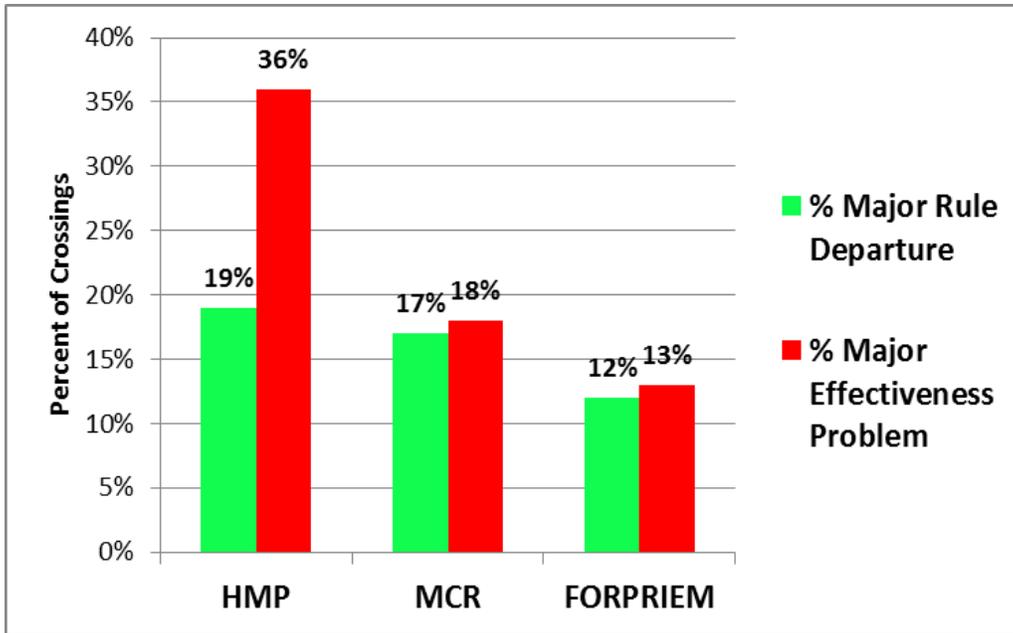
Figure 75. Comparison of THP watercourse crossing Forest Practice Rule implementation and effectiveness ratings for three monitoring programs spanning 1996 to 2013.

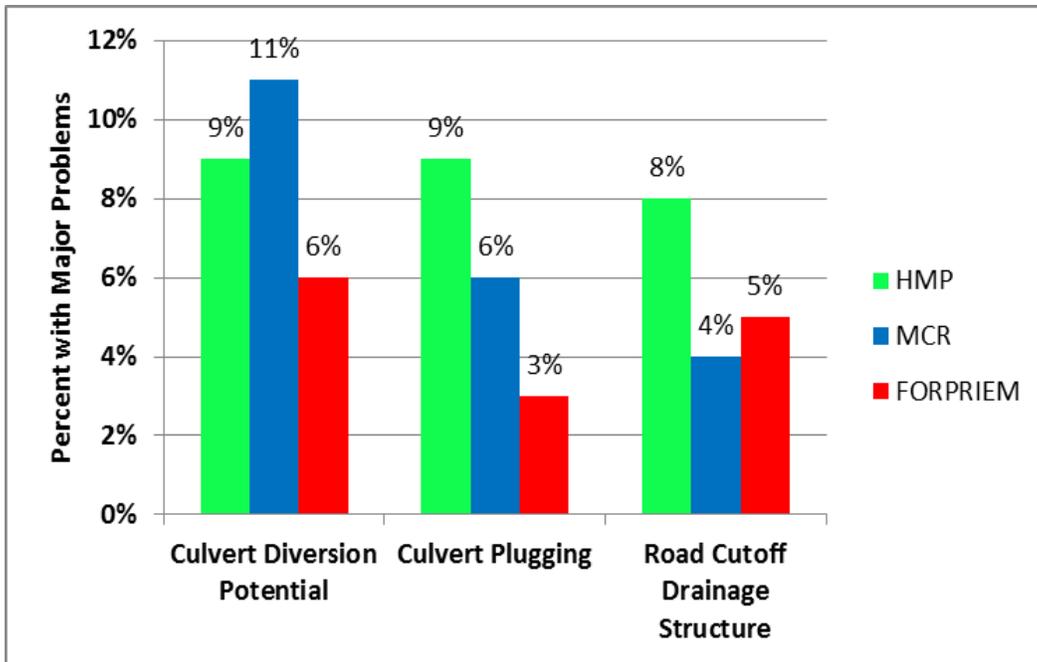
Figure 76. Comparison of three effectiveness categories evaluated with three different monitoring programs spanning 1996 to 2013.

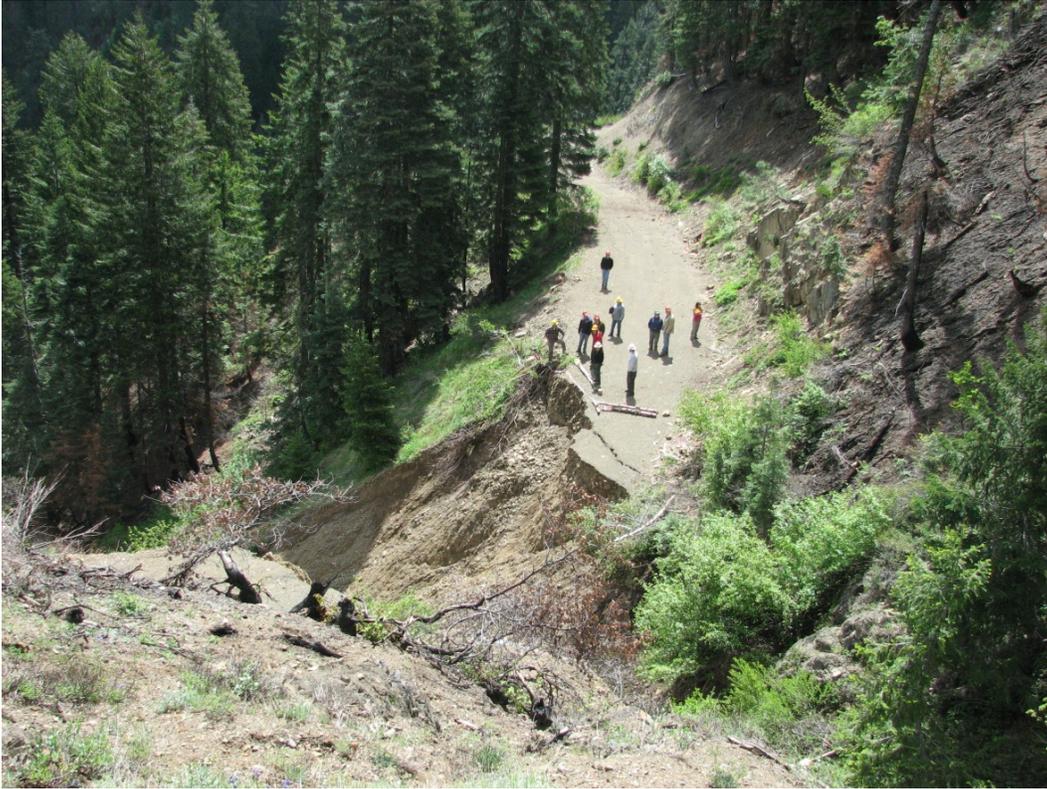
Figure 77. Road fill failure in the Hawkins Creek watershed resulting from the December 2012 storm event (photo from USFS 2013, provided by Juan de la Fuente, Shasta-Trinity National Forest).

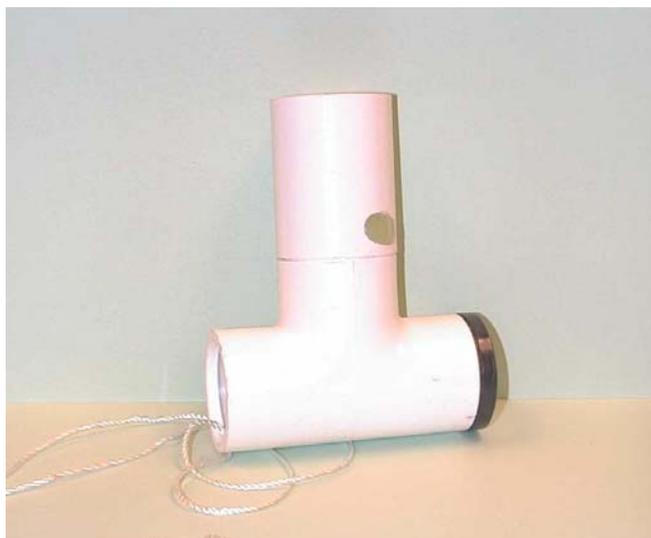
Figure 4. Example of a sighting tube used for making WLPZ canopy measurements.

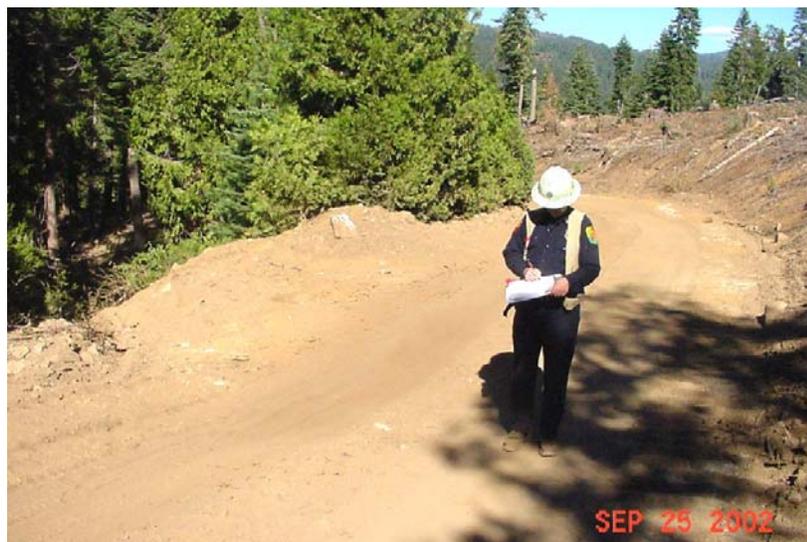
Figure 6. Pete Cafferata recording road observations at a rolling dip. Orange box on his right hip is a hip-chain which meters-out string for tracking distances of specific road-related features along the sample segment.
