Final Report to the California State Board of Forestry and Fire Protection Monitoring Effectiveness Committee

EMC -2018-003 Alternative Meadow Restoration

Principal Investigator: Christopher Surfleet, Professor
Natural Resources Management and Environmental Sciences Department
California Polytechnic State University
San Luis Obispo, California 93407

July 31, 2023

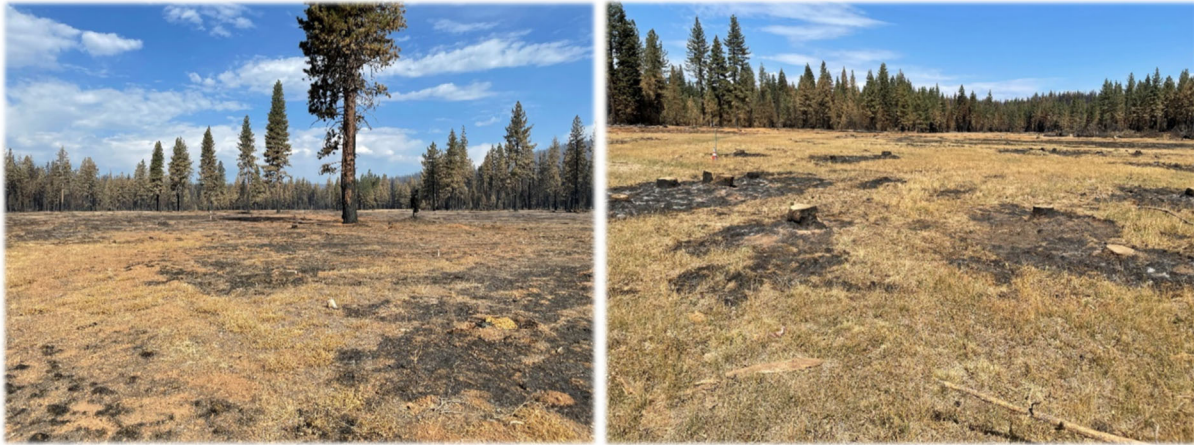
Figure 5. Patches of burnt meadow vegetation in Rock Creek Meadow from the Dixie Fire. Notice the stumps in the right photo from the *Pinus contorta* removal. Photo taken one month after fire, September 2021.

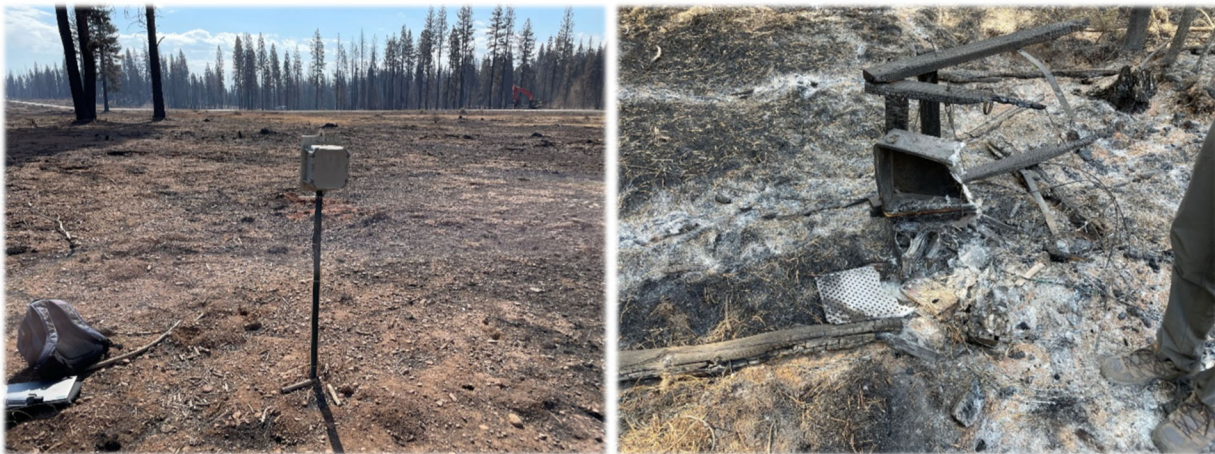
Figure 6. Left photo shows moderate to high burn severity adjacent to data logger case for soil moisture measurement in Marian Meadow. The right photo shows the remains of our sap flow instruments in Rock Creek Meadow, this was one of the few instruments that were a total loss. Photo taken one month after fire, September 2021.

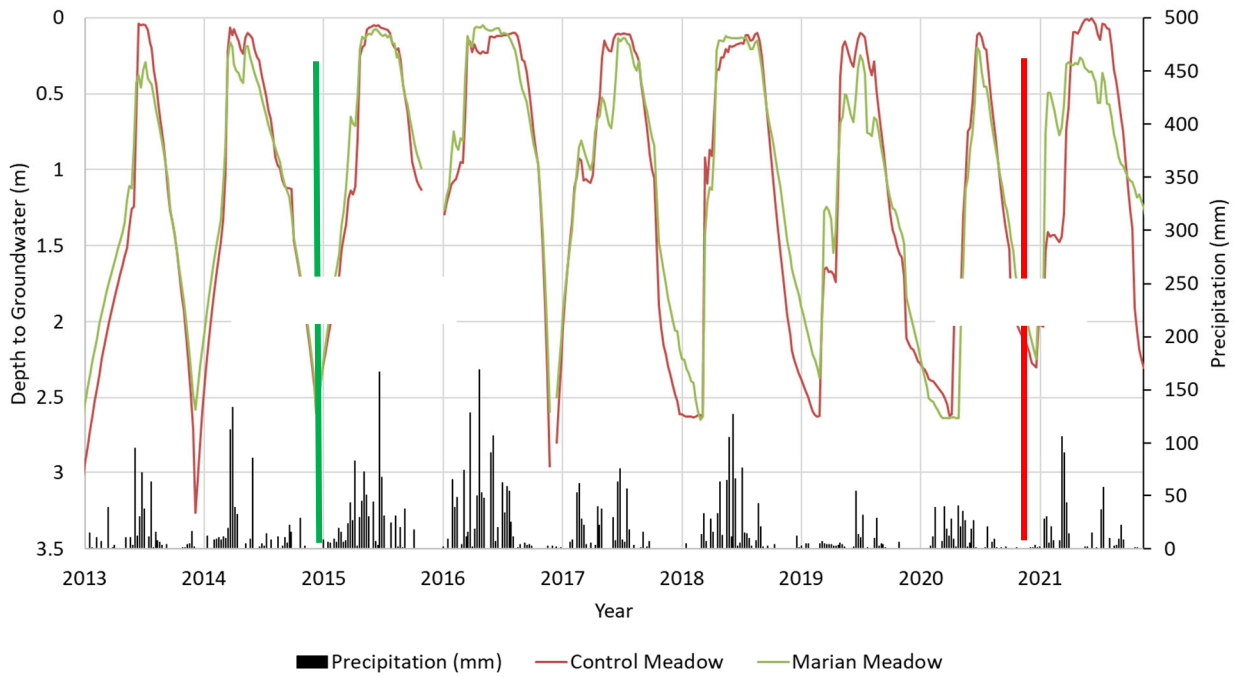
Figure 7. Weekly average depth to groundwater and weekly total precipitation for Marian and Control Meadows for the 2014-2022 Water Years. The time of the *Pinus contorta* removal and Dixie Fire are shown as well as weekly precipitation.

The seven post-restoration years were statistically different compared to pre-restoration (Table 4). The slopes and intercepts of the different years varied providing some interpretations of the groundwater response. The post-restoration water years of 2018, 2019, and 2022 (years 3, 4, and 7 post restoration respectively) had different slopes than the pre-restoration model (Table 4; Figure 8). The 2018 and 2019 water years (post restoration years 3 and 4) had a greater slope than pre-restoration but a lower intercept indicating reduced depth to groundwater in the winter and a slight reduction in groundwater in the drier periods. The water years of 2020 and 2021 had a greater depth to groundwater in MM compared to CM as indicated by the higher intercept value, but same model slope. These two water years were very low precipitation years (Table 4) impacting the hydrologic response of the meadows.

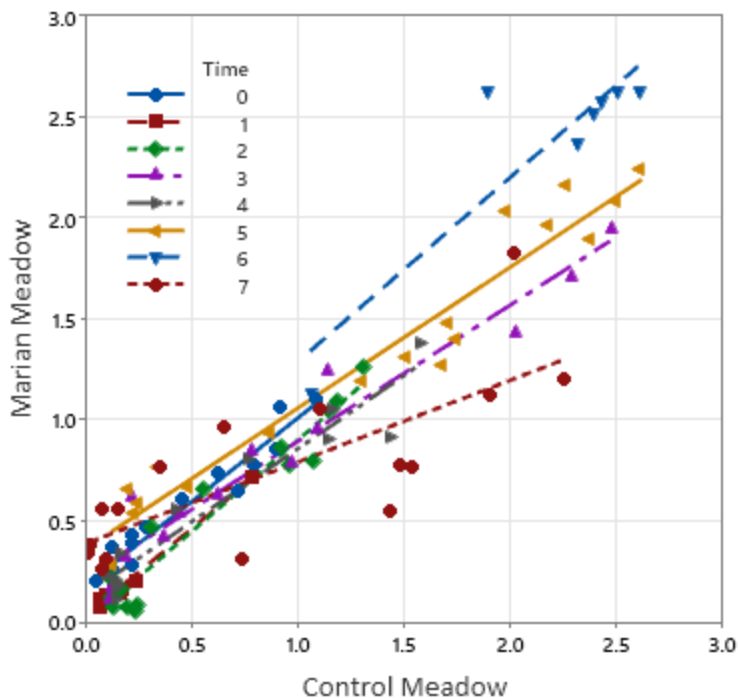
Figure 8. Regression plots by year between Marian and Control Meadows 2014-2022 for depth to groundwater in meters. Time is the sequence of water years since restoration with Time = 0 the water years prior to restoration (2014-2015 WY). Time = 7 is the water year following the Dixie Fire (2022 WY).

The 2022 water year (Time =7; Figure 8) had a reduced slope and slightly higher intercept for the regression model indicating more groundwater in MM compared to pre-restoration, except during the winter period. The 2022 water year was the first year following the Dixie Fire. The CM watershed and meadow had 3% of its area in high or moderate burn severity (Table 2, Figure 4). The MM watershed and meadow had 87% of its area in high or moderate burn severity. The linear regression analysis of the relationship between MM and CM for six post restoration water year prior to the Dixie Fire and the water year following the Dixie Fire indicated a statistically significant difference in MM depth to groundwater (Table 5). This indicates groundwater persisted closer to the surface in MM following the Dixie Fire for all but the wettest time periods.

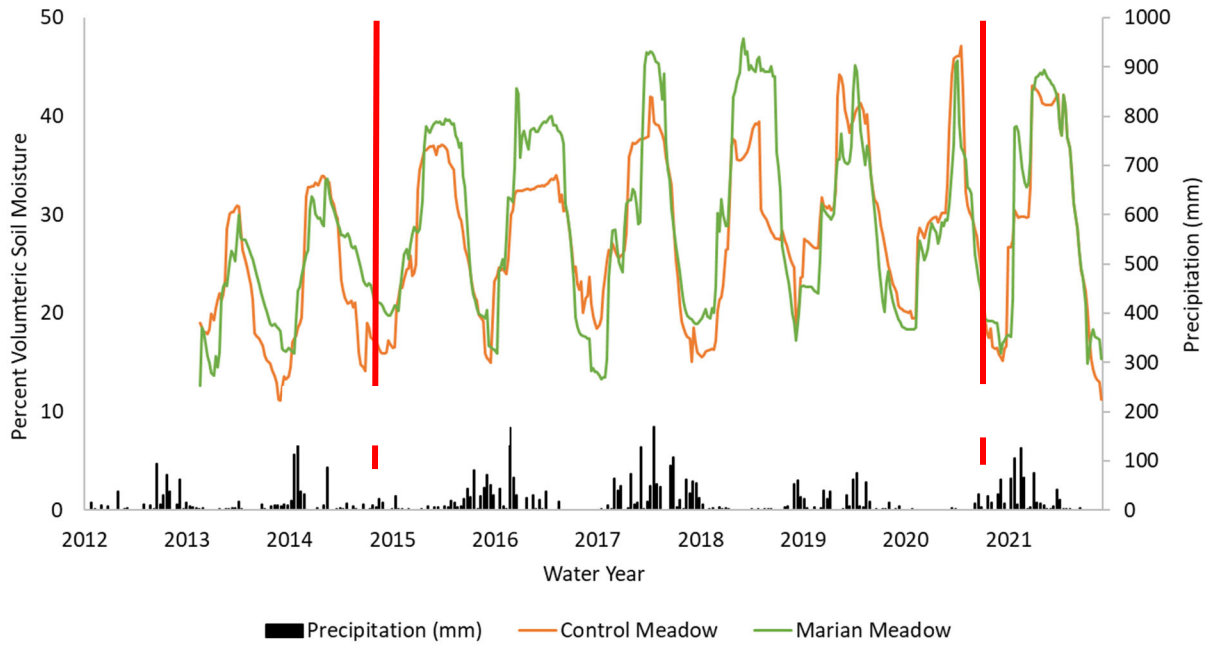
Figure 10. Week-averaged volumetric soil moisture (%) and total weekly precipitation (mm) for Marian and Control Meadows, 2014–2022 WY. The time of the *Pinus contorta* removal and Dixie Fire are shown.

The hydrograph of weekly average soil moisture for 2014–2022 WY for CM and MM is shown (Figure 10). There was a statistically significant relationship between CM and MM soil moisture pre-restoration (Table 2). The analysis of covariance of the intercepts and slopes of linear relationships for post-restoration water years were significantly different from the pre-restoration model. The resulting pre-restoration regression equation had an intercept of 10.71 percent soil moisture (p-value <0.001) while the post-restoration regression equations had varied intercepts and slopes by year post restoration (Table 6, Figure 11). This difference in slopes and intercepts for the post-restoration year models suggests both positive and negative differences in soil moisture depending on the magnitude of the soil moisture. At lower soil moistures, post-restoration MM soil moisture percentages decreased while, at higher soil moisture percentages, MM soil moisture increased when compared to CM (Figure 12). There was not a statistically significant difference between the post-restoration soil moisture (2016-2021 WY) and the year following the Dixie Fire (2022 WY) soil moisture in MM when compared to the CM, p-value = 0.88 (Figure 12)

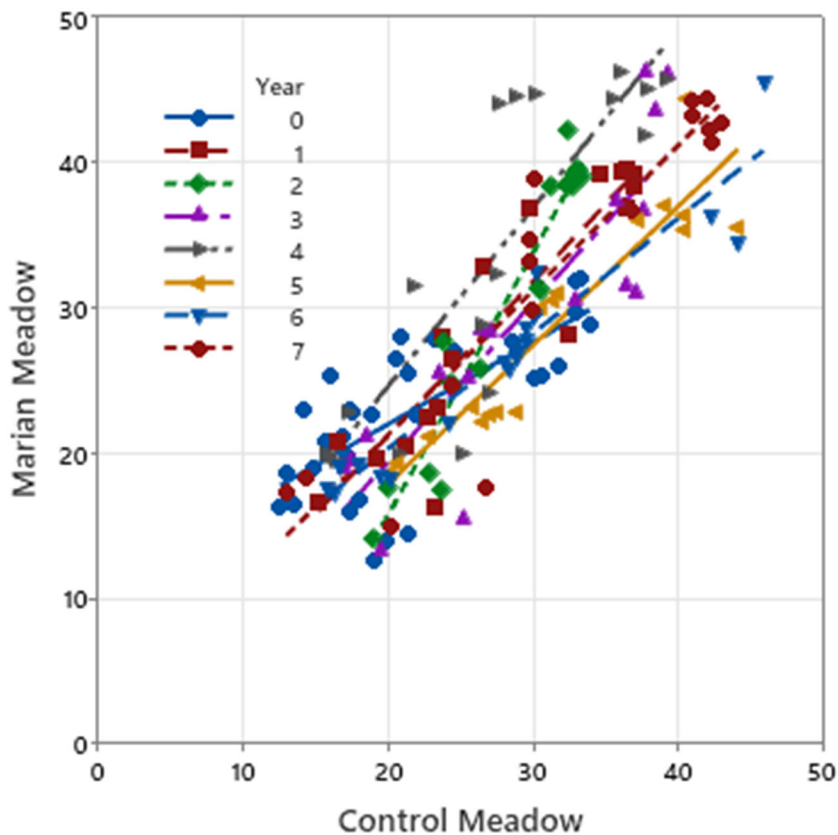
Figure 11. Regression plots by year between Marian and Control Meadows 2014-2022 for percent soil volumetric water content (VWC). Time is the sequence of water years since restoration with Time = 0 the water years prior to restoration (2014-2015 WY). Time = 7 is the water year following the Dixie Fire, seven years after restoration (2022 WY). The varied regression model slopes and intercepts are evident.

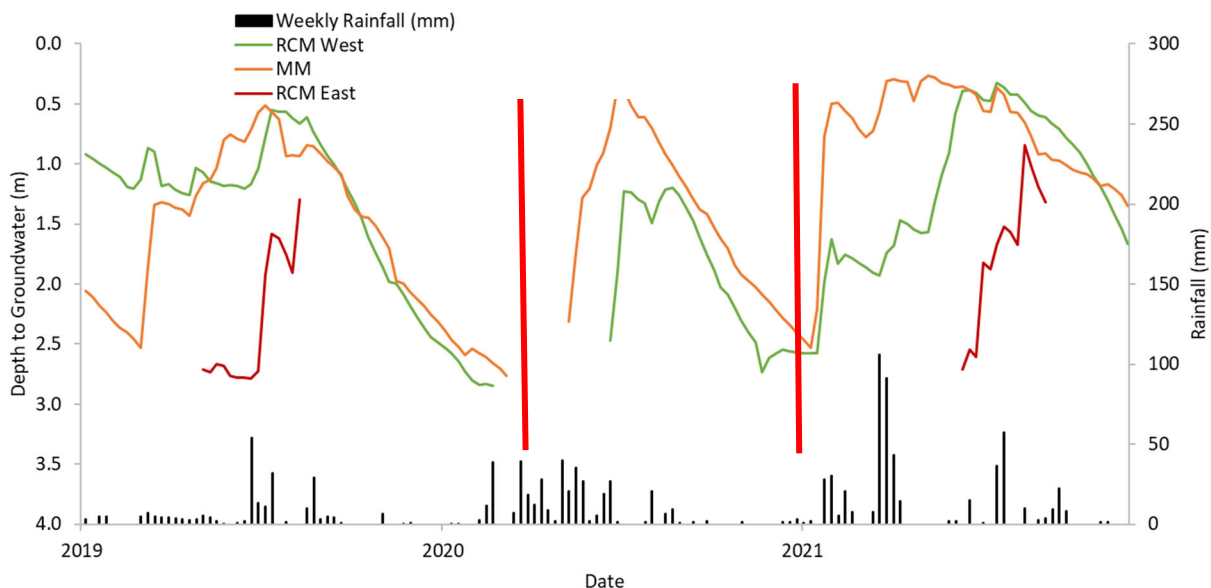
Figure 12. Weekly average depth to groundwater and weekly total precipitation for Marian and Rock Creek Meadows for the 2014-2022 Water Years. The time of the *Pinus contorta* removal and Dixie Fire are shown as well as weekly precipitation.

The average depth to groundwater and weekly precipitation for the western and eastern portions of RCM compared to MM are shown for 2019-2022 water years (Figure 12). The average depth to groundwater pre- and post-conifer removal was determined to be, on average, 0.56 m deeper at Rock Creek following the removal of encroached conifers (2021-2022 water years). The regression analysis of Rock Creek western portion compared to Marian Meadow showed a statistically significant decrease in groundwater the 1st year (2021 WY) following the restoration but no difference the 2nd year (2022 WY following the Dixie Fire) (Table 7; Figure 13). The eastern portion of Rock Creek Meadow only had measurable groundwater for a short portion in the pre-restoration year (2020 WY) and the 2nd year post-restoration (2022). The 2021 water year was a drought year, there were instrument malfunctions for portions of 2020 and 2022 water years that were partially responsible for the incomplete groundwater data set for the eastern portion of RCM. Therefore, no statistical evaluation was performed on the RCM East measurements. Only the western portion of RCM was used for statistical evaluation.

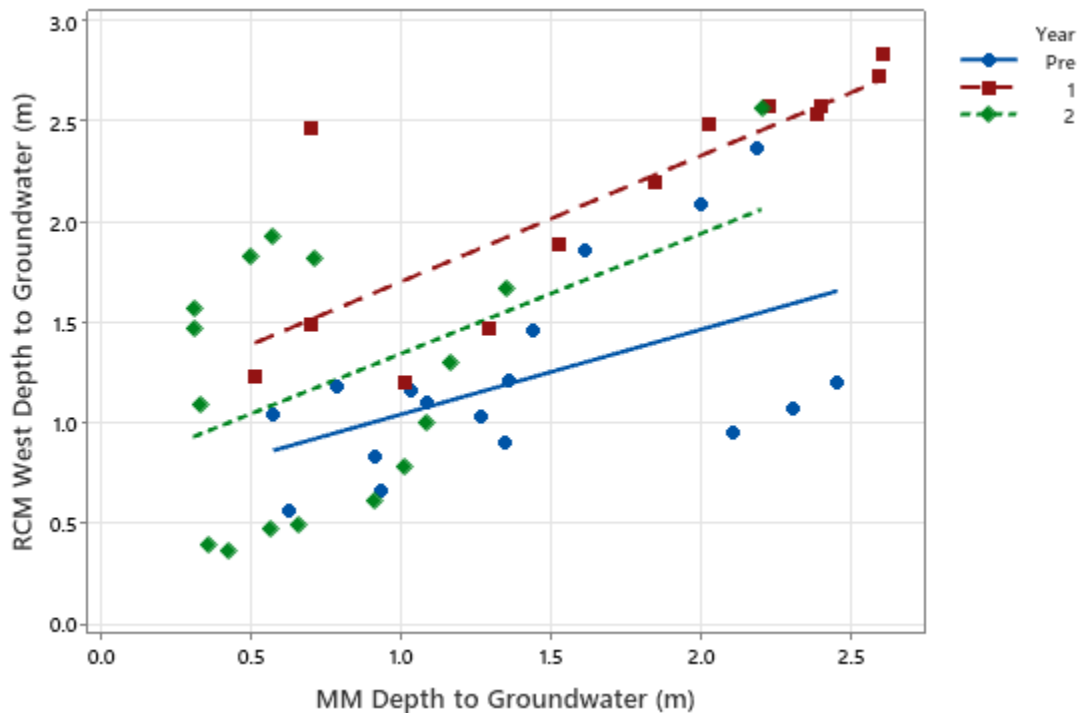
Figure 13. Regression plots by year between Rock Creek western portion and Marian Meadows 2020-2022 for depth to groundwater in meters. Year is the sequence of water years since restoration Year = 2 is the water year following the Dixie Fire (2022 WY). Note that year 2 is not statistically different from pre-restoration year (p value = 0.34).

The groundwater results following restoration at Rock Creek showed an average decrease following restoration. This result was not expected. When comparing the long-term results from Marian Meadow, the 2020 and 2021 water years were found to not be statistically different from the pre-restoration levels. The reasoning is the extreme drought conditions for those years. The 2022 water year precipitation was below the annual average but substantially improved compared to 2020 or 2021 water years. However, the 2022 water year was the first year following the Dixie Fire. Marian Meadow groundwater in 2022 water year was statistically greater than pre-restoration levels. The watershed contributing to Marian meadow had 87% of its area in high and moderate burn severity from the Dixie Fire. The Rock Creek watershed had 48% in high and moderate burn severity from the Dixie Fire. Marian Meadow would be expected to have greater runoff and groundwater recharge potential due to greater loss of forest vegetation (e.g. Saxe et al., 2018; Niemeyer, 2019). Marian Meadow is also being used as the control for Rock Creek Meadow. The significance of Rock Creek Meadow not being statistically different in the 2022 water year, even when compared to a meadow and watershed with greater area of burn severity than Rock Creek Meadow suggests an increase in groundwater in Rock Creek Meadow. Rock Creek Meadow depth to groundwater was statistically greater than pre-restoration in 2022 but not statistically different from Marian Meadow, which had greater groundwater in 2022.

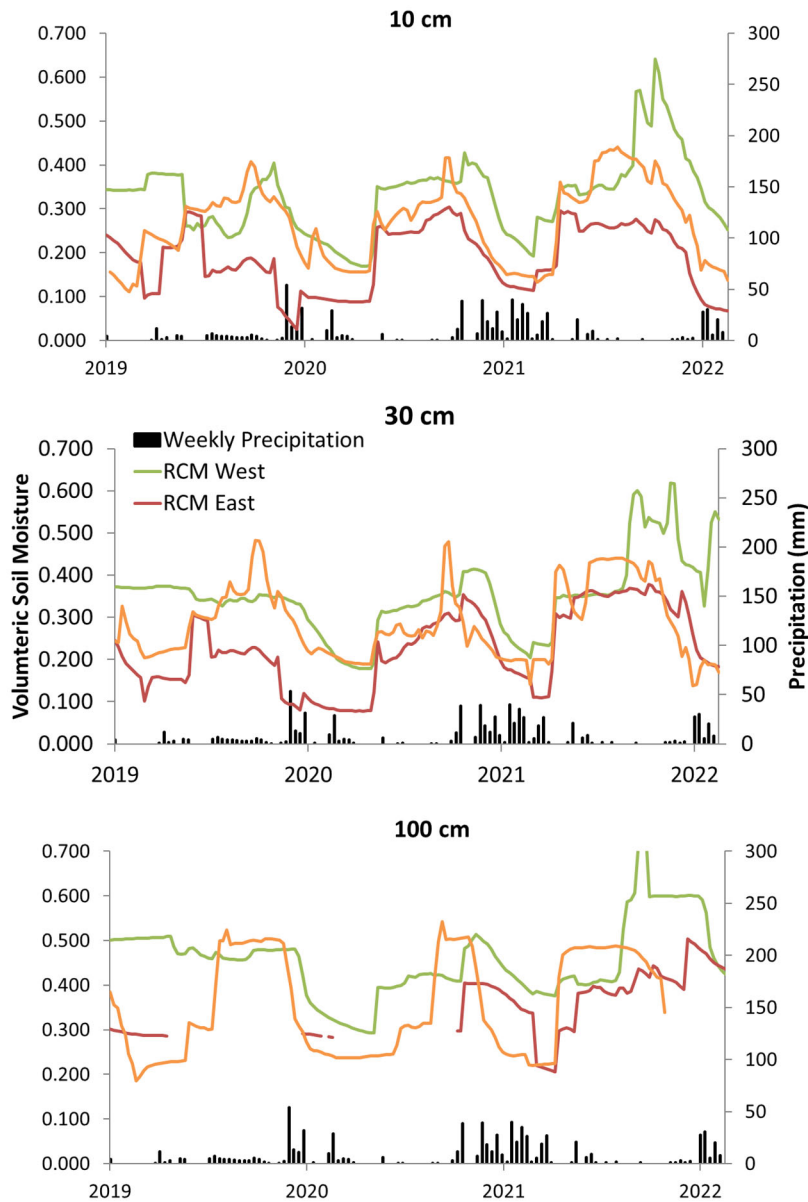
Figure 15. Weekly average volumetric soil moisture and total weekly precipitation for 2020–2022 WY for Rock Creek Meadow western and eastern portions and Marian Meadow at depths of 10, 30, and 100 cm.

The hydrograph of weekly average soil moisture for 2020–2022 WY for Rock Creek Meadow and Marian Meadow at depths of 10, 30, and 100 cm is shown (Figure 15).

Soil moisture differences over time did vary at different depths measured (Figure 15). An additional statistical analysis was done for the 30 cm depth between the western and eastern portions of Rock Creek Meadow and Marian Meadow (Table 10). The 30 cm depth was considered indicative of the highest root density of herbaceous vegetation roots. This analysis demonstrated a statistical difference for years 1 and 2 post restoration for the eastern portion and year 2 post restoration for the western portion of RCM. This demonstrates that the drier, eastern portion of RCM had a greater soil moisture

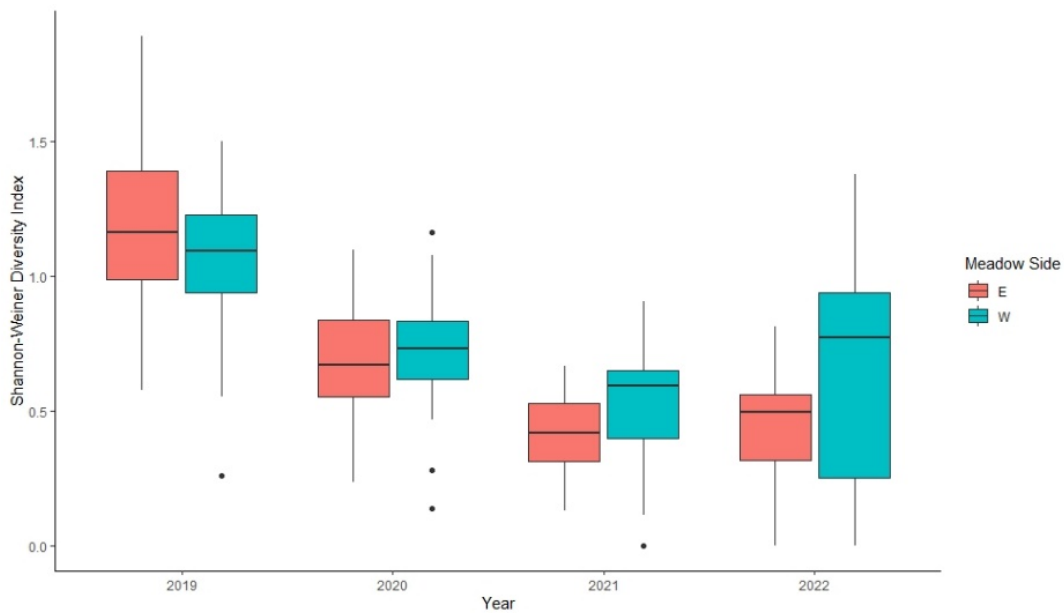
Figure 20. Shannon-Weiner diversity index by eastern (red) and western (blue) portions of Rock Creek Meadow by year.

The percentage of facultative wetland plants, species richness, Shannon-Weiner diversity index, and Simpson diversity index are presented in Figures 18-21. Additional figures for other wetland indicators are located in Appendix A.

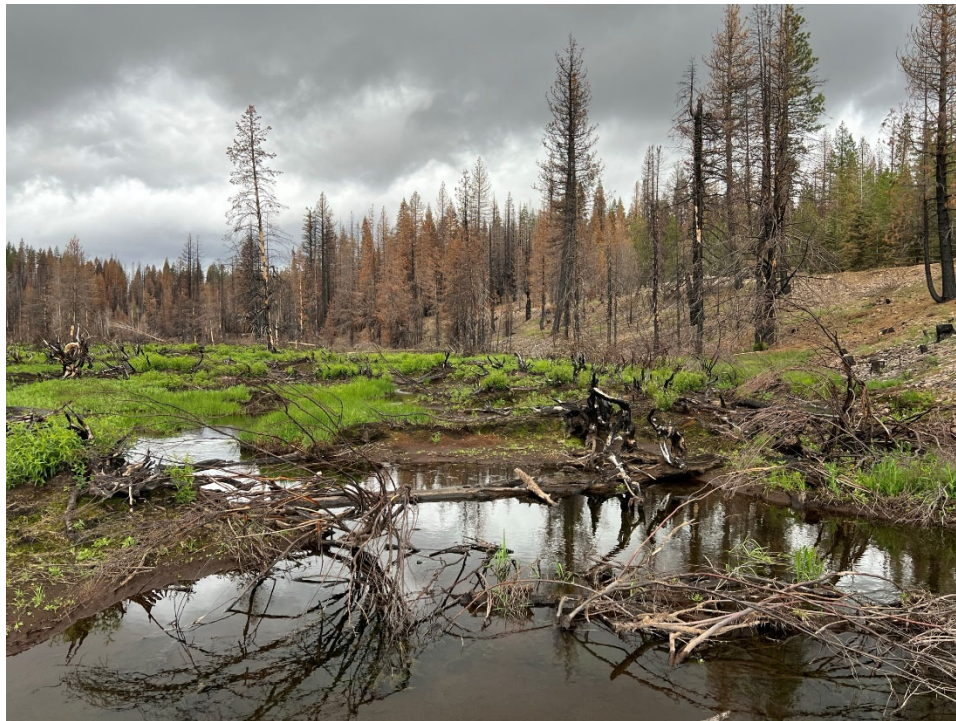
Figure 23. Riparian stream cover was substantially reduced upstream of the restoration site following the Dixie Fire, photo taken in summer 2022.

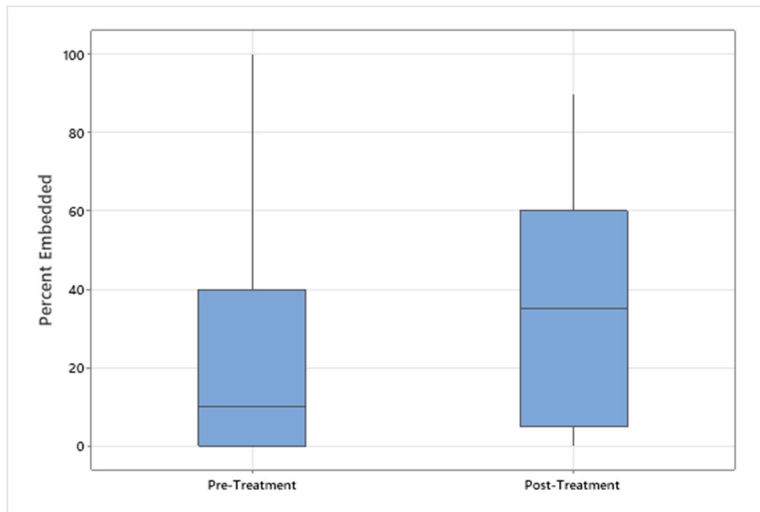
Figure 24. Distribution of percentage of cobble sized particles embedded in the streambed. Pre-treatment measurements in Rock Creek in summer of 2019, post-treatment measurements in summer of 2022.

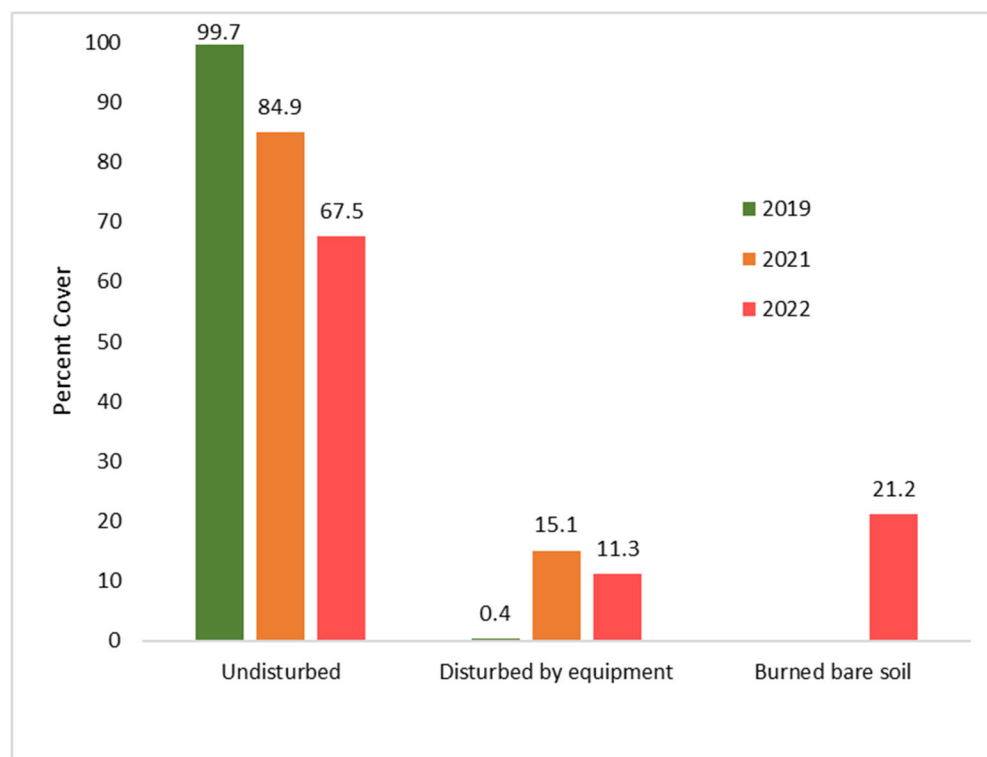
Figure 27. Percent of undisturbed and disturbed soil cover pre-treatment (2019), post-treatment (2021), and 2 years post-treatment after the Dixie Fire (2022) in the Class I WLPZ for Rock Creek Meadow.

The soil cover in the WLPZ was found to be slightly disturbed, 15.3% of soil cover disturbed, by the logging equipment during removal of the encroached *Pinus contorta* (Figure 27). The amount of disturbed soil cover increased to 32.5% the 2nd year following treatment primarily due to burnt soil cover, 21.2%, from the Dixie Fire (see Figures 27, 5, and 6). The percentage of equipment disturbance was reduced by 4% in 2022 compared to 2021 from vegetation recovery of the disturbed soil cover.

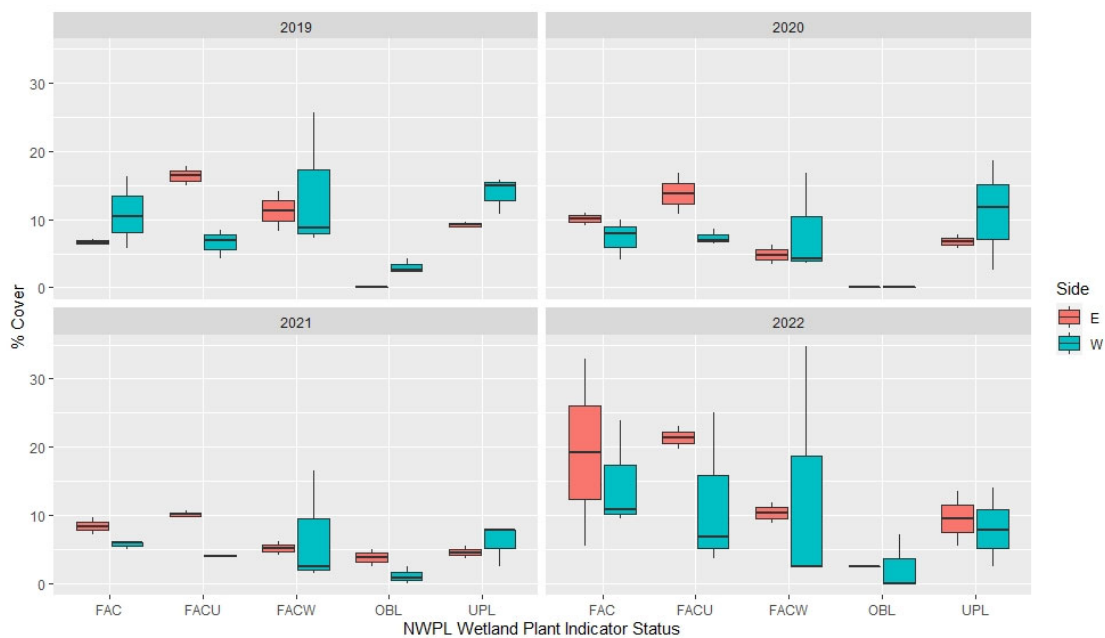
Figure A-4. Percentage cover wetland species type by eastern (red) and western (blue) portions of Rock Creek Meadow
