Abstract #383259

STORM INDUCED MASS WASTING ON DISTURBED SLOPES ACROSS A THIRTY-FOUR YEAR TIMELINE

FULLER, Mike¹, ROFFERS, Peter D¹, O'CONNOR, Matt² and SHORT, William¹, (1)State of California Department of Conservation, 715 P Street, Sacramento, CA 95814, (2)O'Connor Environmental Inc., 447 Hudson St, Healdsburg, CA 95448

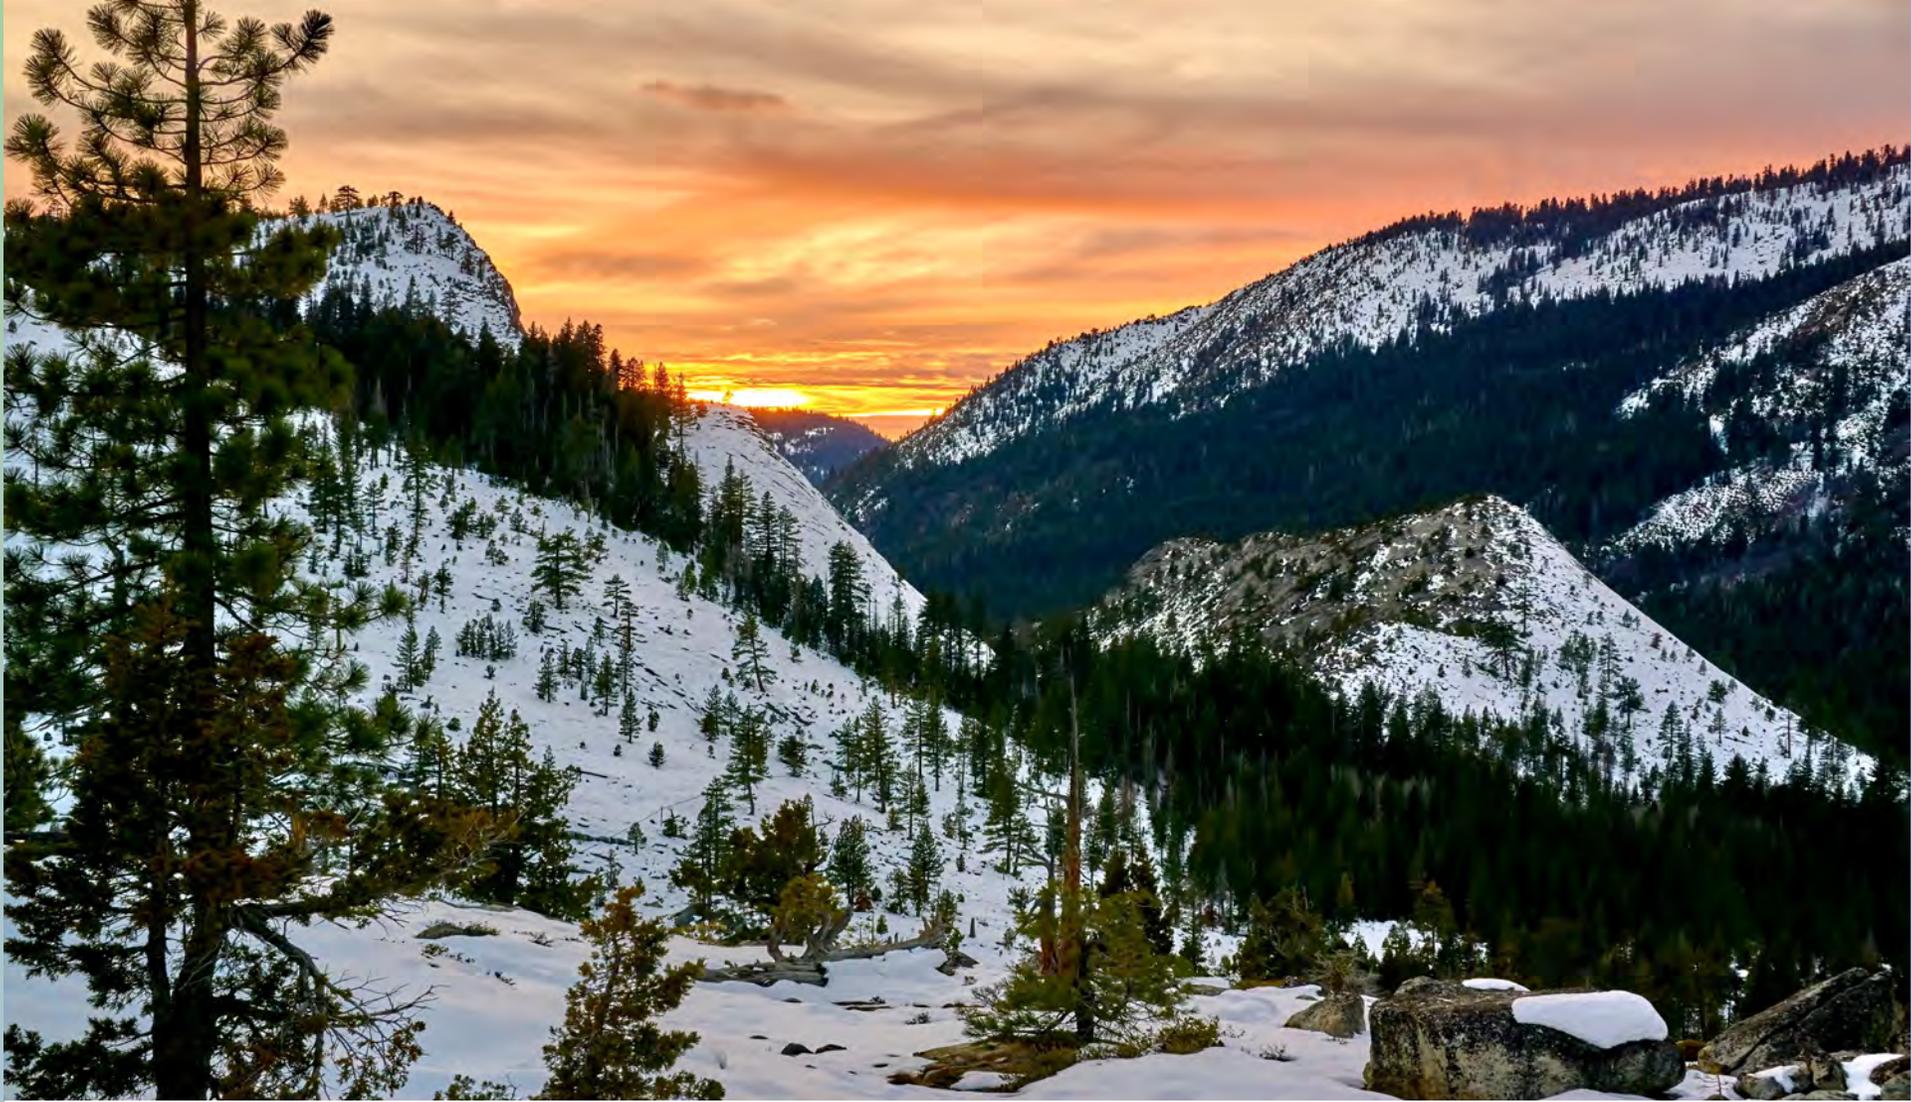
Study Area

Upper SF American River

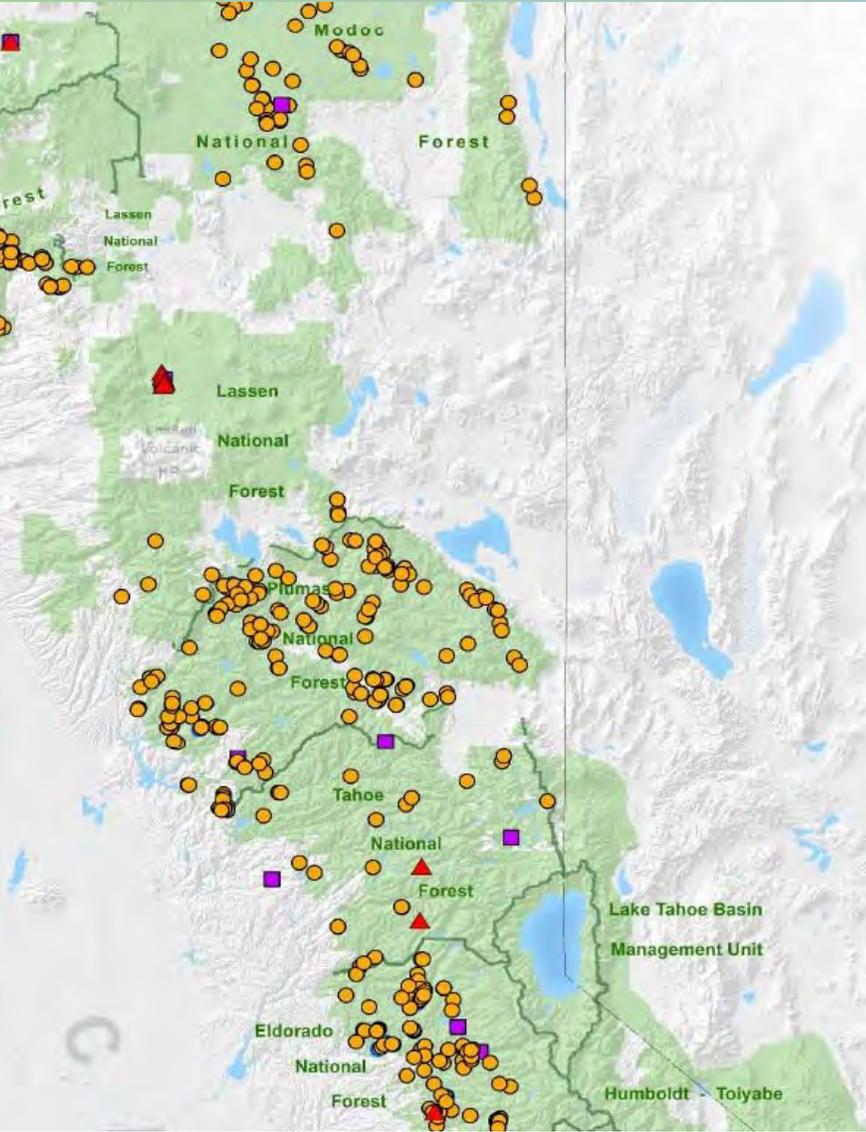
2016-17 WINTER STORM DAMAGE SUMMARY As of August 23, 2017

- Road Damage
- ▲ Trail & Recreation Facility Damage
- Administrative Facility Damage
- Other Damage

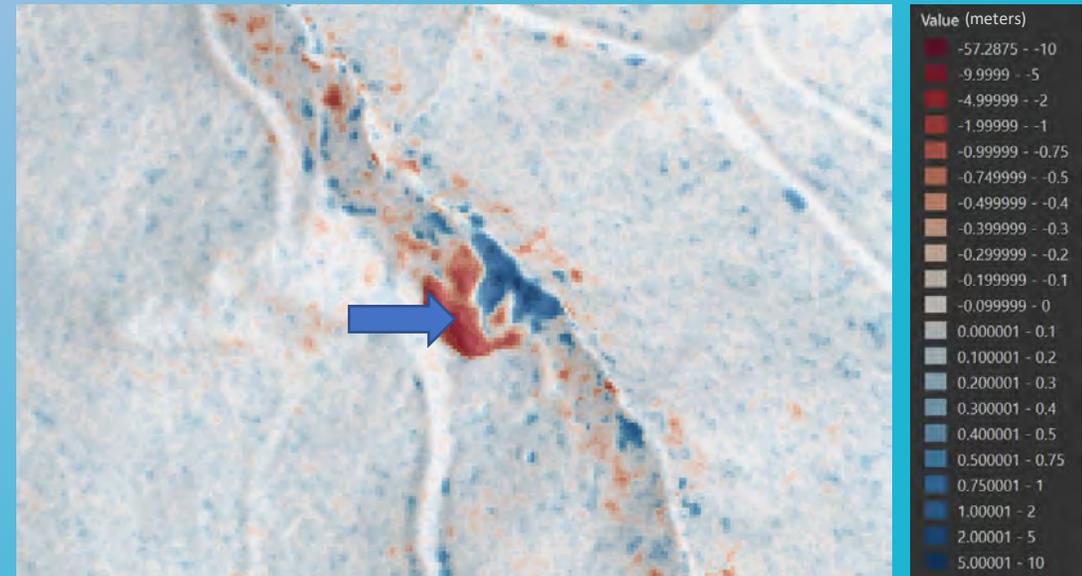
Lidar Datasets

Time Frame	Dataset	QL	Collection Dates	DEM Post Spacing
Pre-storm	USFS Pacific Southwest Region Lidar *	1	10/2014 – 06/2015	1 m
Post-storm	CA_UpperSouthAmerican_2019_B19	1	10/2019 – 03/2020	1 m

- Source lidar datasets first converted to common coordinate system, geoid, cell size
- DoD (DEM of Difference) created by subtracting 2014 lidar from 2019 lidar

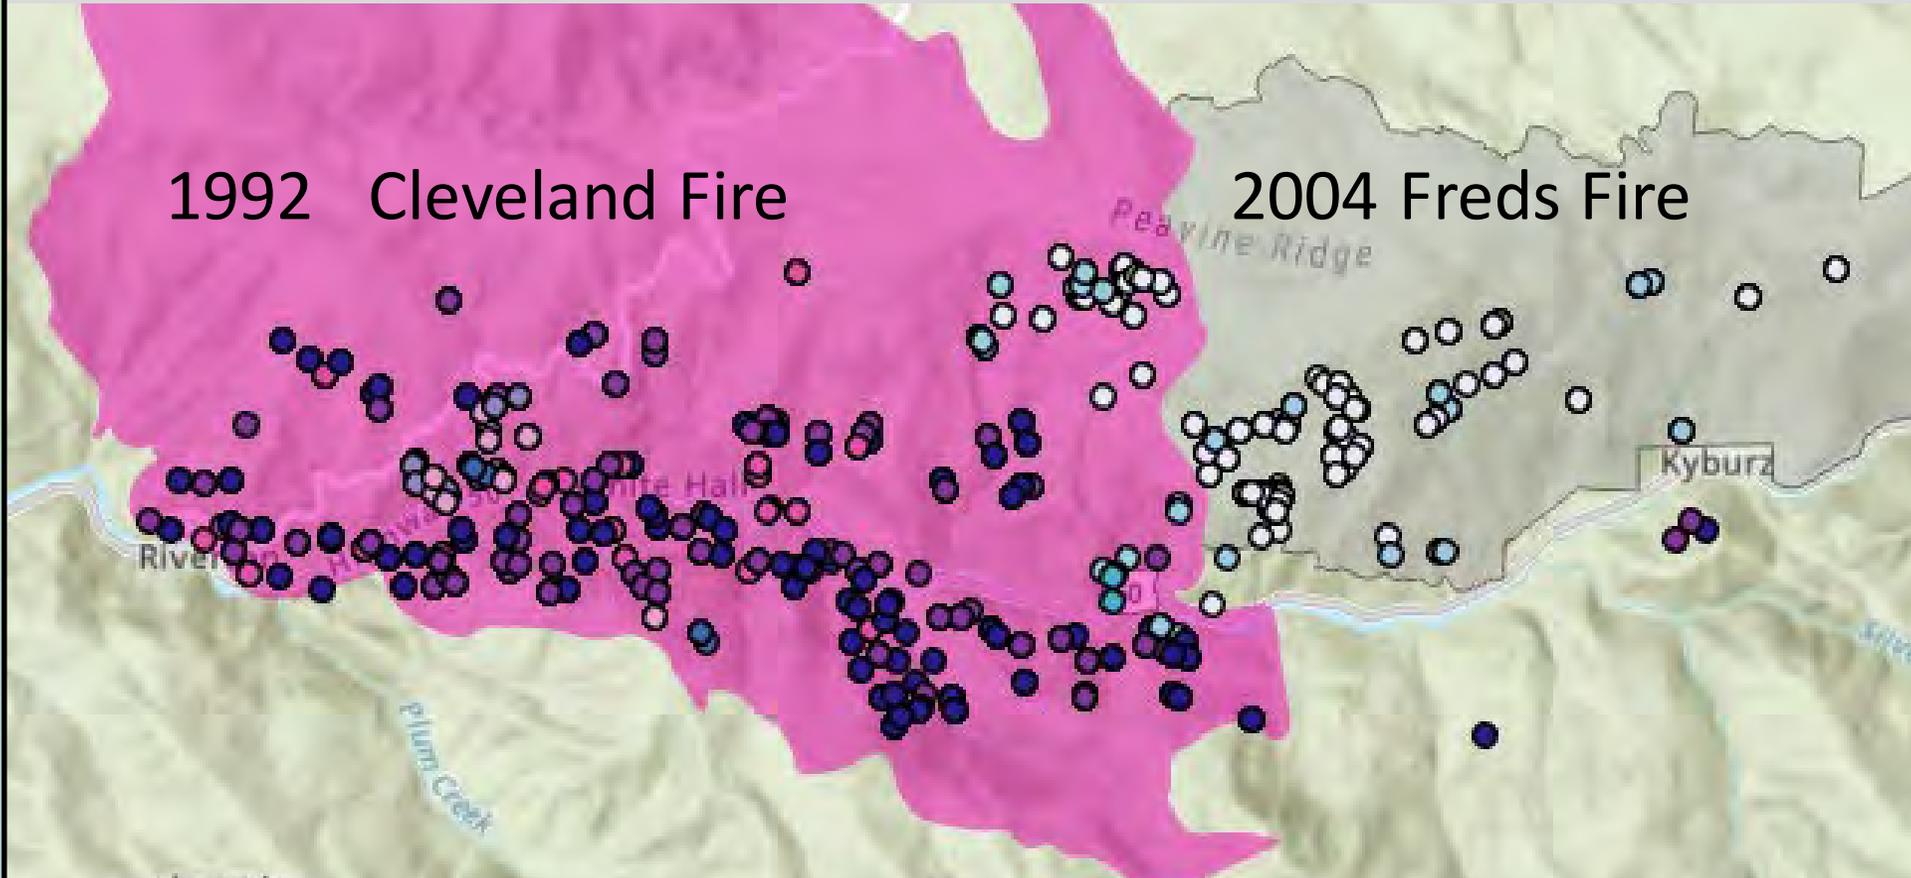
Potential Geomorphic Features & Canopy Density

Old burn

Sparse Dense
Vegetation

Young burn

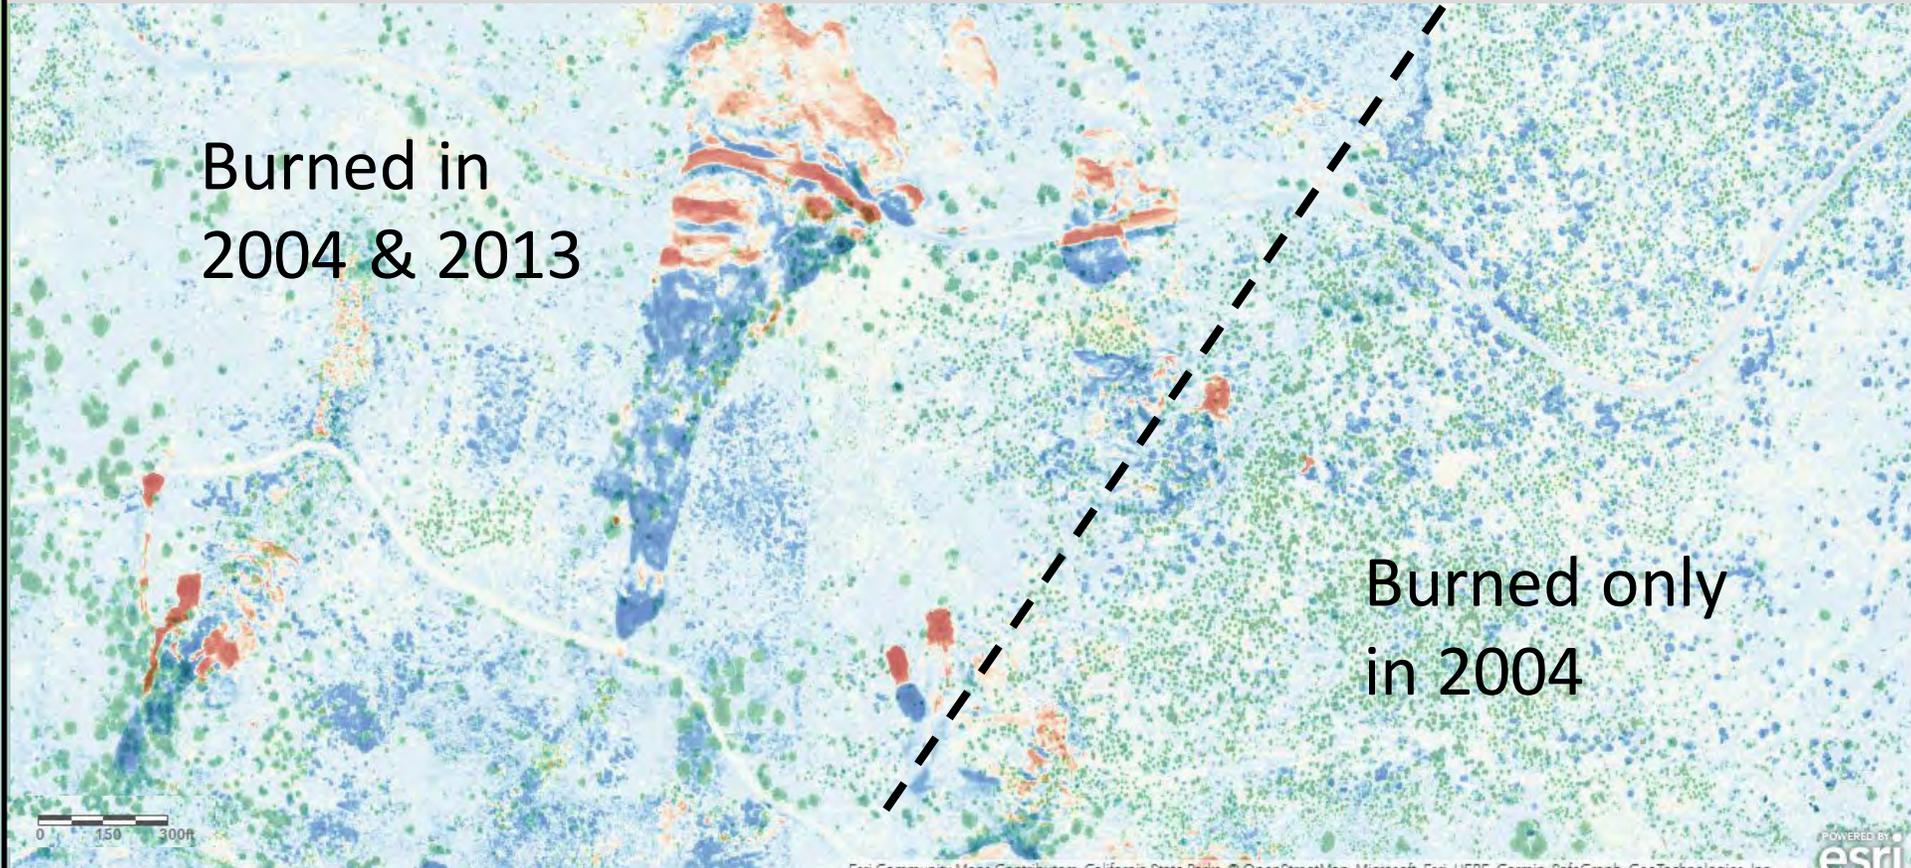
Canopy Density & Elevation Change

Elevation Change

Negative

Positive

Canopy Density

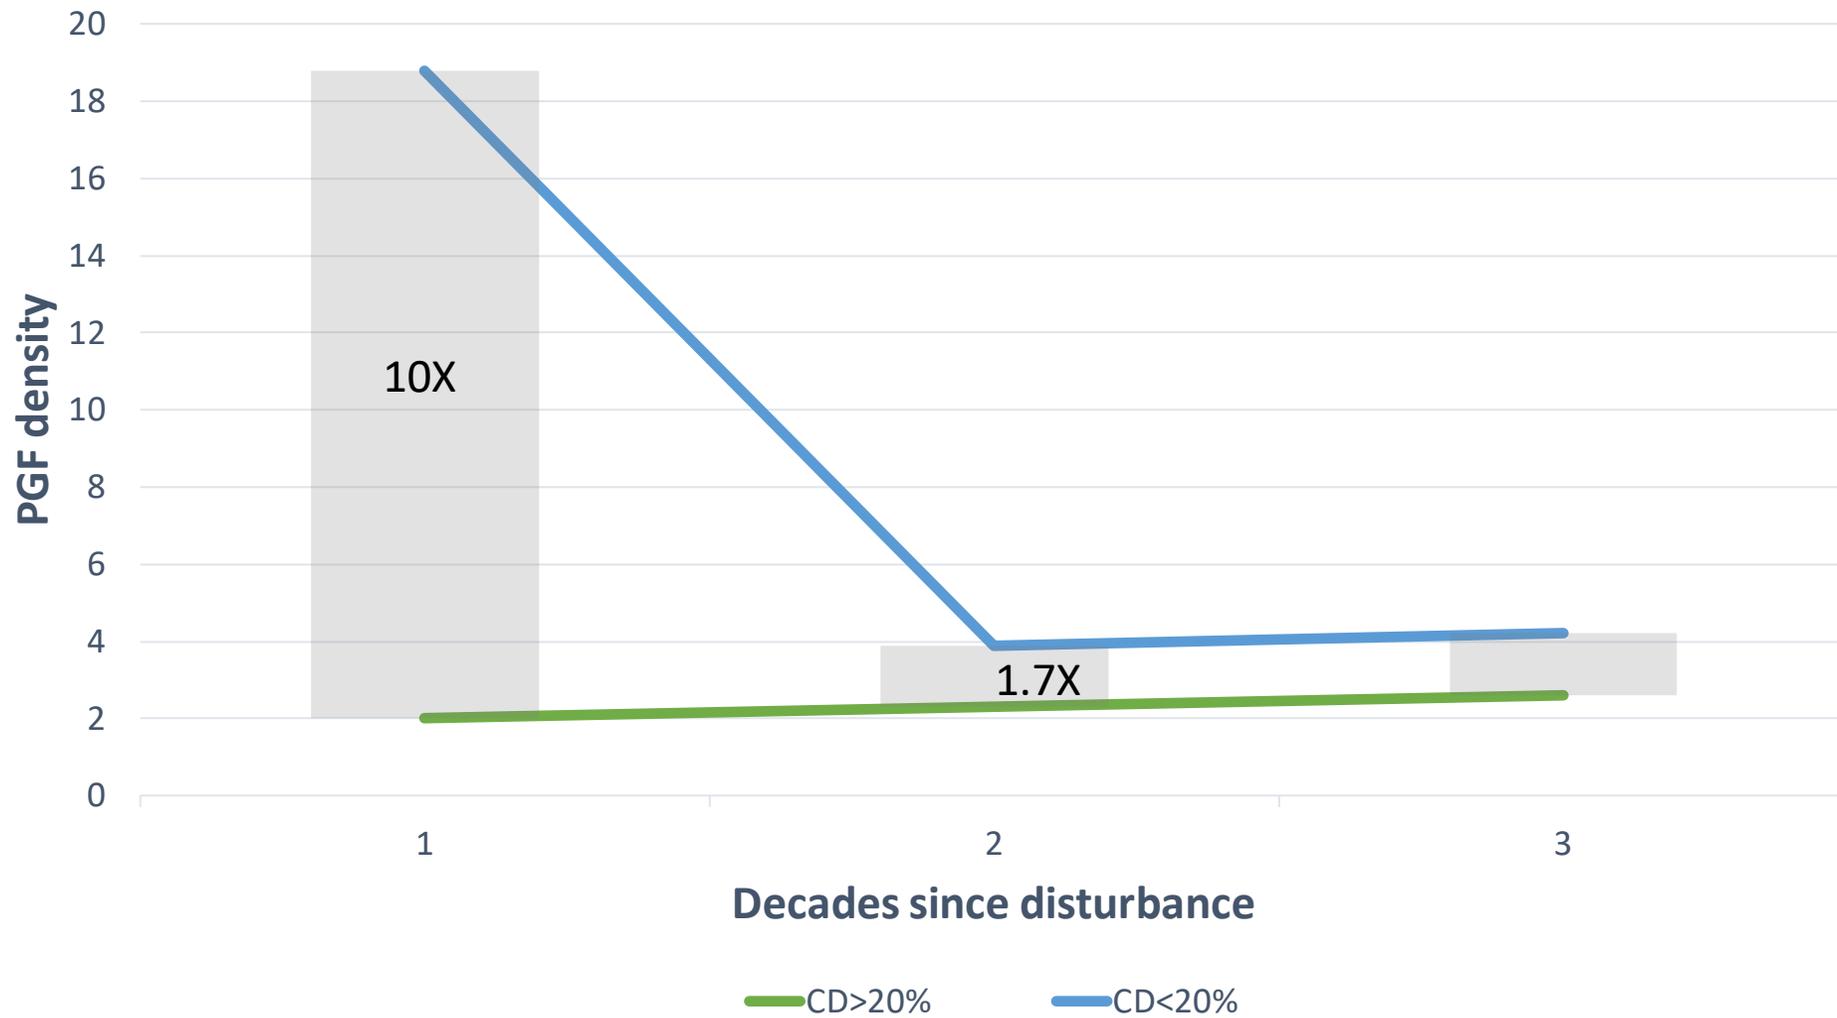
The Effect of Canopy Density on PGF Density by Decade

PGF density was highest where canopy density was less than 20% which in reforested areas lasted for 20 years.

During this prolonged recovery period, the 2017 storms hit while canopy density remained below the geomorphic threshold.
