Santa Cruz Mountains Post-Fire Redwood Defect Study

Nadia Hamey, Hamey Woods

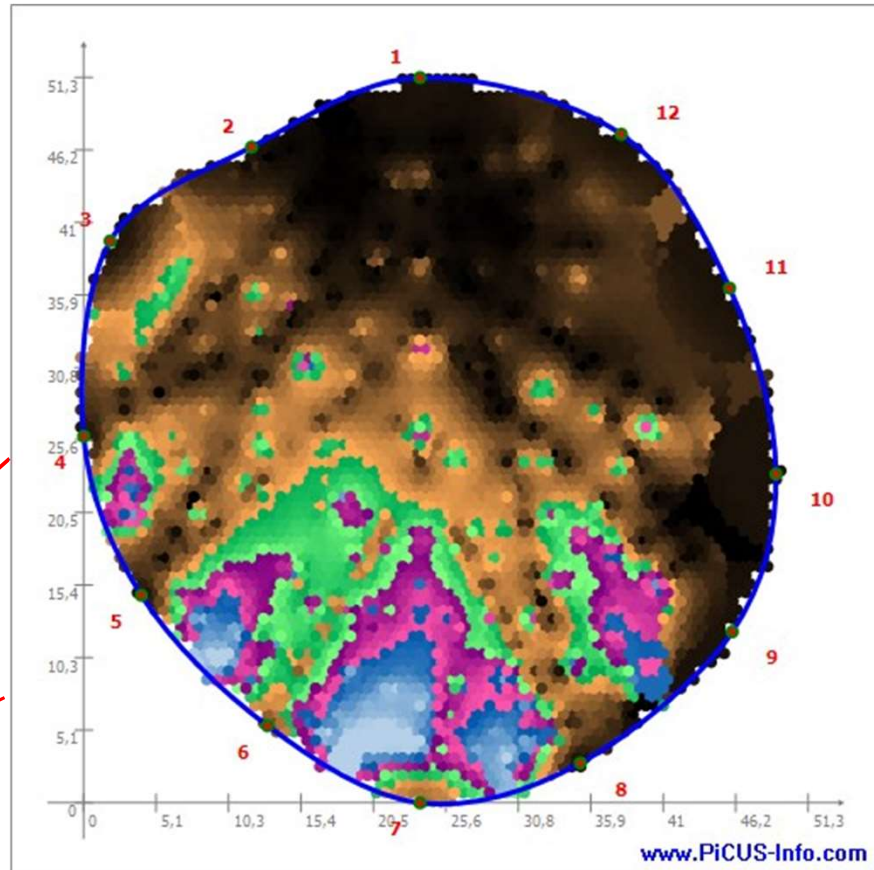
Sonic tomography

= Decay   = Healthy
  = Severe Decay

- Noninvasive technology, PiCUS 3 Sonic Tomograph
- Structural integrity at 1m from base
- Measures velocity of sound
- Sound travels faster in solid wood

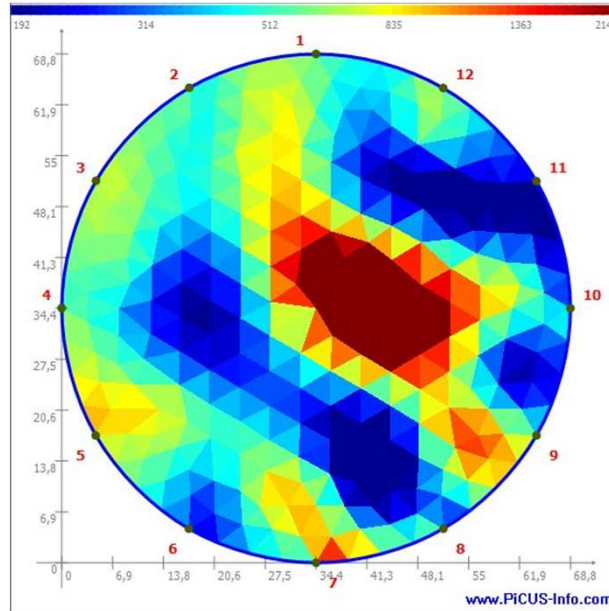
Cross-section

62% Decay

35% Severe Decay

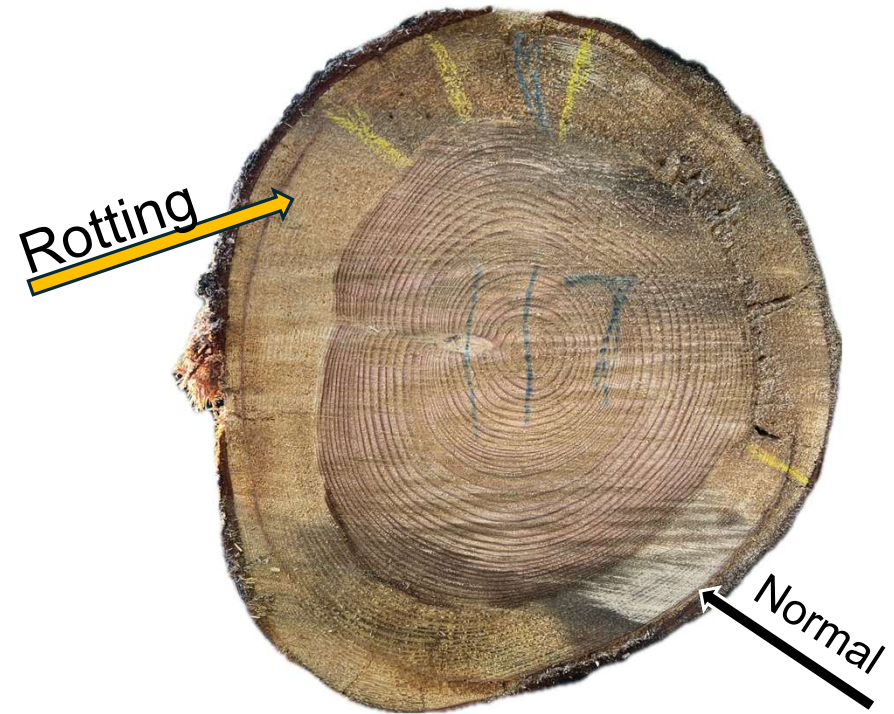
Gross and Net Volume of Logs After Deductions (Board Feet)

Volume	Volume After Deductions
Log #1	220 bf	110 bf
Log #2	80 bf	80 bf

- Majority of logs showed discoloration of the sapwood
- The big end of the first log had an average circumference decay of **34%**
- The average % volume deduction in the first log was **21%**

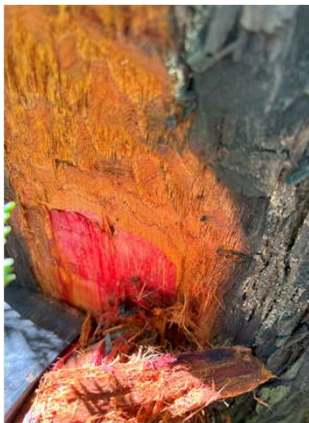
Cambium check

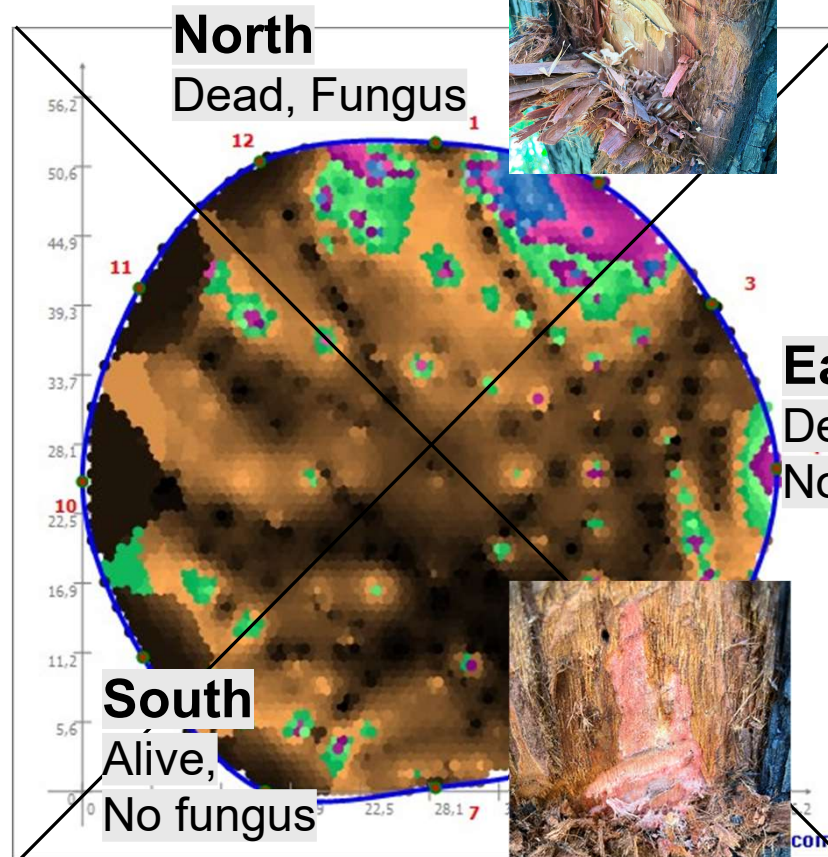
West
Alive,
Fungus
