**9GA22700
HAMEY WOODS
SANTA CRUZ MOUNTAINS POST-FIRE REDWOOD DEFECT STUDY**

Date: December 30, 2023

Project Status and Progress Report:

Post-fire Effects, Tomography Scans, and Log Scaling of
San Vicente Redwood Trees -- Photo Documentation
DRAFT

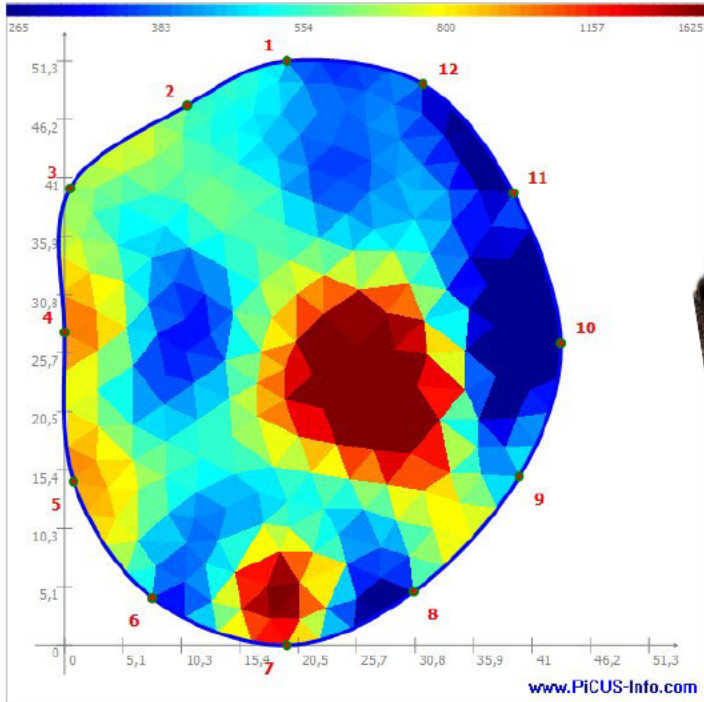
Electrical Impedance Tomography Scan

- ~64 sq. in of white rot
- ¼ quadrants of fungus
- ¼ quadrants of dead cambium
- Branch & Bole Sprouting
- Low-Moderate Burn Severity Zone

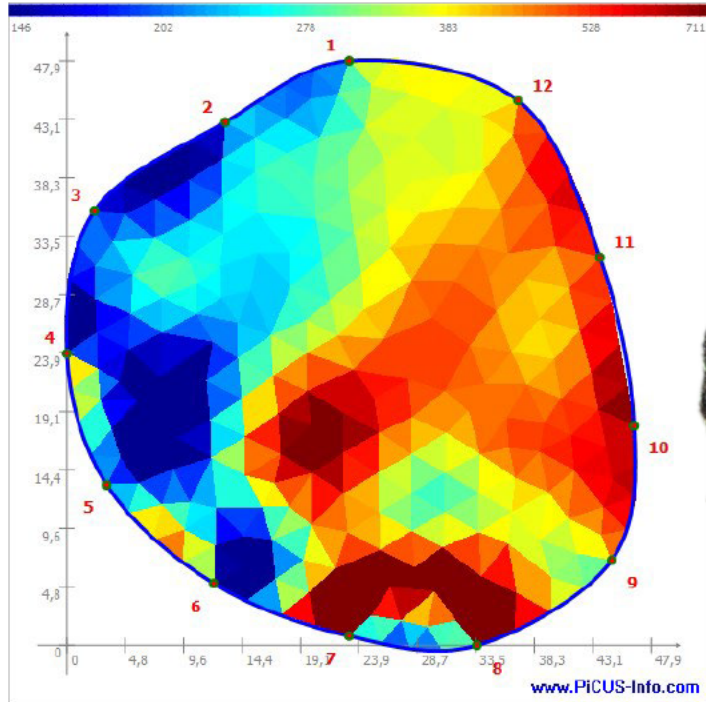
Electrical Impedance Tomography Scan

- ¼ quadrants of fungus
- ¼ quadrants of dead cambium
- Bole Sprouting
- Moderate-High Burn Severity Zone
- Dead top

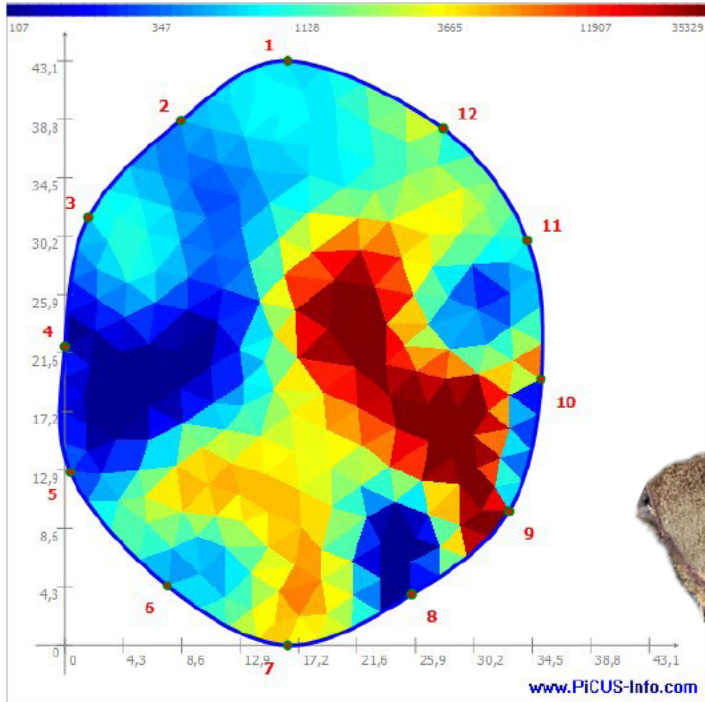
Electrical Impedance Tomography Scan

- ~890 sq. in of white rot
- $\frac{3}{4}$ quadrants of fungus
- $\frac{4}{4}$ quadrants of dead cambium
- Tree was dying at time of measurement and was dead at the time of cutting
- Branch & Bole Sprouting (Branch sprouts dead at time of measurement)
- Moderate-High Burn Severity Zone

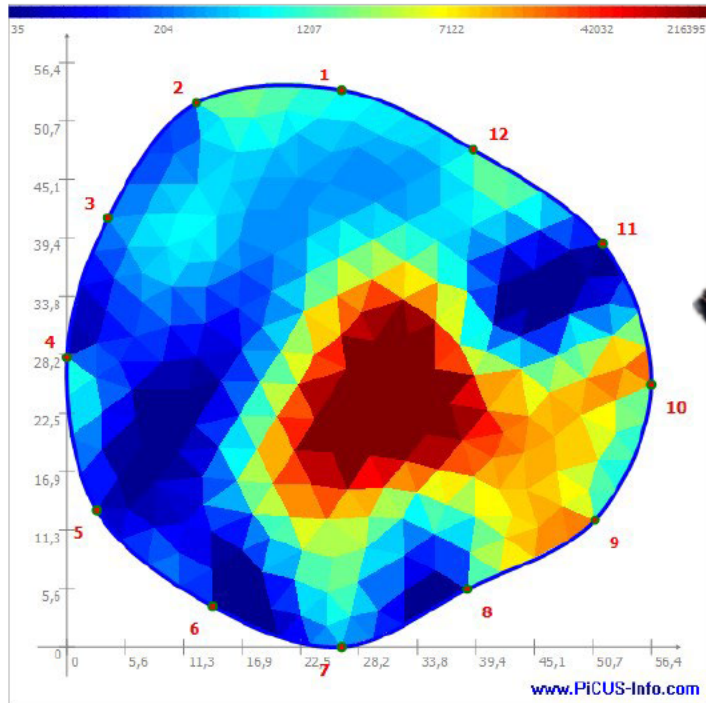
Electrical Impedance Tomography Scan

- ~74 sq. in of white rot
- 1/4 quadrants of fungus
- 9/4 quadrants of dead cambium
- Branch & Bole Sprouting
- Low-Moderate Burn Severity Zone
