WOODY DEBRIS TRANSPORT THROUGH LOW-ORDER STREAM CHANNELS
OF NORTHWEST CALIFORNIA – IMPLICATIONS FOR ROAD-STREAM
CROSSING FAILURE

A Thesis

In Environmental Systems: Geology

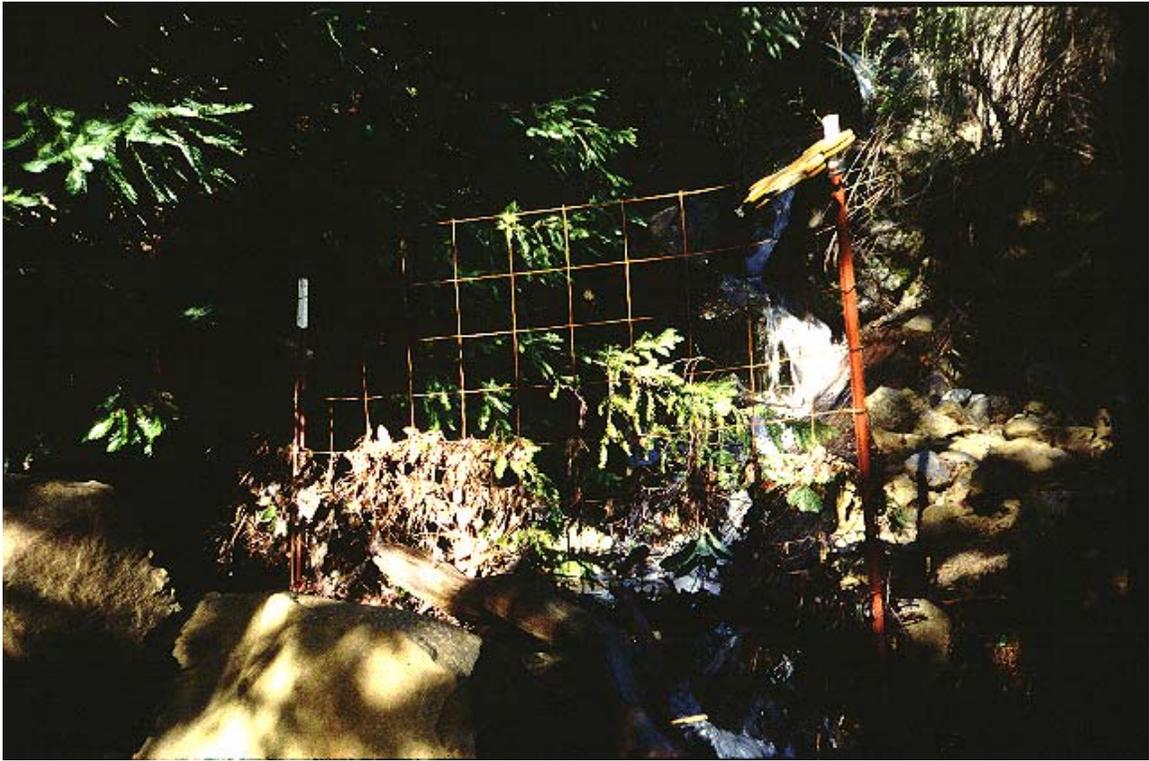
Figure 6. Debris screens consisted of 15 cm square mesh fencing secured by three or more metal fence posts. Accumulation of redwood limbs can be seen on this screen in Bull Creek.

At each site, 15.2 cm square mesh fencing was strung across the channel 5 – 10 m below the culvert outlet. The fencing was secured by three or more fence posts pounded into the bed and banks. These "debris screens" captured a portion of fluvially transported woody debris (Figure 6).

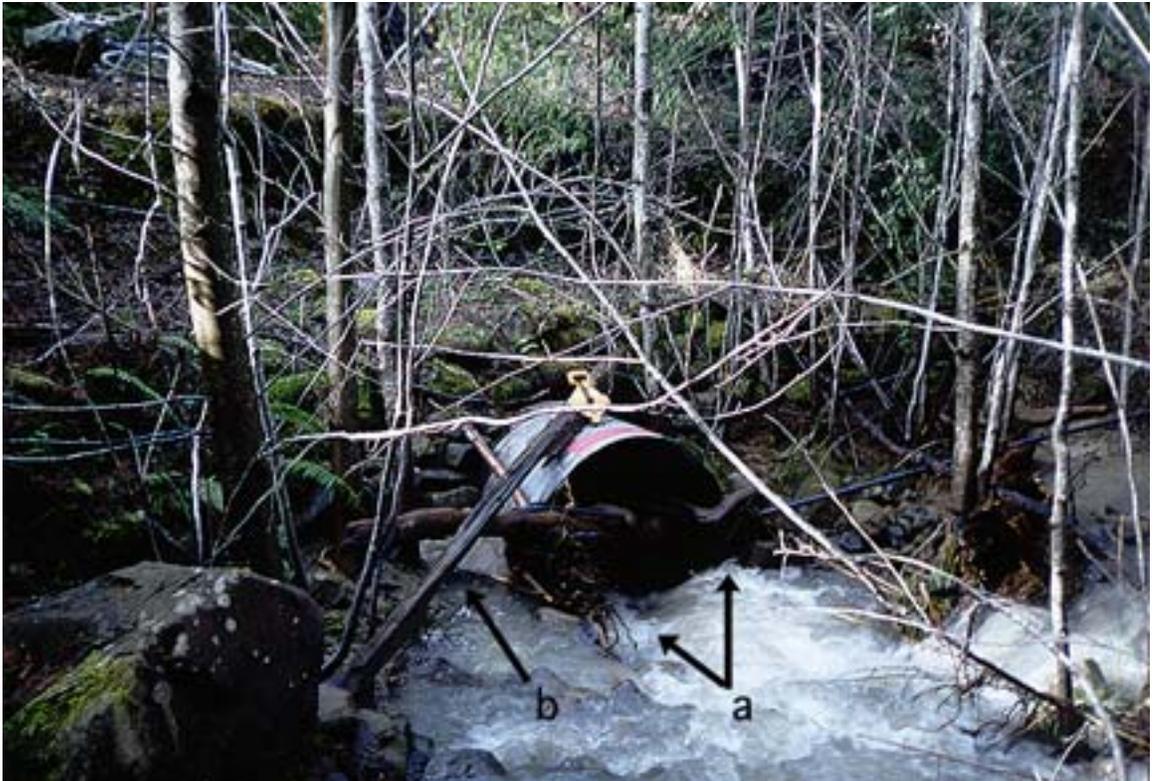
Figure 8. Criteria for culvert plugging. A culvert was considered plugged if one or more pieces were lodged across and in contact with culvert inlet at one or more places. Piece “a” satisfies this criteria by contacting the inlet lip at two points. Piece “b”, although in contact with the pipe, is not counted because it does not contact the inlet.

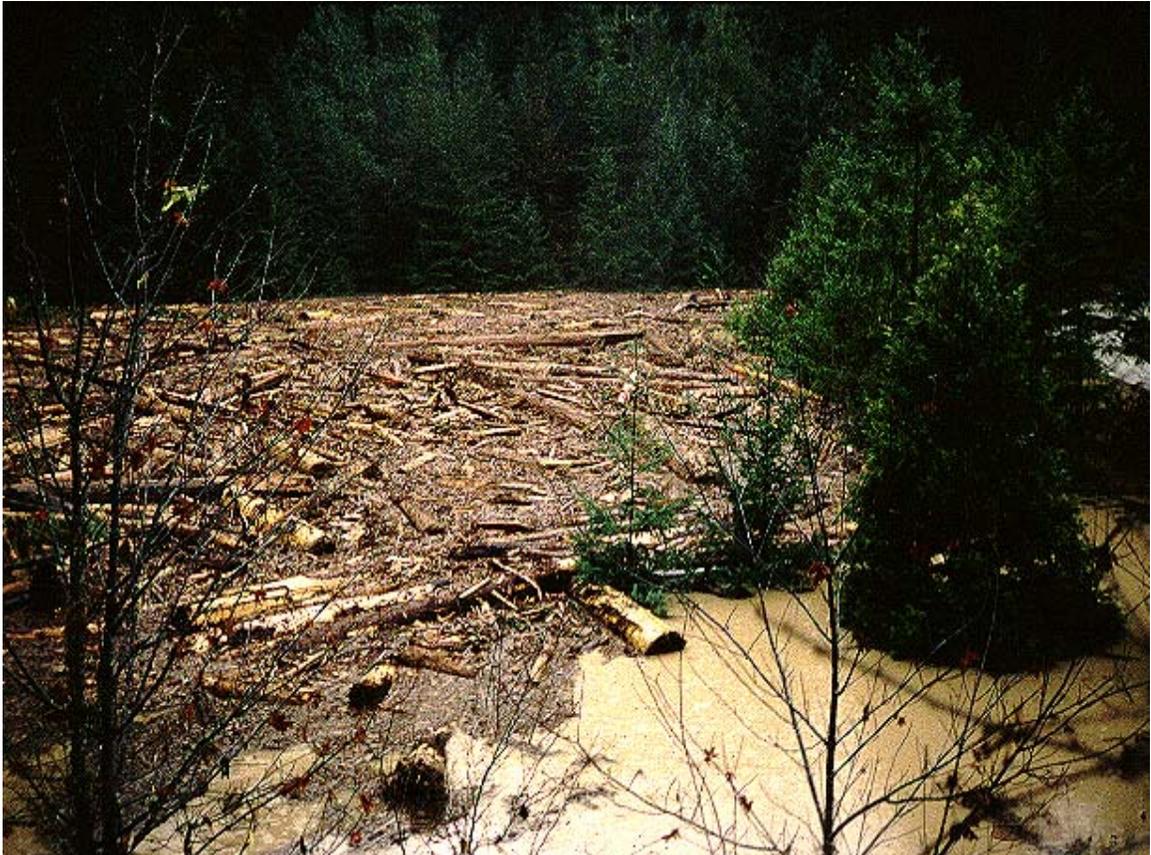
Figure 20. When water is ponded over the inlet crown ($HW/d > 1$), wood accumulates in the inlet basin enhancing the chance of plugging during receding flows. This photo is from the central Cascades of Oregon following a peak flow event in the early winter of 1997.

Note that for $HW/d \geq 1.0$, debris passage is effectively eliminated. During ponded conditions, wood accumulates above the inlet (Figure 19 and Figure 20). During receding flows, the wood converges on the inlet in a large mass. I observed several instances where a short duration, high intensity rainfall submerged the inlet. A floating mass of wood rapidly accumulated in the pond. When the inlet crown was exposed during the receding flows, the interlocking mass of wood plugged the culvert. As the flow dropped further, floating pieces of wood continued to lodge and some pieces lodged above dropped to lower points on the inlet. At one site, where ponding had occurred, the inlet was 80% plugged with debris and sediment when the flow had fully receded. Culvert designs that reduce the probability of ponding also reduce plugging hazard.
