TALLWOOD
DESIGN INSTITUTE

Report

Cross-Laminated Timber Layup Tests Using Mixed Fir Species

January 2024

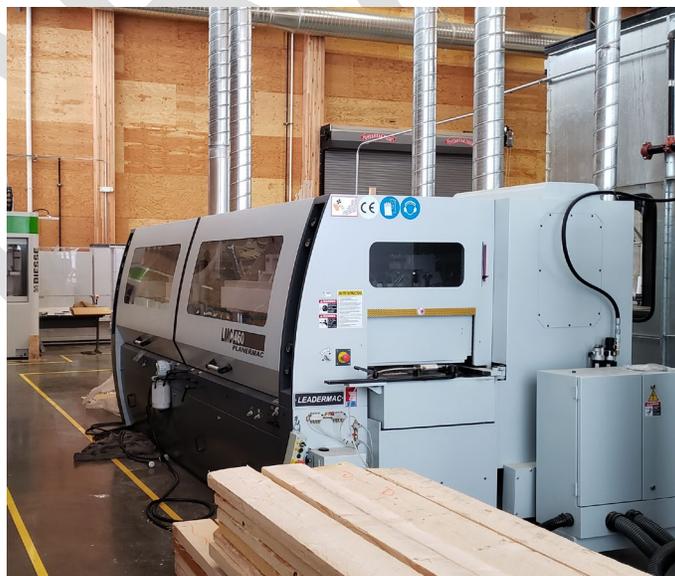
Figure 1: Leadermac Planer

Prior to machining, five boards of each species were selected at random to have had their moisture content checked with a pin moisture meter (see Table 1). As noted above, the white-fir lumber used was rough sawn, while the Douglas fir was S4S, but all material was planed to a nominal dimension of 1.375" x 5.15" based on dimensions used in the previous JIWPI project performed at TDI. For a few of the 5-ply panels towards the end of the fabrication run, an additional step was added to crosscut some boards for use as 8' transverse lamellas. A Leadermac LMC 460 4-sided planer was used to dimension the lumber (Figure 1).

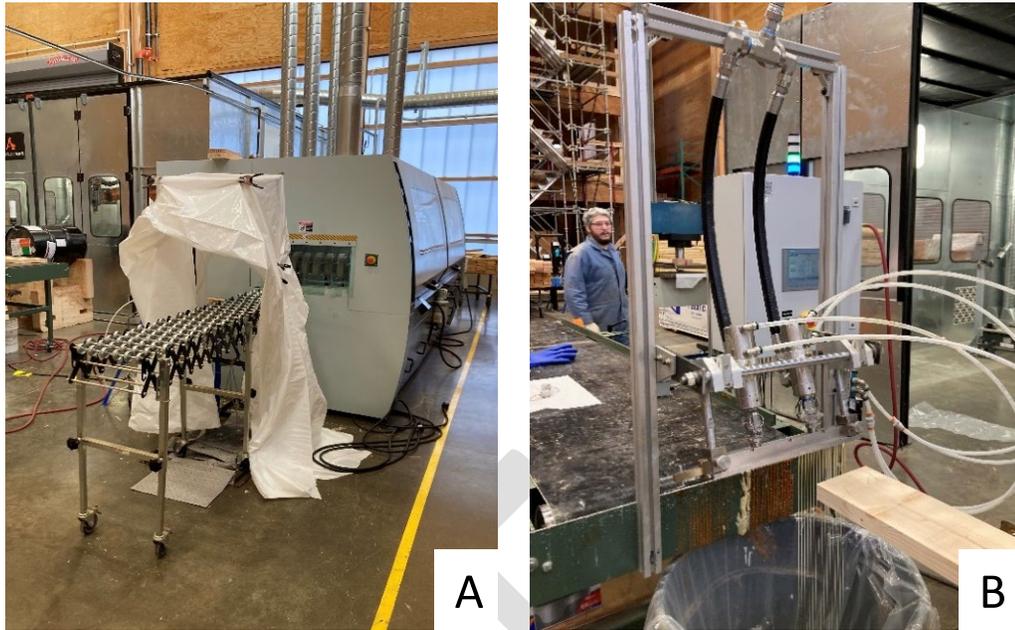
For the panels using the PUR resin, a shop-made primer misting system was installed at the end of the planer outfeed, applied a PUR primer solution to the top and bottom of the boards as they came out of the planer (Figure 1). Henkel’s (Loctite PR 3105) primer was applied at a rate of 2 g/m², according to the manufacturer’s instructions. The milled boards were then stacked using stickers of non-absorbent material to allow even airflow then allowed to dry for a minimum of ten minutes before resin application.

Figure 2: (A) Primer tent on planer outfeed; (B) PUR resin curtain applicator

The adhesive resin used in the fabrication of the CLT panels was a Henkel, one-part, PUR adhesive (Loctite HB X602 Purbond). The recommended spread rate of 28 lbs./1000 ft² was verified by weight prior to resin application. As with the MF panels, the individual boards were placed on a belt conveyor that passed underneath a curtain of the resin, ensuring a consistent spread rate throughout the panel (Figure 2B).

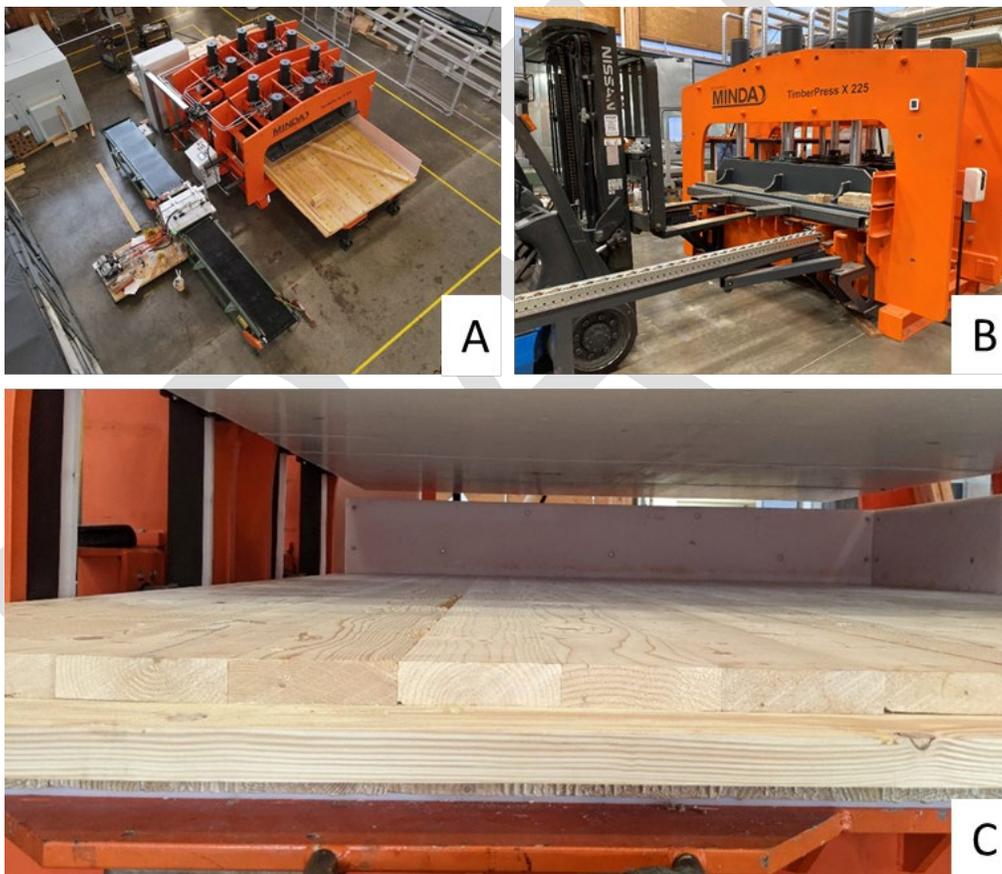
The PUR manufacturer recommended a press pressure of 73-116 psi and for this operation the set value of the press was 115 psi. Since the adhesive manufacturer advises longer pressing times for temperatures below 68 °F (Table 1), panels were left in the press until the end of the work day to maximize clamping time, and making the actual pressing time was a minimum of 4 hours. Panels were stored in the lab overnight or longer before machining to allow for the full curing of the resin.

Figure 3: (A) Minda press and Apquip resin applicator; (B) Forklift applied end pressure caul; (C) CLT panel immediately after pressing

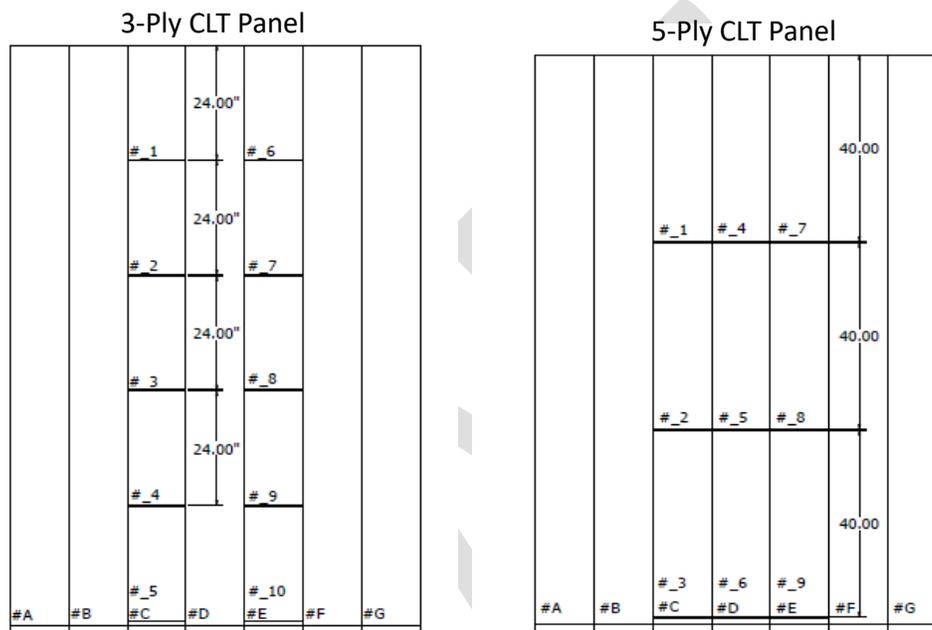
The processing of the CLT panels was performed on a Biesse Uniteam Ultra, 5-axis, computer numerical control (CNC) machine which is designed for mass timber material. Each panel was ripped into a total of 7 (12" x 120") strips and then labeled with the panel number (1-14) and the location of the panel (A-G). Strips A, B, D, F, and G were put aside for long span testing, while strips C and E were cut down further for short span testing, shear block testing, and delamination testing. The cutting pattern can be seen in Figure 4.

Figure 4: Sample Cutting List

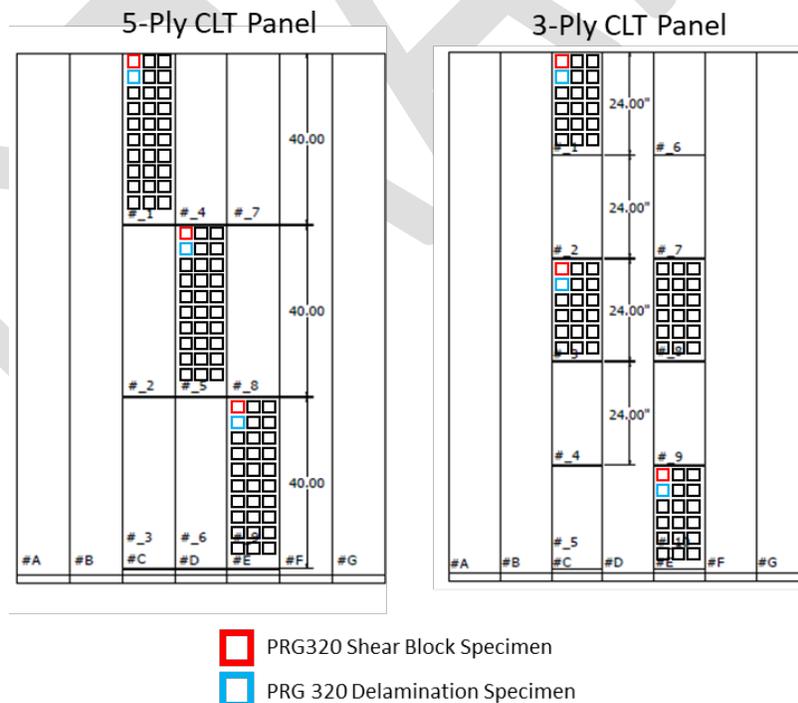
The shear block and cyclic delamination specimens were obtained from sections 1, 3, 8, and 10 of the 3-ply panel and sections 1, 5, and 9 of the 5-ply panel (Figure 5). Even though about 45 pairs of delamination and shear block specimens have been harvested from the panels (15 from sections C1, 15 from D5 and 15 from E9), only three pairs from each section have been used to for qualification of each panel to follow PRG320-2019 sampling scheme (block specimens marked red for delamination tests and blue for block shear tests on the cutup diagram in Figure 5). The results from the remaining blocks were used for better understanding of the representativeness of specimens harvested following the standard.

Figure 5: PRG320-2019 subsample locations for shear block and cyclic delamination specimens

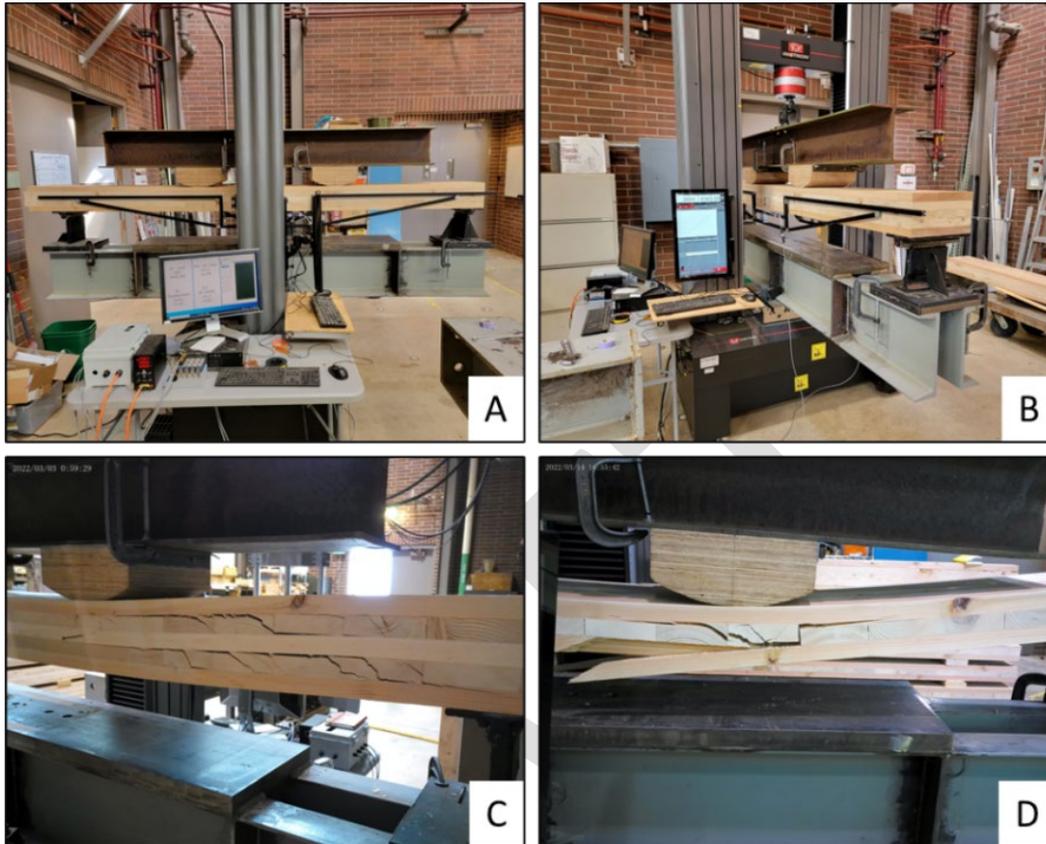
The long-span flexure test specimens used the 12" x 120" strips that were cut from each panel. The samples were tested in 3rd-point bending following the ASTM D198-15 Standard Test Methods of Static Tests of Lumber in Structural Sizes. The samples were tested as a total span of 114" with a mid-span of 38" (1/3 of the total span). The total span and mid-span deflections were measured with string potentiometers, which were attached to a deflection measuring apparatus (Figure 6). Due to limitations of the press the 5-ply CLT was not able to meet the span/depth ratio of 30 time the specimen depth. The total sample size for the 5-ply and 3-ply were 22 specimens and 30 specimens, respectively.

Figure 6: (A&B) Long-Span Flexure Test setup, (C) 5-ply sample failure (Shear failure, due to 10 ft span), (D) 3-ply sample failure (Expected failure in tension)

The samples were tested at a rate of 0.25 in/minute until failure, and had deflections, load, and failure type recorded. The recorded data was then used to calculate the Modulus of Rupture (MOR), the Modulus of Elasticity (MOE), E_{app} , Effective Moment Capacity, and Effective Stiffness.

Due to the limitations of the press size, the 5-ply samples could not be manufactured to the test length of 17 feet. As a result, the 5-ply samples could not be directly compared to the PRG320. The short lengths of the 5-ply samples caused shear failures during the test rather than a flexural/tension failure within the sample (Figure 5).

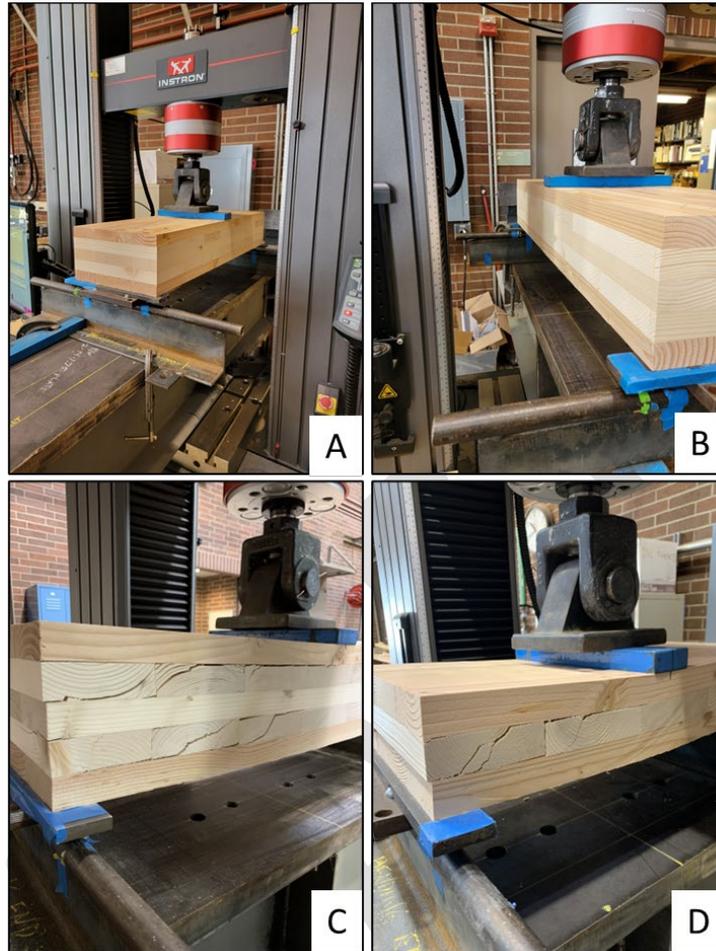
The short-span shear test specimens used 12" x 23" strips from the 3-ply panels and 12" x 38" strips from the 5-ply panels. The samples were tested in center point bending following the ASTM D198-15 Standard Test Methods of Static Tests of Lumber in Structural Sizes (Figure 7). The testing used a span to depth ratio of 5.1:1, making spans of approximately 21" and 35" for 3-ply and 5-ply samples, respectively. The total sample size for both thicknesses were 35 specimens, with a grand total of 70 specimens tested.

Figure 7: (A&B) Short-Span Shear Test Setup, (C) 5-ply shear failure, (D) 3-ply shear failure

The samples were tested at a rate of 0.1 in./minute until failure, and had the actuator deflection, load, and failure type recorded. The recorded data was then used to calculate the shear stress (f_v) and the shear capacity in the minor direction.

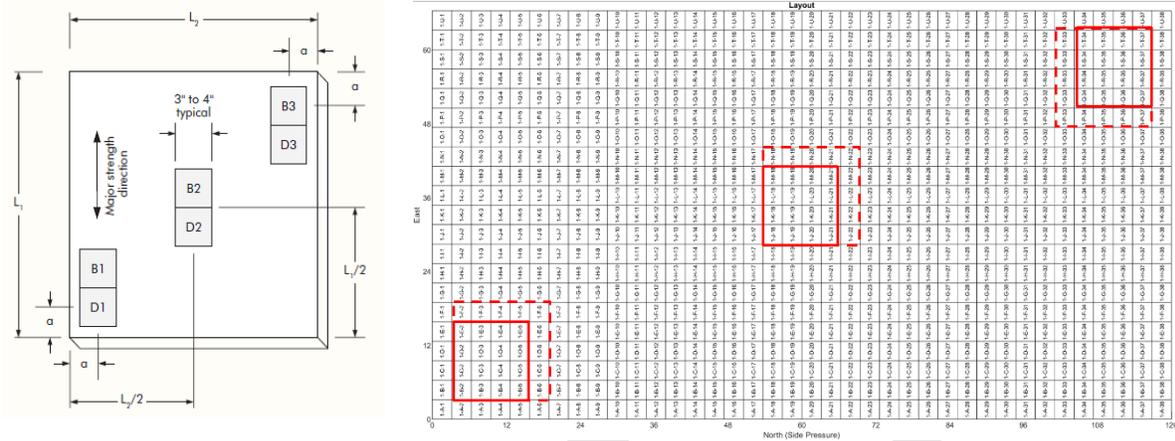
Figure 8. Standard PRG320 sampling scheme for delamination specimens allows more options in small lab-scale billets (left) than in larger test panels (right).

It should be also noted that the prescribed sampling scheme for bond integrity test is often taken for granted. ANSI/APA PRG320 requires just three sets of block shear and delamination specimens per prequalification billet and a minimum of two specimens per shift for subsequent quality assurance. The areas of sampling are assigned in a way that leaves few options in small billets, but leaves substantial freedom in harvesting test specimens from larger panels (Figure 1). The standard does not support the prescribed sampling scheme with any external reference or rationale and we are not aware of any empirical or theoretical study to back the scheme.

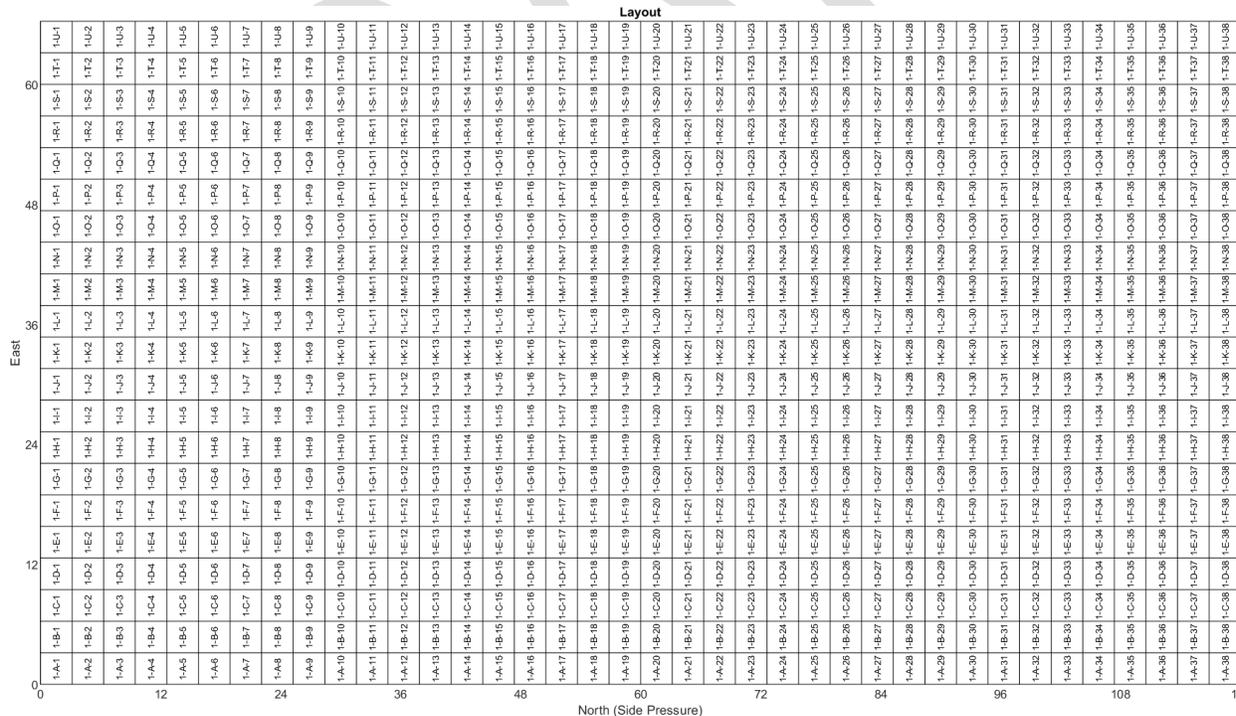
The complete cutting scheme for both panels is shown in Figure 2. In line with original marking and cutup sequence, the horizontal strips are referred to as columns and are marked with letters (A, B, C, ... through U) while the vertical strips are referred to as rows and are marked with numerals (1, 2, 3, ..., through 38).

Figure 9. Sub-study panel cutup scheme. In line with original marking, in the subsequent text the horizontal strips are referred to as *columns* (A, B, C,...) while the vertical strips are referred to as *rows* (1, 2, 3, ...).

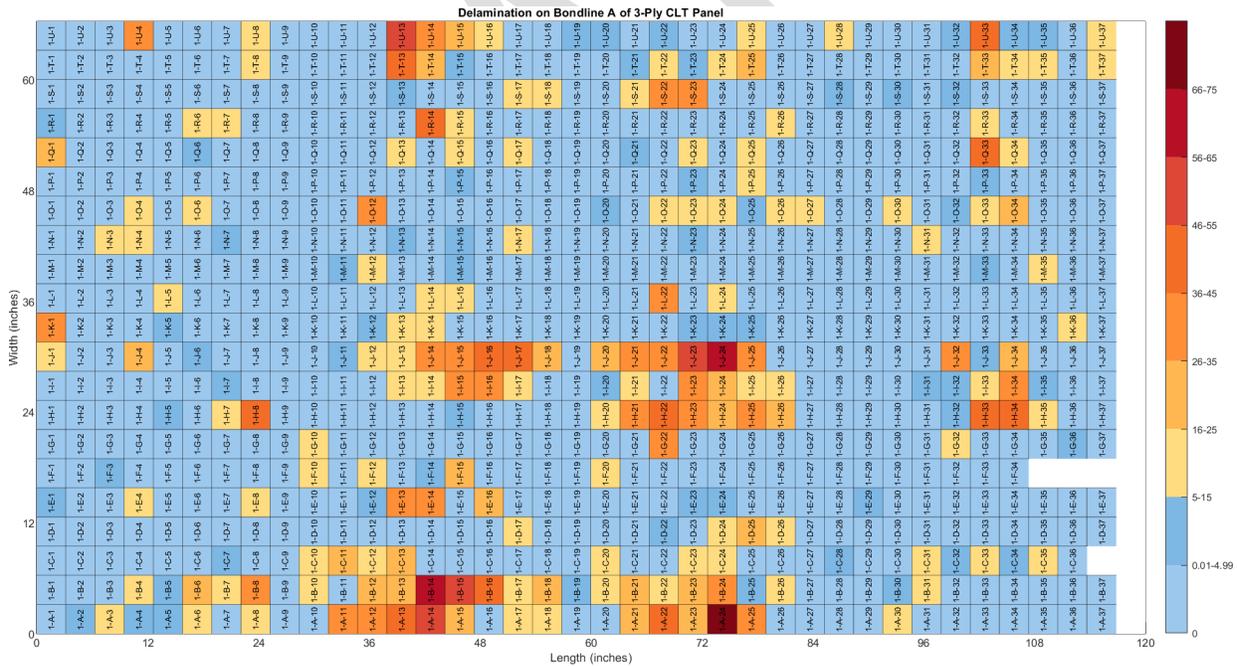
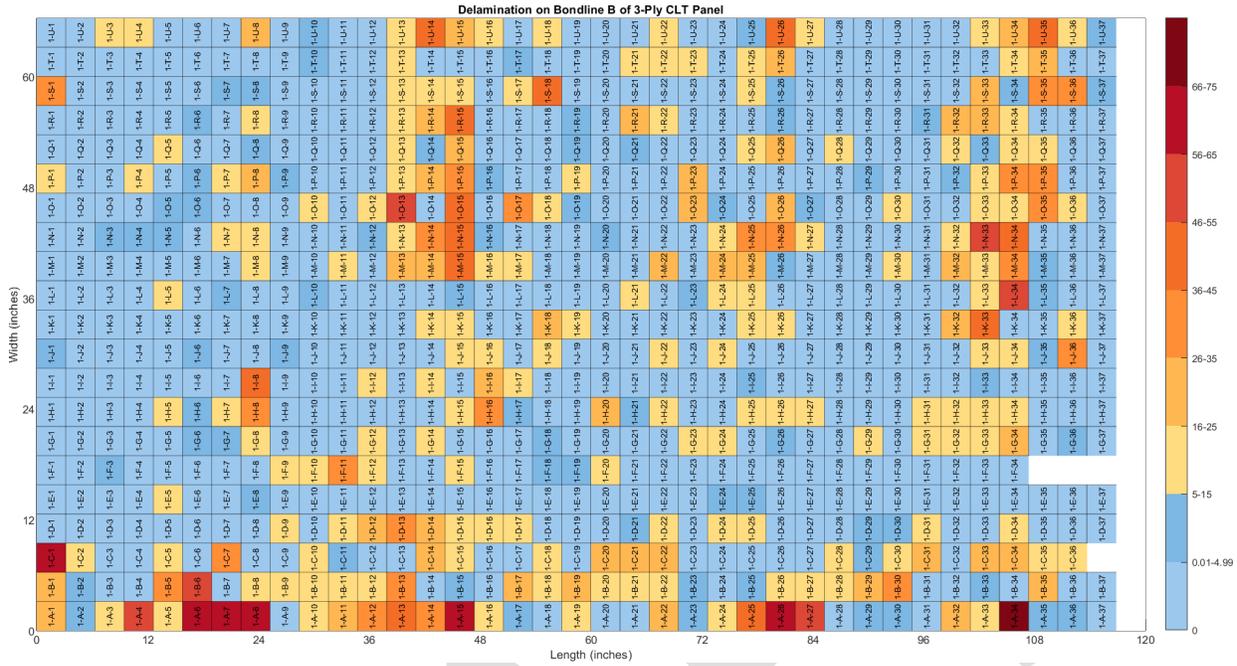
The results of PRG320-2019 delamination tests for all block specimens obtained from 3-ply panel are summarized in Figure 3. The color-coded maps show levels of delamination recorded in two bond planes of individual specimens. The shades of blue indicate acceptable (passing) level of delamination in that bond line (within 5%).

Figure 10. Color coded *Delamination map* for two bond planes in 3-ply MF panel. Color scale reflects the percent of delamination in each block measured after PRG320-2019 PRG delamination test (shades of blue show acceptable level of delamination or pass).

Careful visual examination of delamination in individual bond planes in Figure 3, reveals that the delaminations away from the rammed edge tend to form constellations aligned along individual pieces running either the longitudinal or transverse direction.

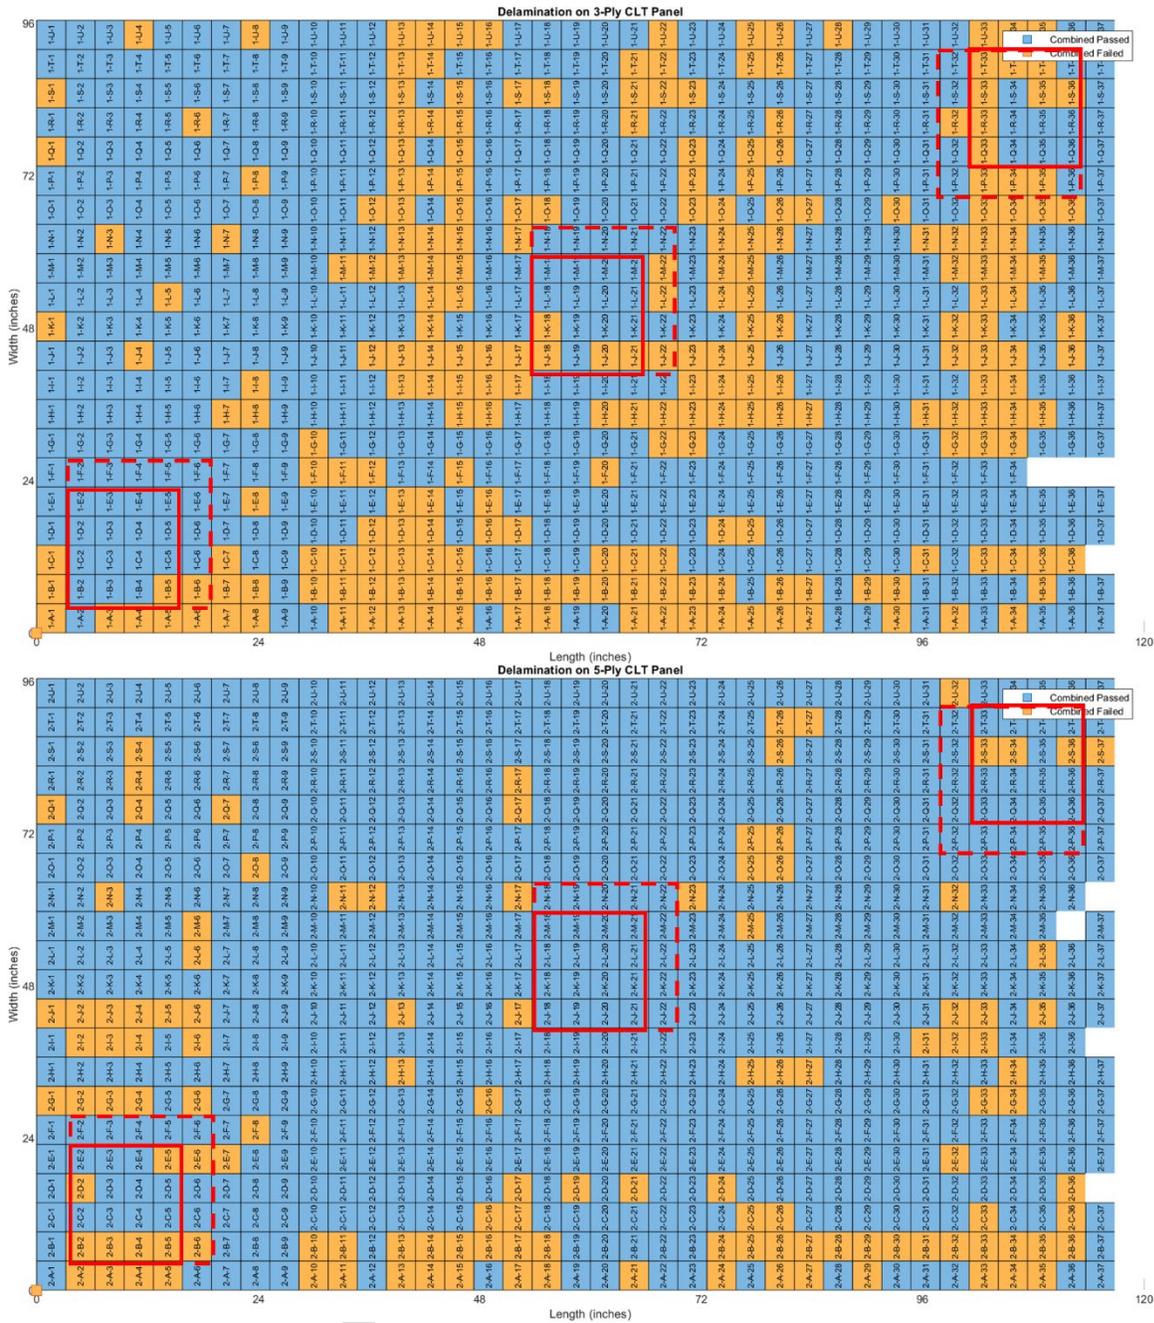
However, it is the average delamination in these two bond planes, or in four bond planes in 5-ply panel, that decides whether or not the specimen is considered passing or failing the PRG320 delamination criterion. Distributions of specimens failing the PRG320-2019 delamination criterion in the 3-ply and 5-ply MF panels are shown in Figure 4.

Figure 11. Distribution of specimens failing PRG320-2019 delamination criterion in 3-ply (top) and 5-ply (bottom) MF panels with possible sampling areas marked as solid and dashed red rectangles.

While both panels show disappointing numbers of specimens failing the PRG320-2019 delamination criteria, examination of the content of the possible sampling areas marked on the panel maps as solid

A quick inspection of Figure 4 and the summary columns showing numbers of passing and failing specimens in *Table 2* and *Table 3*, proves that 70% (in 3-ply panel) to 80% (in 5-ply panel) of the specimens with these features passed the PRG320-2019 delamination test.

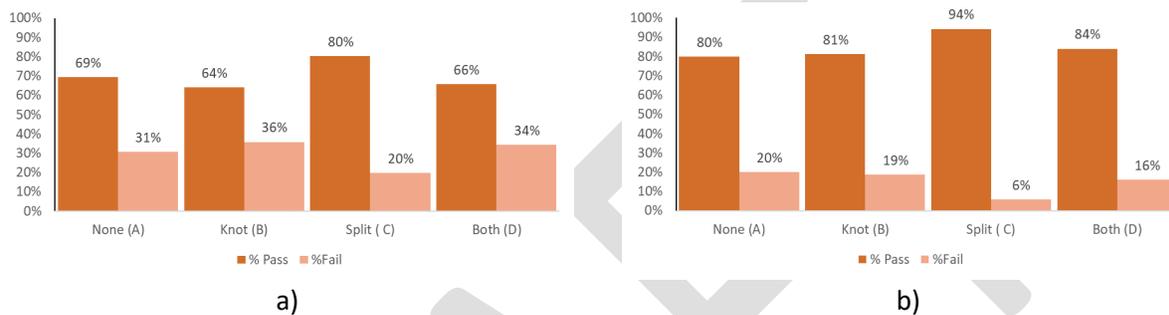
Nonparametric Kruskal-Wallis test performed at 0.95 confidence level on the groups represented in the columns of *Table 2* and *Table 3* show that specimens containing knots were just as likely and splits significantly less likely to fail the delamination test in both 3-ply and 5-ply panels. Specimens containing both knots and splits were again just as likely to fail delamination tests as the clear specimens.

Figure 13. Comparison of proportions of specimens passing and failing the PRG320-2019 delamination tests in 3-ply (a) and 5-ply (b) MF panels by categories: clear specimens (A), specimens with knots touching a bond plane (B), specimens with inter-lamination gaps (C) and with both, knots and gaps (D). (Based on n=775 in both panels).

Comparison of absolute numbers and proportions of specimens passing and failing the PRG320-2019 delamination tests in 3-ply (a) and 5-oly (b) MF panels by categories: clear specimens (A), specimens with knots touching a bond plane (B), specimens with inter-lamination gaps (C) and with both, knots and gaps (D) based on 775 delamination specimens harvested from each panel are shown in the middle sections of *Table 2* and *Table 3* and in Figure 6.

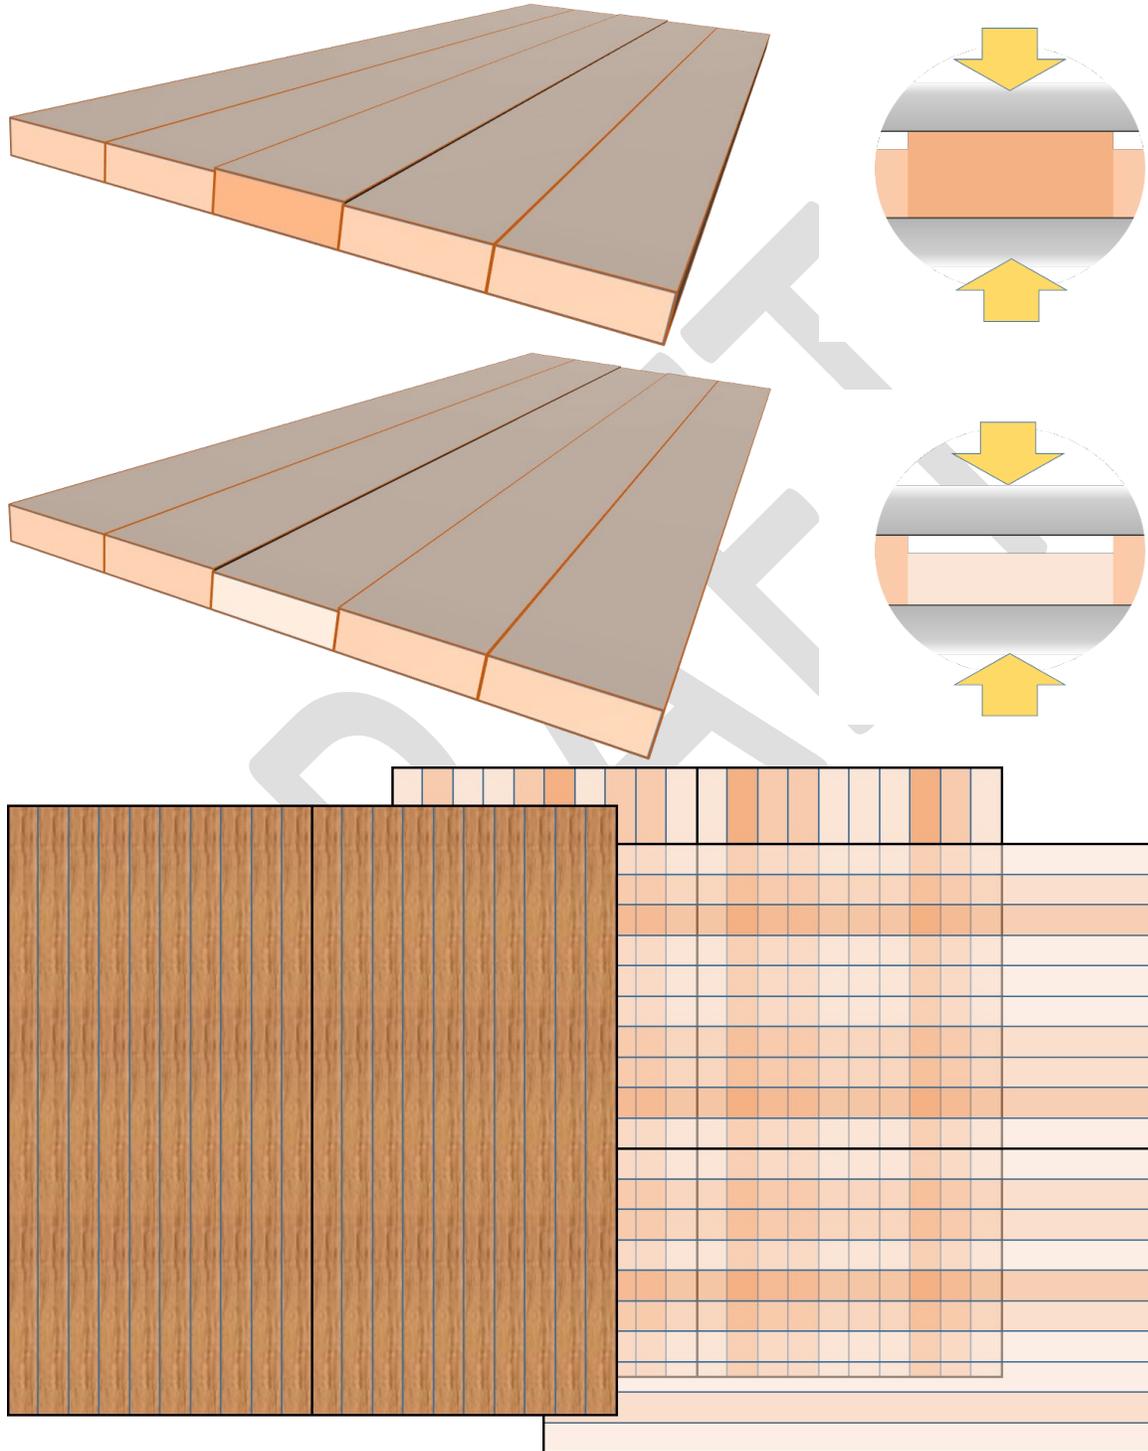
clamping pressure of that layer. Things get quickly complicated when layers with loose thickness tolerances are cross laminated. The effect is schematically illustrated in Figure 7.

Figure 14. Schematic diagram illustrating propagation of thickness variation along the lamination within one layer, and a potential for bridging when layers with variable lamination thicknesses are cross laminated.

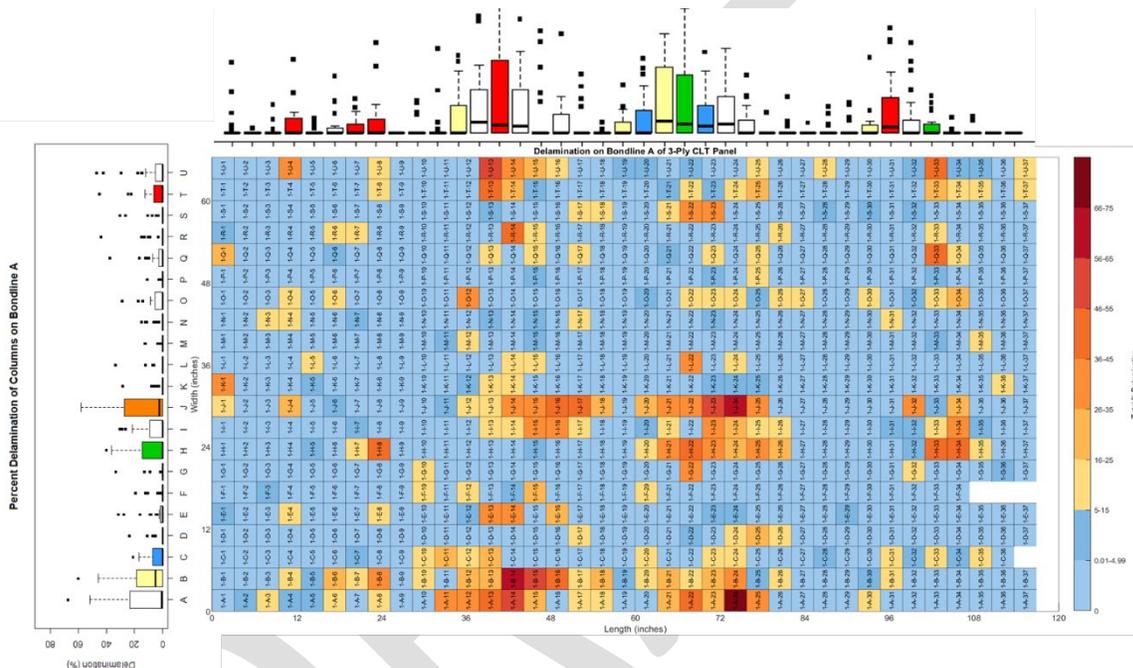
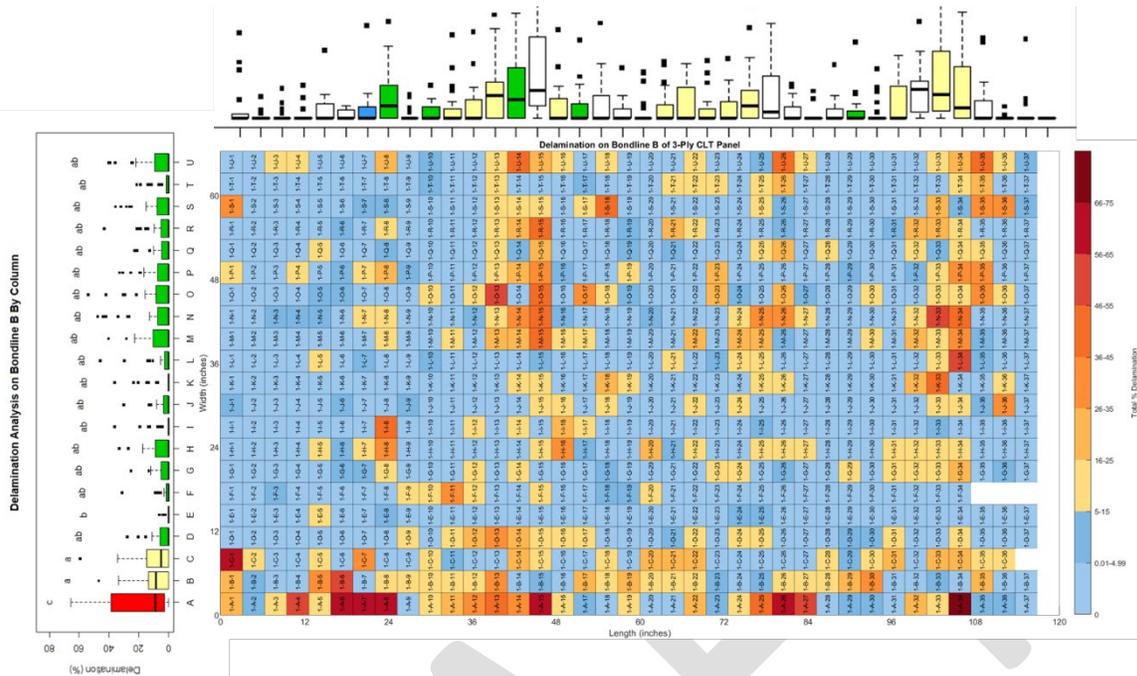
This observation is corroborated by the analysis of the frequency of delaminations within these layers shown in Figure 8.

Figure 15. Distribution of frequency of delaminations within individual bond planes in 3-ply MF panels within horizontal and vertical strips. Alignment along individual laminations may be an indication of an effect of lamination thickness variation

While this is not a definite proof, it is nevertheless a clue indicating a potential role of lamination thickness variation in the delamination failures found in the MF panels.
